Re: Easton Pond Dam and Moat Study
Final Report

Final Report
Easton Pond Dam and Moat Study

City of Newport
Newport, Rhode Island

September 2007

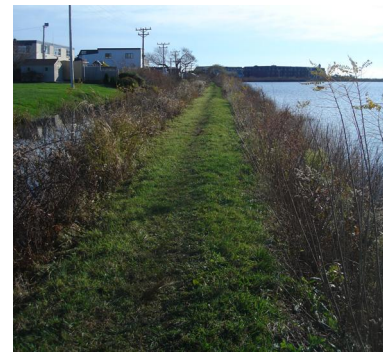
Dam STA-1 Clear and Grub Woody Vegetation from Embankment Slopes – Brush and woody vegetation is heavily established on the entire East Embankment and portions of upstream slopes of all other embankments. Trees were also observed within 25 feet of embankment structures. These conditions are a concern because woody vegetation obscures the embankment surface and prevents early and direct observation of deficiencies during inspections, root systems can create seepage pathways through embankments, and overturning of trees can create significant voids when root systems are disrupted, which could create pathways for seepage through the embankment. If left unattended, these conditions could develop into significant seeps with internal piping of soils, leading ultimately to a localized failure of the embankment and posing a potential hazard to downstream persons and property. In addition trees and brush can attract and harbor animals whose burrows can cause serious structural and/or hydraulic deficiencies.

Photograph 1: Vegetation on East Embankment

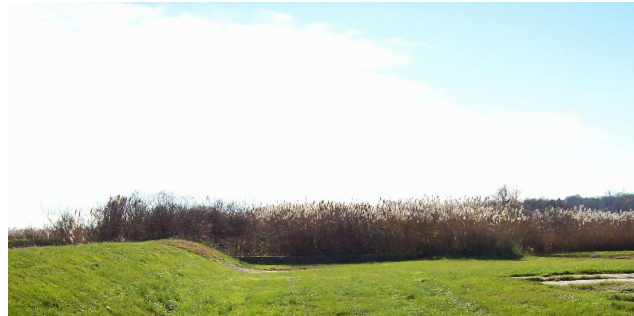
This vegetation impedes flow when discharges occur, resulting in surface runoff overflowing the channel banks and surcharging the adjacent downstream area. Recommended practice for dams is to maintain overflow spillways and channels free of vegetation that would obstruct flows.

Photograph 2: Vegetation in North Pond Emergency Spillway Channel

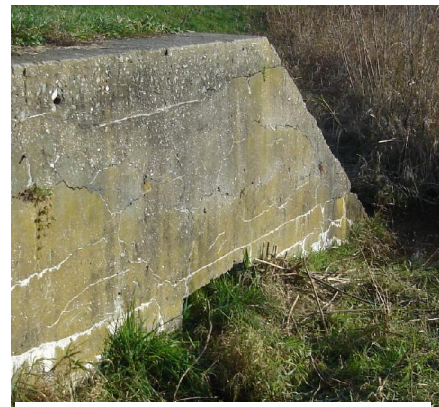
— Severe cracks were observed on the concrete spillway bar and abutments, and a void was observed at the bottom of the left (east) abutment. In addition, there were several areas along the spillway bar where apron scour stones were missing, resulting in voids that could develop to undermine the spillway bar during significant flows. Finally, worn areas were observed on the embankment immediately adjacent to the right abutment, likely resulting from foot traffic and having developed to a point where they collect and channelize stormwater runoff from the embankment crest. If left unattended, these locations could deteriorate further resulting in significant loss of embankment soils and a possible rupture of the embankment during high water conditions.

Photograph 3: Void at Bottom of Left Abutment

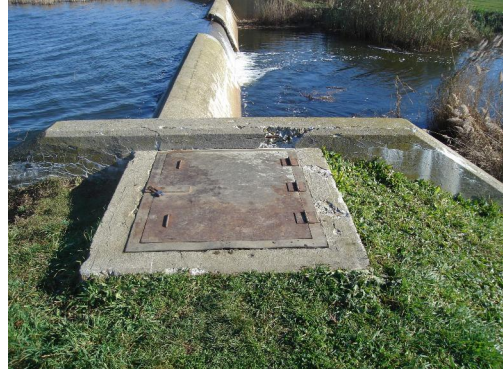
Dam STA-5 Repair South Pond Spillway Concrete Structures — Significant cracks and areas of spalling were observed on the spillway, abutments, and drawdown gate chamber during the inspection. In addition, the bracing forming the low-level weir board channel at the center of the spillway was found to be secured by weakened concrete exhibiting significant spalling. These conditions will continue to deteriorate in the future and ultimately lead to more significant deficiencies requiring replacement of these structures (replacement is identified in this report as a long-term alternative for the spillway weir only; abutments and the valve chamber were observed to be in satisfactory condition at the time of the inspection).

Photograph 4: Deteriorating Concrete at South Pond Spillway

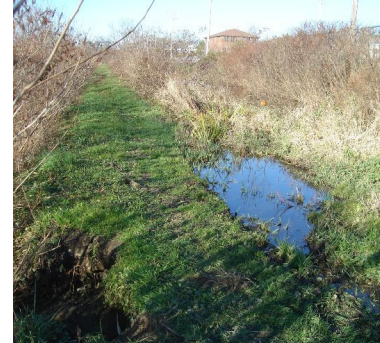
Dam STA-6 Construct Stormwater Channel Along East Embankment Slope —A small body of standing water and a submerged stormwater discharge pipe draining from Middletown were observed near the north end of the East Embankment. A significant scarp resulting from stormwater runoff from these features was observed at the embankment crest reflecting previous discharges from these structures entering South Pond (direct stormwater runoff entering South Pond). A grassed area was observed further downstream of this area, separating the standing water and pipe outlet from a drainage channel located approximately 300-feet down gradient, which ultimately discharges to the stilling basin associated with the South Pond spillway.

Photograph 5: Rilling/Scarp on East Embankment (Standing Water Obscured in Background)

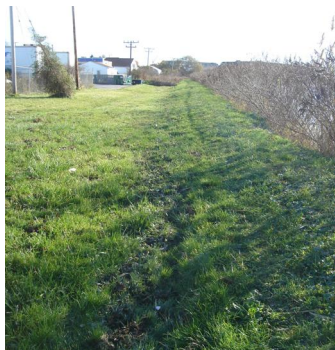
Photograph 6: Grassed Area Downstream of Rilling/Scarp

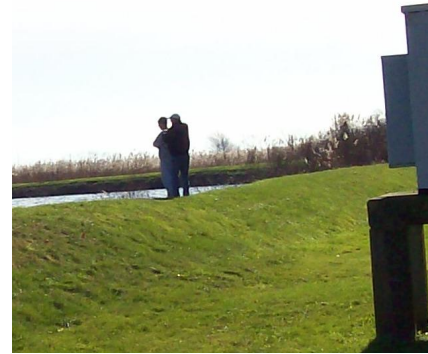
Dam STA-7 Repair North Pond Embankment Settlement Area – A limited area where the embankment crest and adjoining portion of the upstream slope had settled was observed in the general location of where the treatment plant's intake pipe passed below the embankment to the raw water process building. This area extended for approximately 40 feet along the embankment and if not addressed could develop in the future to a point where the embankment crest falls to an elevation at which it would become a preferential pathway during sufficiently high water conditions in the impoundment. This area should be backfilled with impervious fill and topsoil to original grades and revegetated with grass and slope armor protection to match adjacent areas.

Photograph 7: North Pond Embankment Settlement Area

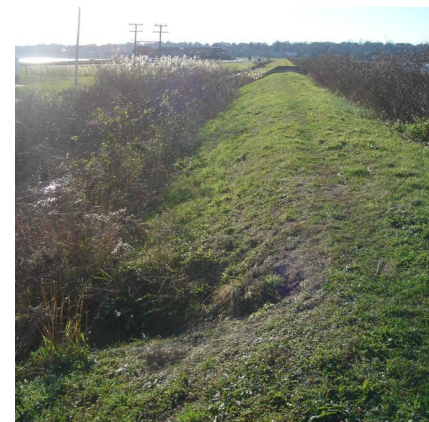
Dam STA-8 Repair East Embankment Settlement Area and Footpath – An area of limited settlement was also observed immediately adjacent to the left upstream abutment of the South Pond spillway. This area extends approximately 50 feet from the abutment on the upstream slope of the embankment. In addition, a worn footpath running from the crest over the downstream slope to a plank over the drainage ditch approximately 100 feet east of the South Pond Spillway has developed as a preferential pathway for stormwater runoff. If left unaddressed, these areas could continue to worsen as from future and/or significant rain events resulting in increased erosion, loss of embankment material, and potential failure of the embankment during high-water conditions in the impoundment. These areas should be backfilled with impervious fill and topsoil to original grades and revegetated with grass and slope armor protection to match adjacent areas.

Photograph 8: Worn Footpath Causing Erosion on East Embankment

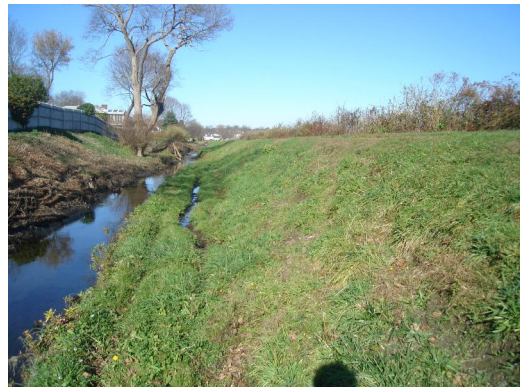
Dam LTA-1 Realign Portions of Embankments – The moat channel was observed to be scouring the grassed bench area adjacent to the downstream slope at a number of locations along the South, West and North embankments. Further, at some of the locations near the north end of the West Embankment, the scouring has progressed to such a degree that the moat channel is beginning to encroach upon the downstream embankment slope. The moat channel is characterized by an 18-inch to 24-inch deep scarp along its banks as a result of this scouring. Mowing equipment rutting on the downstream slope and bench further exacerbate this condition by pushing soil toward the moat channel, where it ultimately calves in sections into the moat channel due to shear forces during high flows.

Photograph 9: Moat Encroachment and Bench Rutting along West Embankment

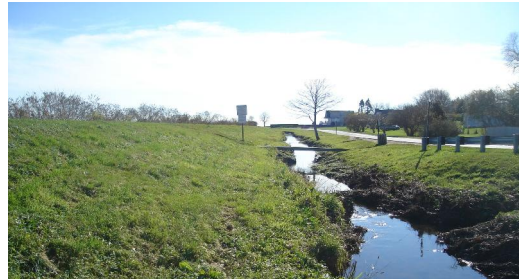
to a greater potential to lose additional soil at a quickening rate. Further, the loss of soil mass along the downstream toe contributes to the embankments overall instability, as an adequately sized bench composed of soil having a suitable strength serves to buttress the embankment, acting as a restraint to sliding and slip-circle failures. This instability was previously evaluated in a 1991 geotechnical evaluation of the embankments; it is understood that no work (e.g., gravel slinging as conducted on portions of the North Embankment) was subsequently conducted on this portion of the embankment to address the concerns of this report.

Photograph 10: Moat Scouring and Encroaching along West Embankment

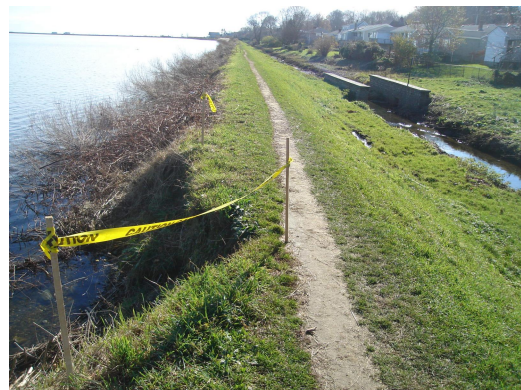
Photograph 11: Upstream Slope Failure and Worn Footpath on West Embankment

- Realign the West Embankment as required to provide a minimum bench width of 10-feet along the moat channel, maximum 3H:1V slopes in accordance with current accepted dam construction guidelines, and a minimum crest width of 12-feet. Some portions of this embankment (primarily southern portions) currently have between 4-feet and 8-feet

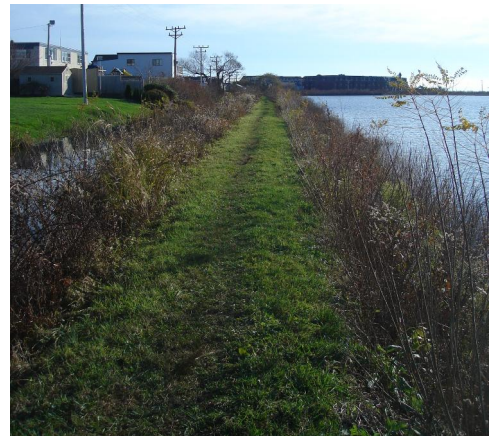
Photograph 12: Narrow Crest Width on East Embankment

- Realign the East Embankment as required to provide a minimum 10-foot bench width, maximum 3H:1V slopes and a 12-foot crest width. This work would also result in the removal of trees and other woody vegetation from the embankment, restoration of upgradient slope protection and providing adequate room on the crest and at the downgradient toe of slope for future equipment access. Based on the current embankment dimensions and the recommended embankment configuration noted above, a horizontal movement of approximately 14 feet into the impoundment would result (assuming a 5 percent impoundment bottom slope).

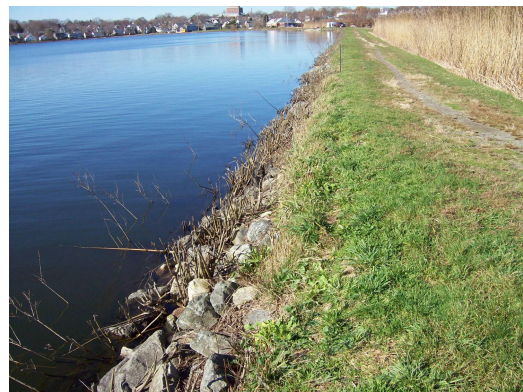
Photograph 13: Upstream Slope Protection and Worn Footpath on North Embankment

- Restore upstream slope protection along the North and South Embankments, both sides of the North Pond/South Pond Dividing Embankment, and the North Pond Embankment. This work would entail placing a fill to provide a stable base upon which to place the slope protection (several

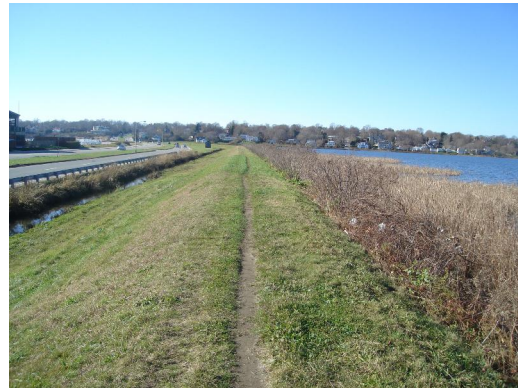
Photograph 14: Worn Footpath on Crest of South Embankment

Dam LTA-6 Rebuild/Regrade Embankment Crests - This alternative would be to regrade and reestablish grass vegetation with subsurface reinforcement for a walking surface on all embankment crests (with the exception of the section from the dividing embankment to the North Pond emergency spillway) without increasing the crest widths. The reinforced walking path could consist of a geosynthetic product similar in configuration to the cellular confinement slope protection product described in Dam LTA-1.

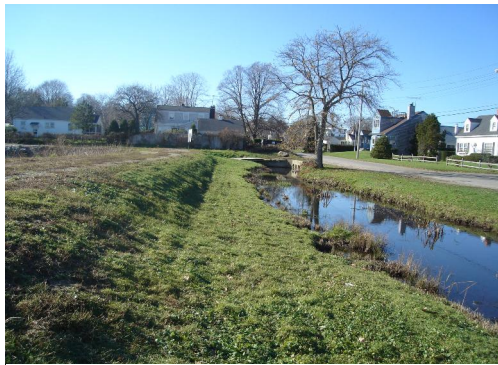
Photograph 15: Moat Along Ellery Road

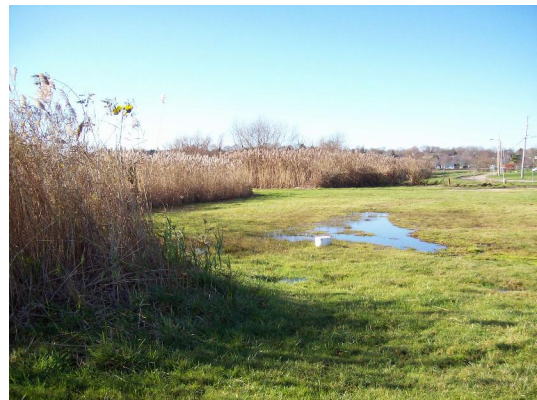
plant (consistent with the typical Manning's coefficient value for weedy, unmaintained channels). As shown in Photograph 16, this area is inundated with reeds. Refer to Appendix F of this report for a copy of typical Manning's coefficients used in channel and overbank areas (from HEC-RAS Hydraulic Reference Manual Version 3.0, January 2001). Additionally, photos of the Moat and overbank areas are provided in Appendix G.

Photograph 16: Moat Overbank Areas Adjacent to Old Filtration Plant
