Technical Memorandum

Phase 1 Part 2 CSO Control Plan Wellington Avenue CSO Facility

Thames Street Interceptor Television Inspection

August 30, 2006

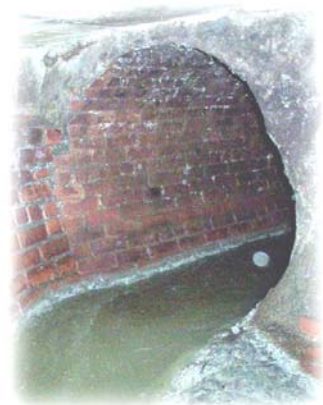
Photo 1 – Typical View of Thames Street Interceptor

The Thames Street Interceptor is the major interceptor sewer serving Newport. It is a brick, egg shaped, 38-inch wide by 49-inch tall sewer (Photo 1) that flows approximately 6,200 linear feet from south to north parallel to the Newport Harbor shoreline between Morton Avenue and Washington Square. As Shown on Figure 2, at an upstream location, flow enters the Thames Street Interceptor from the eastern portion of the City at Narragansett Avenue. An 84-inch storage conduit is located on Narragansett Avenue to provide approximately 0.55 million gallons (mg) of storage of wastewater flows during wet weather. The interceptor also receives flow from the southern portion of the City at the intersection of Carroll Avenue and Morton Avenue and the southeastern portion of the City at Wellington Avenue as well as flow from Middletown's Wave Avenue Pump Station at Memorial Boulevard and Bellevue Avenue. The interceptor receives flow from many direct connections from collector streets between Morton Avenue and its downstream terminus near Touro Street.
