November 7, 2019

Structural Inspections and Evaluation, Waites Wharf buildings

Narragansett Engineering Inc (NEI) and Merk Structural Consulting are pleased to present for your review our inspection of the aforementioned structures located on Waites Wharf in Newport, RI (Subject Properties). An on-site structural survey of the above referenced property was conducted by Narragansett Engineering Inc. (NEI) on August 8, 2019.

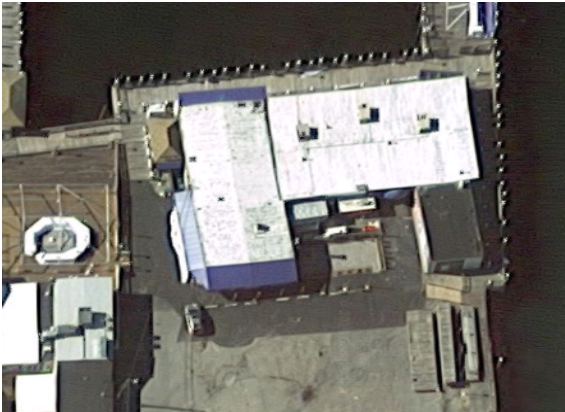
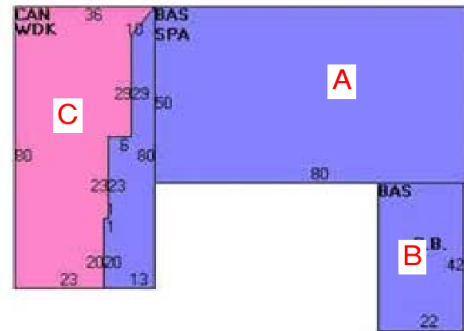
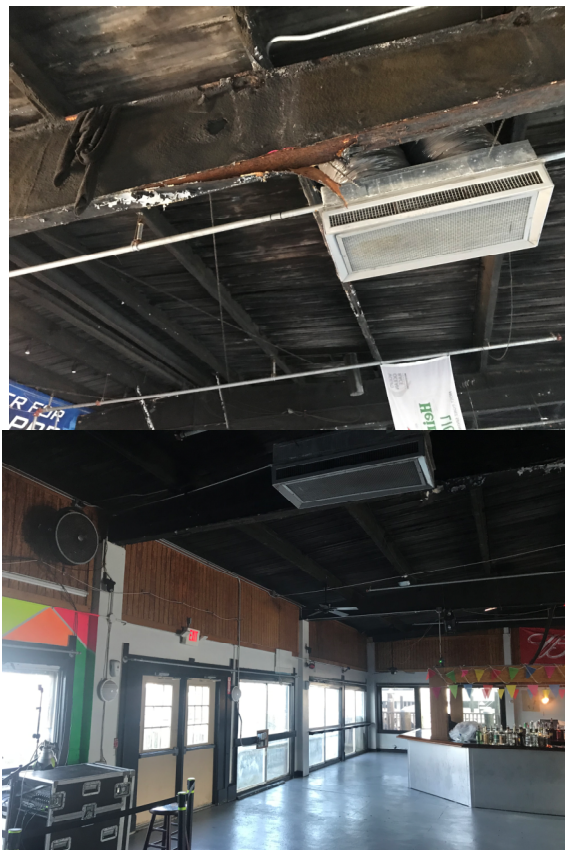
Dockside

Subject 1 is comprised of three sections (denoted A, B, C above). Section A is a pre-engineered metal building consisting of wide flange main frames, light gauge "Z" purlins and metal deck. The ground floor is partial slab on grade and a small portion of the building appears to be supported on wood dock pilings. There is evident steel corrosion and delamination throughout this portion of the building. Additionally, it does not meet the current FEMA regulations and minimum standards for flood zone design and construction.

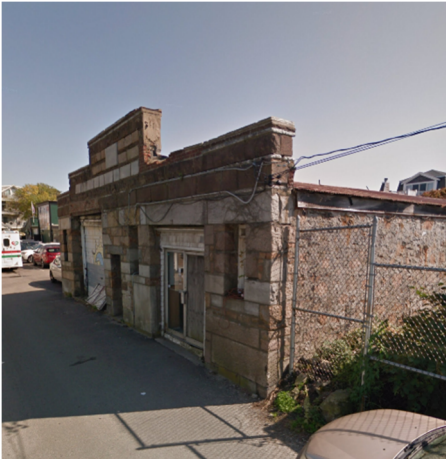
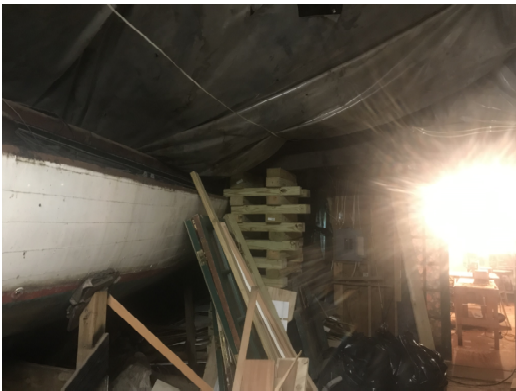
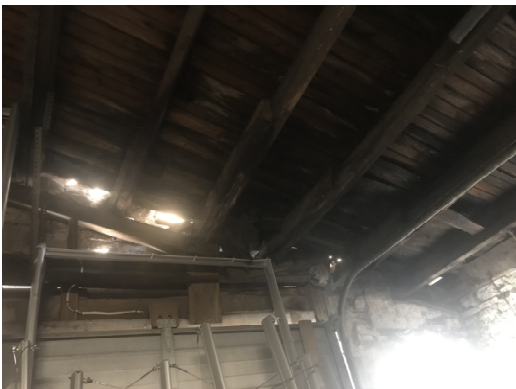
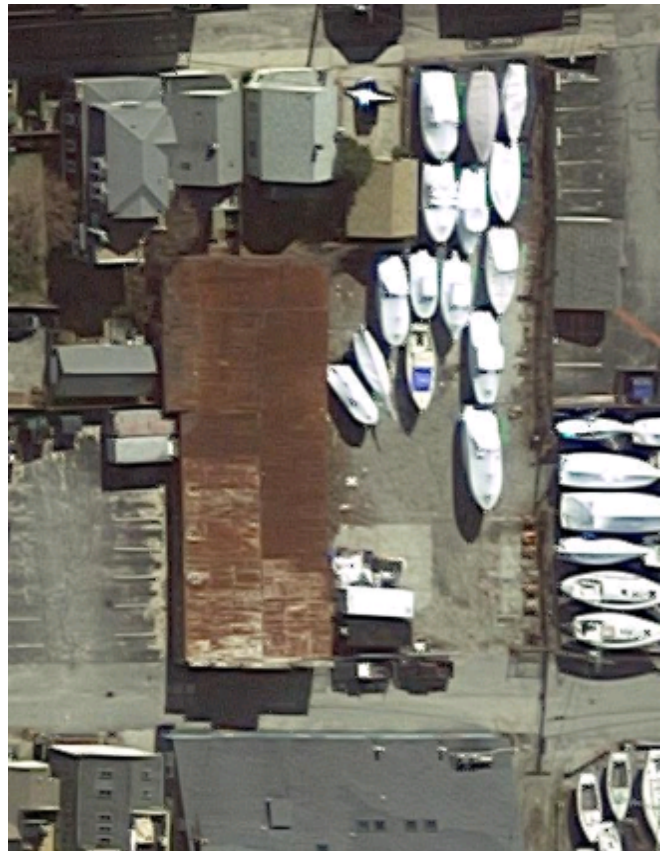
Masonry Storage Building (Private)

Subject 2 is a single story building with stone and brick masonry exterior walls. The majority of the building is a concrete slab on grade but has small areas of dirt floor as well as a section that is wood decking on wood sleepers. The roof is constructed with heavy timber wood trusses spaced approximately 15'-0" on center with transverse 2x purlins spaced approximately 24" on center that support board sheathing. The building is in significant disrepair. The roof is collapsing in several locations with one truss being supported on cribbing. Additionally, it does not meet the current FEMA regulations and minimum standards for flood zone design and construction.

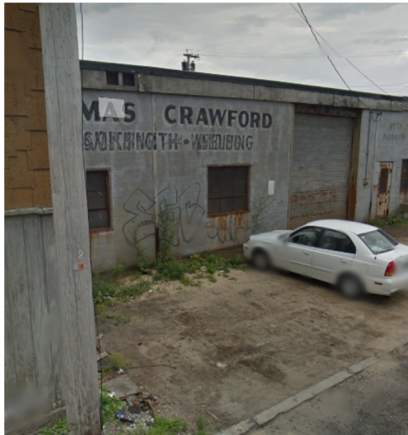
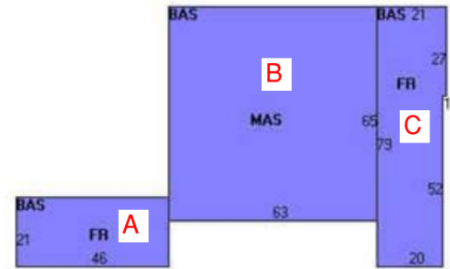
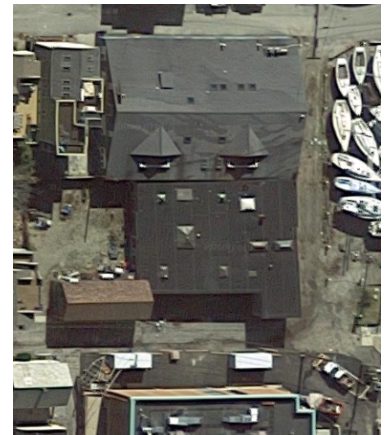
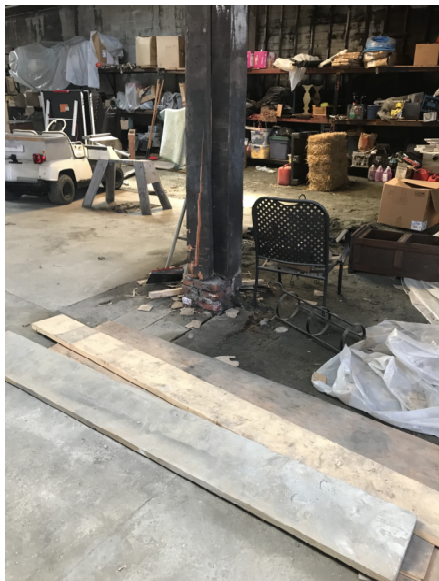
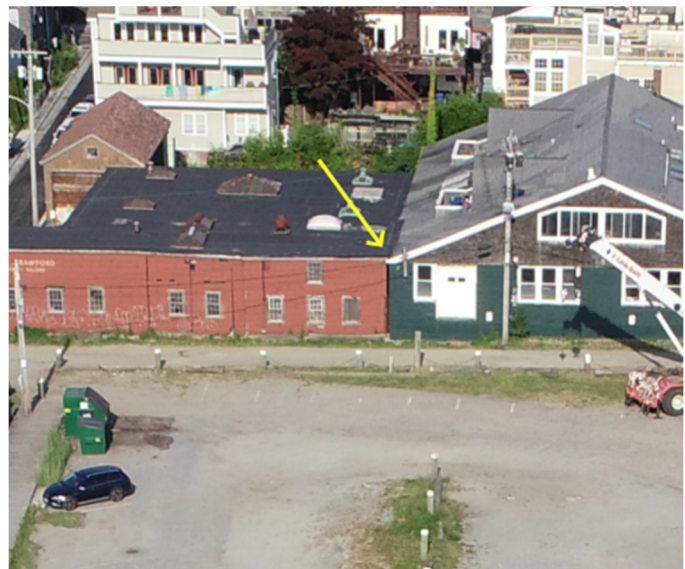
“Crawford Building”

Subject 3 is comprised of three sections (denoted A, B, C above). Section A is constructed with a combination of wood and concrete exterior walls that support a conventional tied roof system. The roof is framed with 2x rafters and 2x rafter ties approximately 16” on center. This section

has a dirt floor. Section B is a steel framed building with concrete block exterior walls infilled between the steel frame. The steel frame has wide flange columns, girders and beams that support heavy timber decking. The beams are spaced approximately six to eight feet on center. The floor is a combination of concrete slab

on grade with some areas of dirt floor. Section C is constructed with wood stud exterior walls, interior steel and wood columns that support steel girders, 2x rafters and timber decking. The floor is a combination of concrete slab on grade with some areas of dirt floor. The roof sheathing of sections B and C is connected to the adjacent “Casey” building. Although the sheathing is connected, this is a “non-structural” connection that can be easily severed prior to site demolition. While caution is required to demolish the Crawford Building, with respect to the Casey building, there are not physical or structural entanglements and demolition can be undertaken by a qualified contractor. Sections A and C of this building are in significant disrepair. There are cracked columns, failed roof joists, and signs of rot throughout. All three sections do not meet the current FEMA regulations and minimum standards for flood zone design and construction.

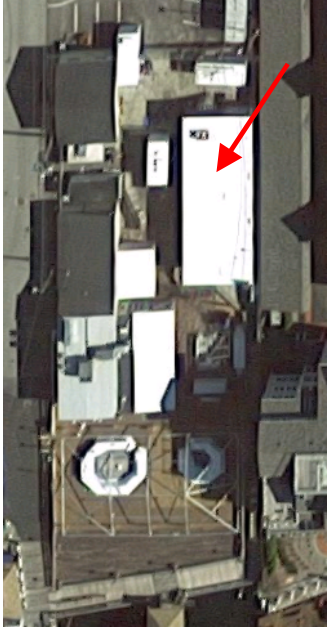
Subject 4 is comprised of three separate buildings, subjects 4A, 4B and 4C as noted above. Subject 4A is constructed with brick and block masonry walls that support heavy timber beams and heavy timber decking. The foundation walls appear to be concrete and there is a concrete slab on grade throughout the structure. Subject 4B is comprised of three sections (denoted A, B, C above). Section A is constructed with brick masonry walls that support heavy timber beams spaced approximately 10'-0" to 12'-0" on center. The timber beams support heavy timber decking. Section B is constructed with heavy timber posts supporting timber girders and beams. The timber beams are spaced approximately 8'-0" on center and support wood purlins spaced approximately 4'-0" on center. The purlins support metal roof deck. Section C is constructed with timber posts and beams that support 2X rafters spaced approximately 16" on center. The roof is sheathed with conventional plywood. Subject 4C is constructed with exterior brick masonry walls that support a loft and the roof. The loft is constructed with heavy timber posts and beams that support timber decking. The roof is framed with timber decking supported by a center heavy timber truss and the gable end walls. The floor is a concrete slab on grade. In general, the framing in these buildings appears to be in good condition but neither building meets the current FEMA regulations and minimum standards for flood zone design and construction.
