Re: *Demolition Application for 13 Clinton Street, Newport, RI
Plat 39 Lot 264*

Camera O'Neill Consulting Engineers • 888.308.7541
201 Clocktower Square, Portsmouth, RI 02871
info@cameraoneill.com • www.cameraoneill.com

Existing structural conditions for existing home located at 13 Clinton Street Newport, RI

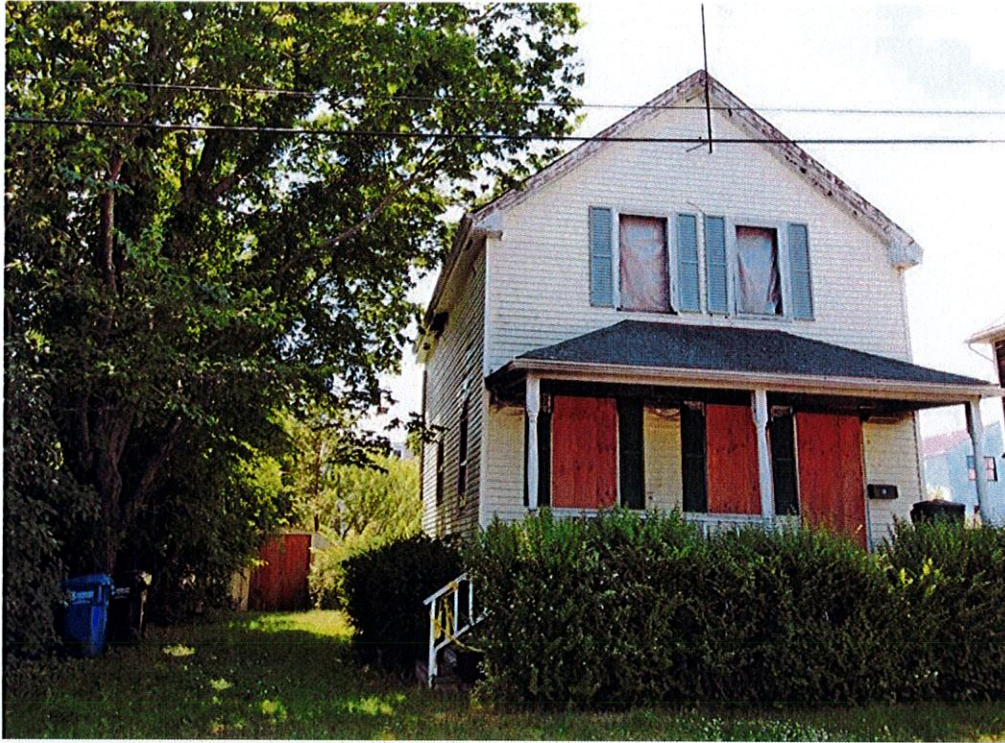
The structure in question is a modest sized wood-framed, single family home that appears to have been built in the late 1800's. Walking around the perimeter of the home, I was able to observe the foundation to be comprised of stone masonry in fair shape. The front porch framing appeared to be in general dis-repair. I was not able to observe the framing under the front porch at the time of my visit. The exterior rear deck, railings, and stairs were modestly constructed and were in significant dis-repair. In my opinion, the rear deck was un-safe at the time of my visit. The exterior siding, trim, and roofing materials appeared to be adversely affected by the recent fire. The exterior windows and doors were mostly broken and boarded up at the time of my visit. To properly repair the fire damage and long-term damage due to deferred maintenance, all of the exterior finished would most likely need to be removed and replaced. This includes the roof, siding, trim, some or all of the exterior sheathing, windows, and doors.

Photo of front of house (boarded up and broken windows/doors)

In my opinion, keeping the existing structural framing, given the proposed renovations would be impractical. I would recommend razing the existing house and its foundation and replacing it with a modern, code-compliant structure.

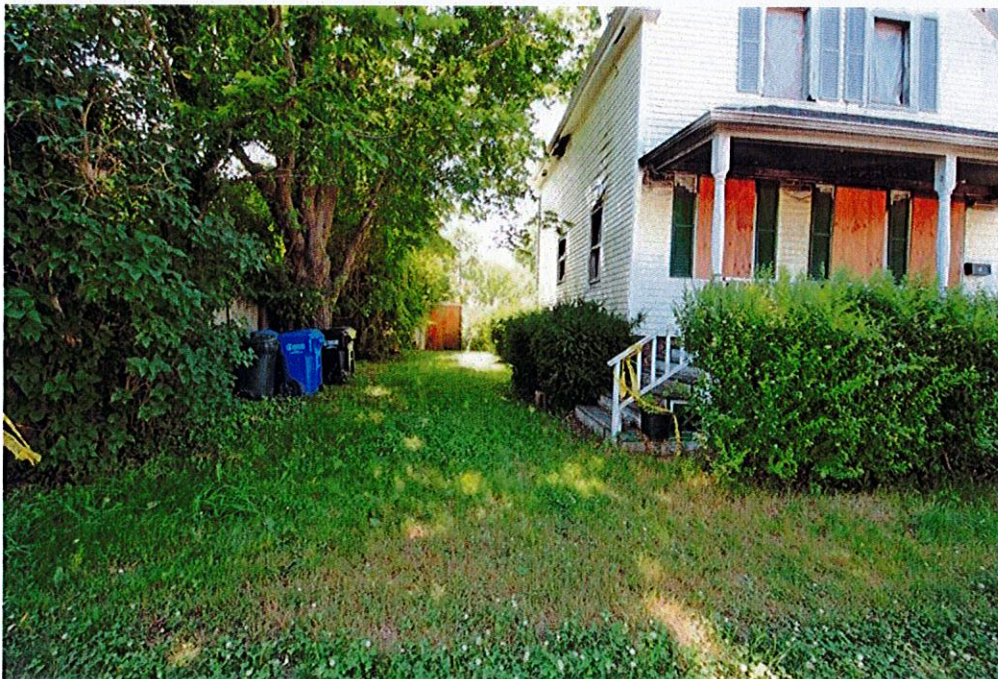
Melted siding, fire damage through upper eaves, boarded up windows/doors

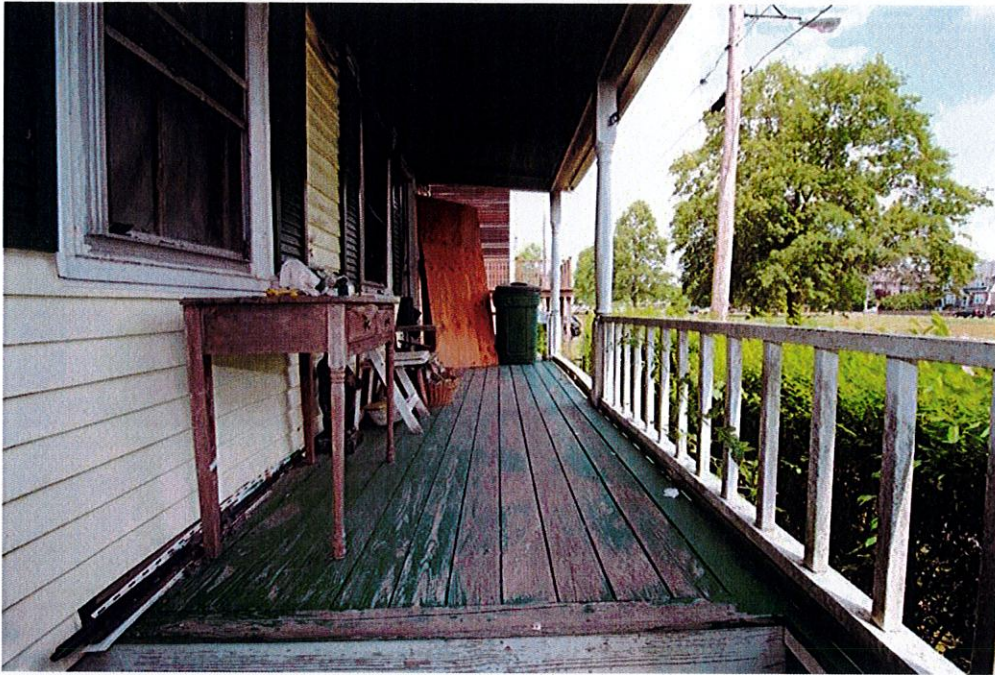
Photo of ill-maintained/leaning front porch

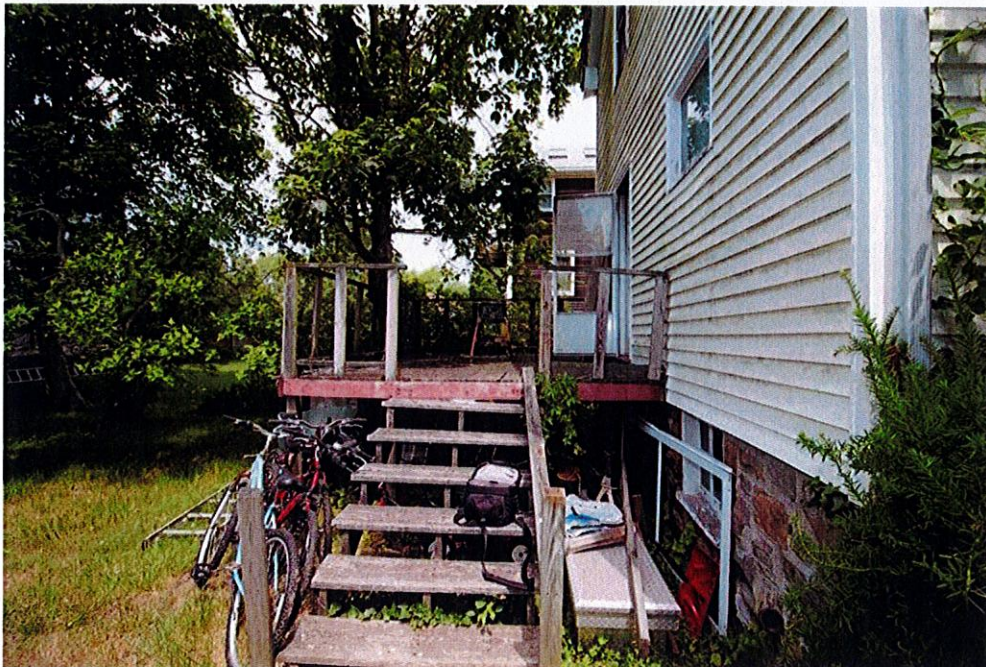
Photo of failing rear deck, railings, stairs

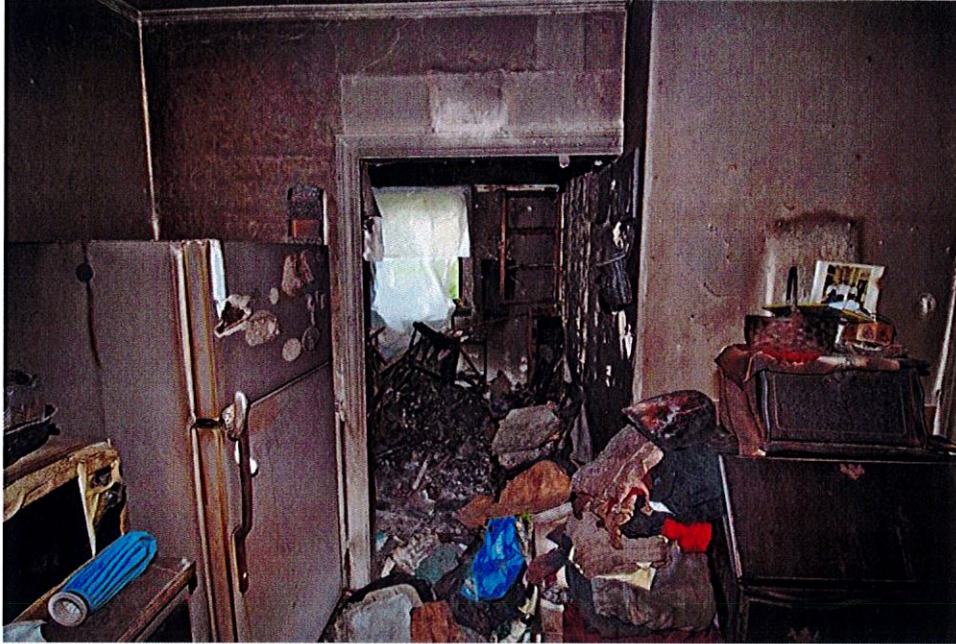
Once inside the first and second floors of the home, I was able to observe clear evidence of a fire. Every surface of every wall showed evidence of smoke damage. There was clear evidence of significant fire damage to 2nd floor joists, attic joists, and roof framing members. There was clear evidence of smoke and water damage throughout the home. In my opinion, the entire house would need to be completely "gutted" of all finishes (including flooring and utilities) to properly remediate the damage. Furthermore, areas of the 2nd floor, attic, and roof should be deemed "un-safe" until the structure is properly shored.

Interior smoke / fire / heat damage in first floor

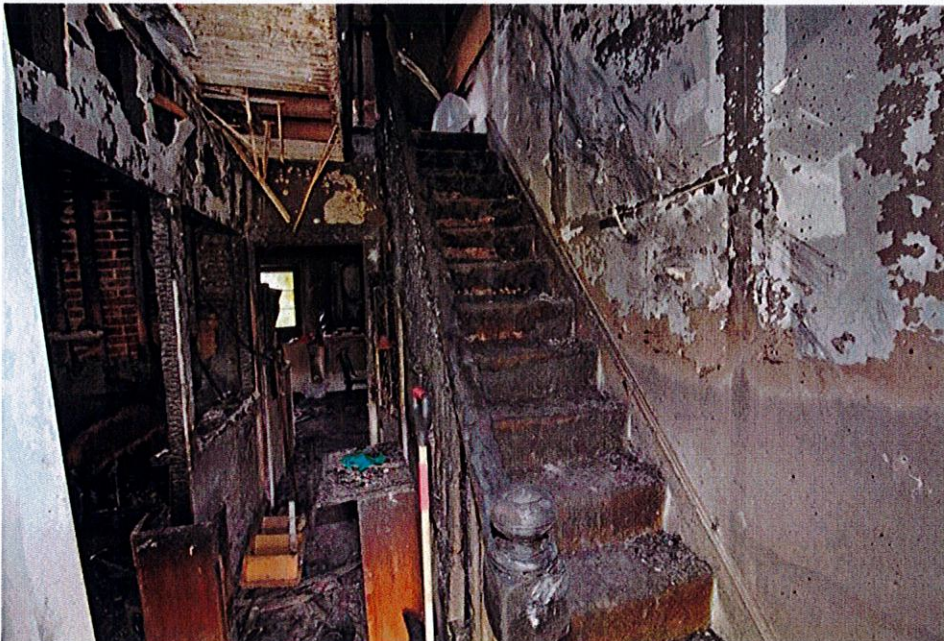
Interior smoke / fire / heat damage in first floor hallway
Note tight steep main stairwell

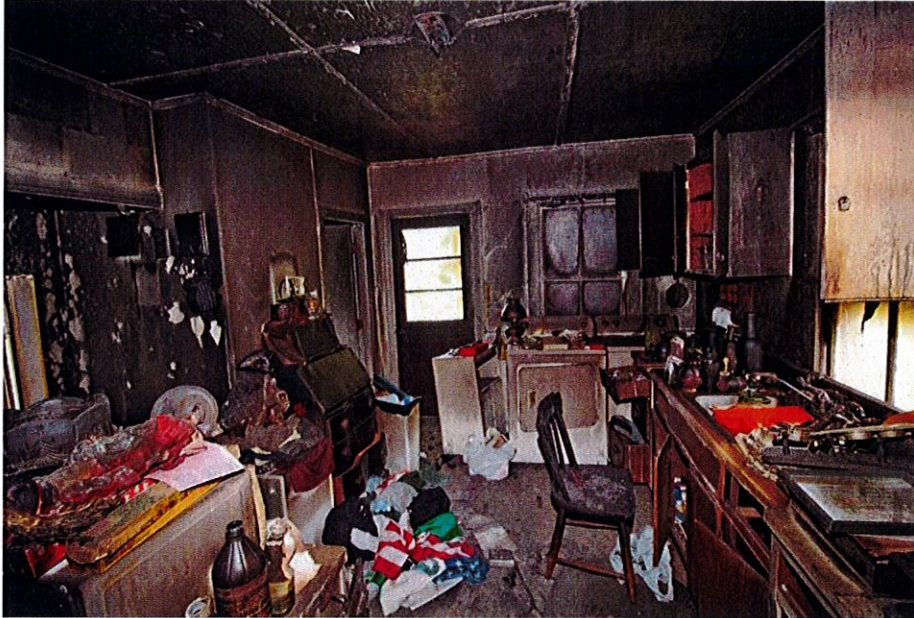
Interior smoke / fire / heat damage in first floor

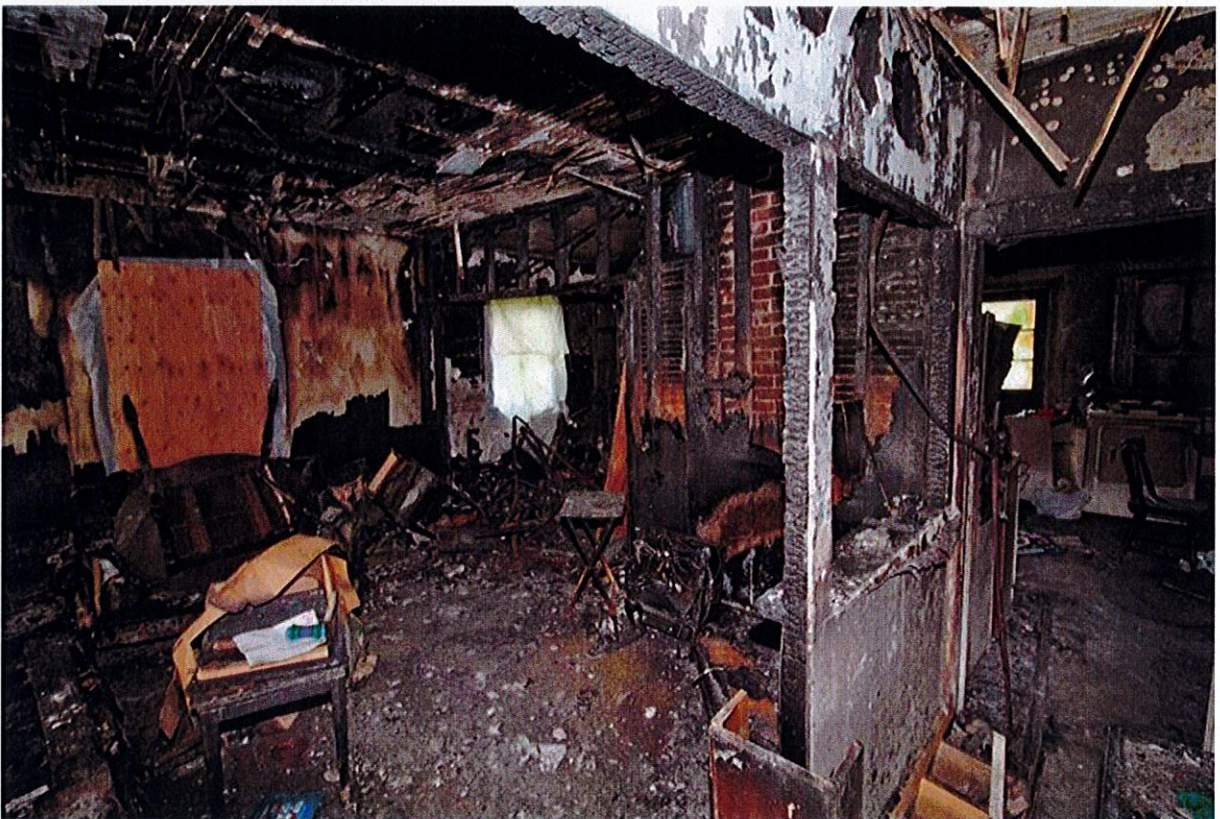
Interior smoke / fire / heat damage in first floor
Note fire damaged 2nd floor joists

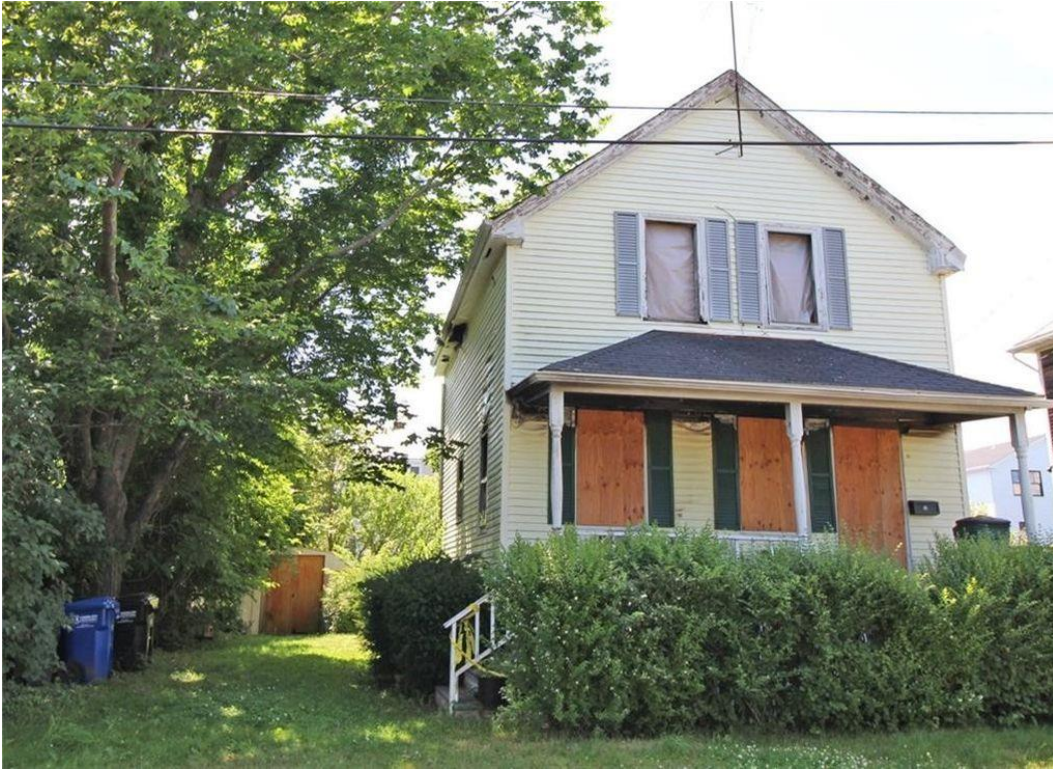
The structure in question is a modest sized wood-framed, single family home that appears to have been built in the late 1800's. Walking around the perimeter of the home, I was able to observe the foundation to be comprised of stone masonry in fair shape. The front porch framing appeared to be in general dis-repair. I was not able to observe the framing under the front porch at the time of my visit. The exterior rear deck, railings, and stairs were modestly constructed and were in significant dis-repair. In my opinion, the rear deck was un-safe at the time of my visit. The exterior siding, trim, and roofing materials appeared to be adversely affected by the recent fire. The exterior windows and doors were mostly broken and boarded up at the time of my visit. To properly repair the fire damage and long-term damage due to deferred maintenance, all of the exterior finished would most likely need to be removed and replaced. This includes the roof, siding, trim, some or all of the exterior sheathing, windows, and doors.

Photo of front of house (boarded up and broken windows/doors)

In my opinion, keeping the existing structural framing, given the proposed renovations would be impractical. I would recommend razing the existing house and its foundation and replacing it with a modern, code-compliant structure.

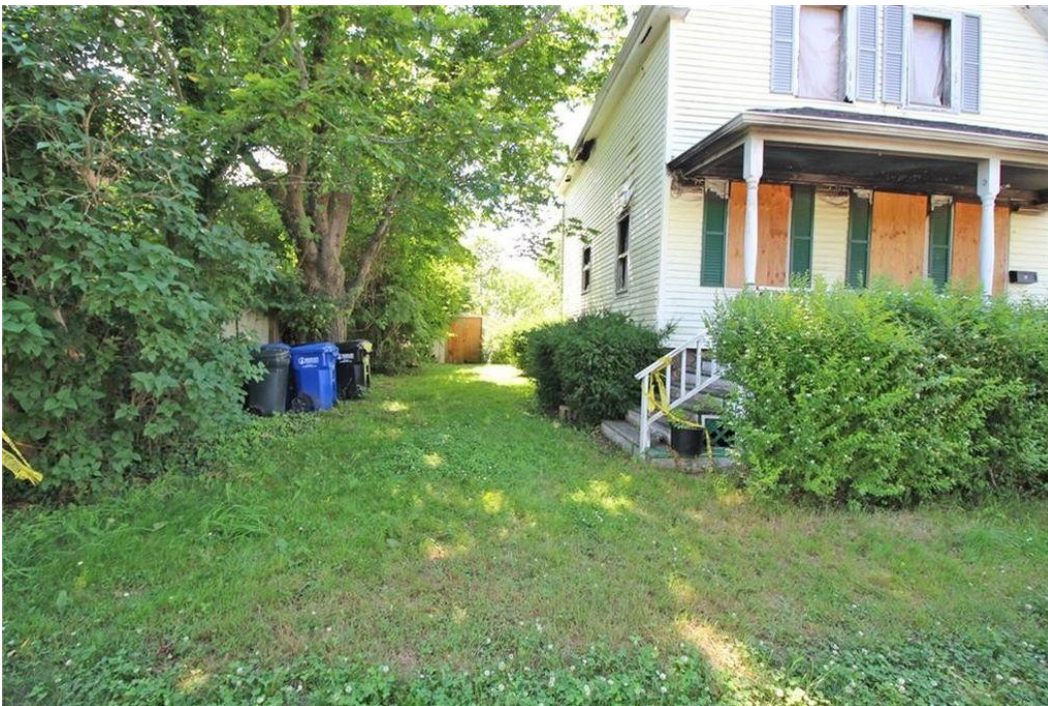
Melted siding, fire damage through upper eaves, boarded up windows/doors

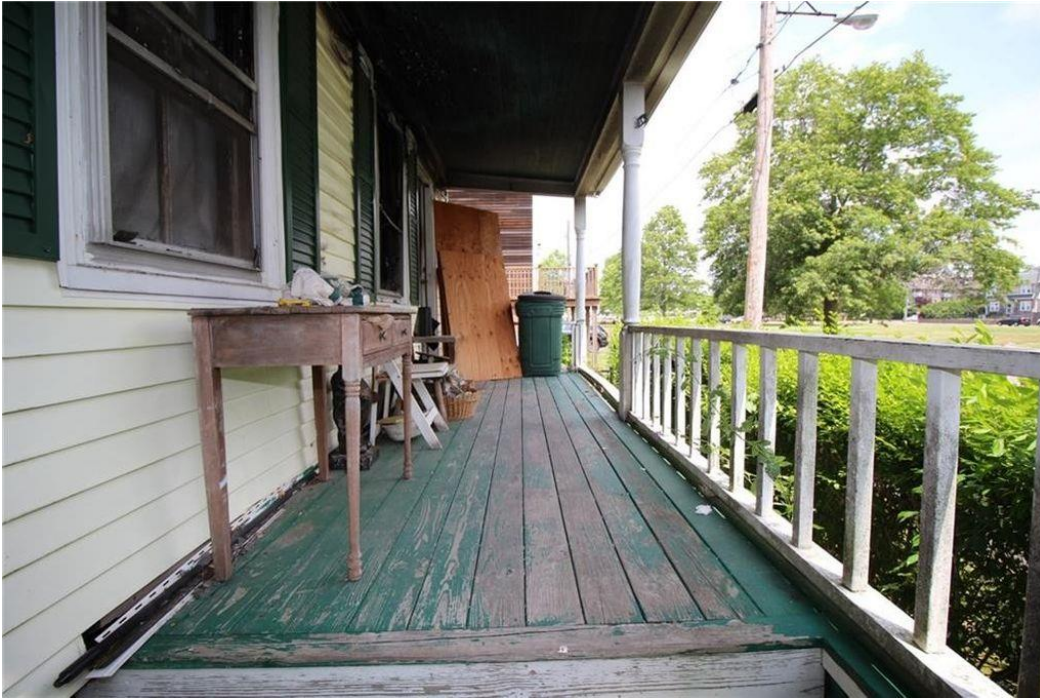
Photo of ill-maintained/leaning front porch

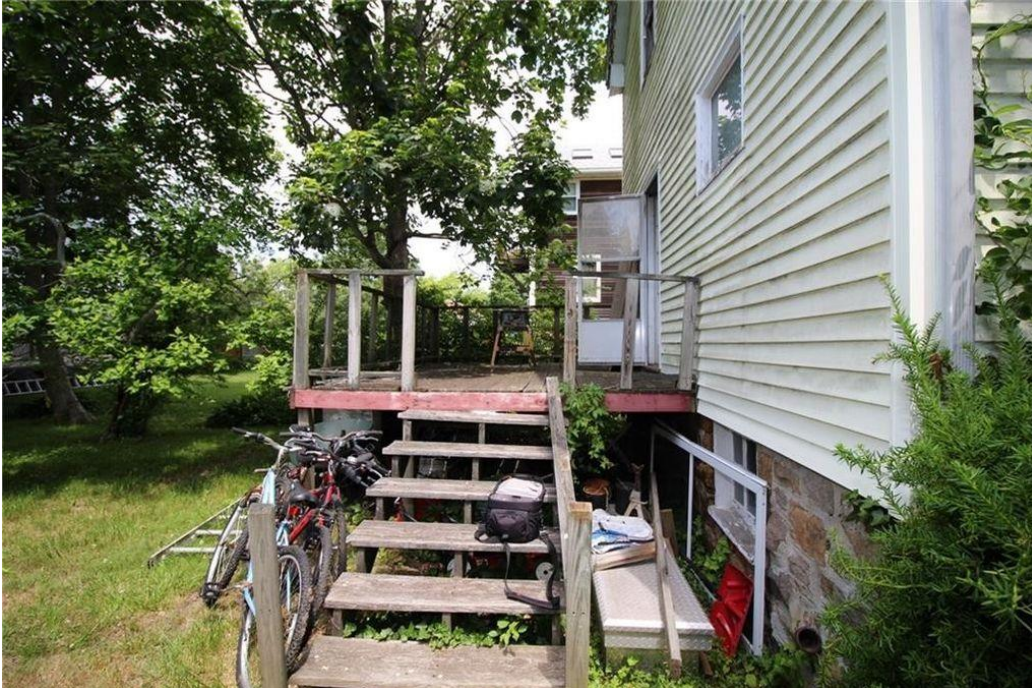
Photo of failing rear deck, railings, stairs

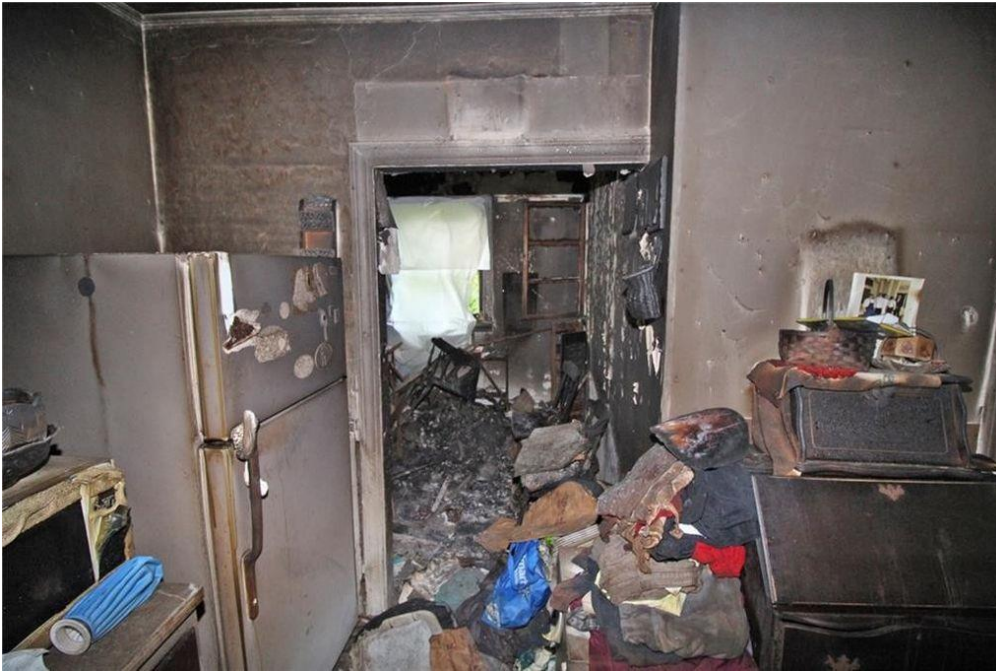
Once inside the first and second floors of the home, I was able to observe clear evidence of a fire. Every surface of every wall showed evidence of smoke damage. There was clear evidence of significant fire damage to 2nd floor joists, attic joists, and roof framing members. There was clear evidence of smoke and water damage throughout the home. In my opinion, the entire house would need to be completely "guttled" of all finishes (including flooring and utilities) to properly remediate the damage. Furthermore, areas of the 2nd floor, attic, and roof should be deemed "un-safe" until the structure is properly shored.

Interior smoke / fire / heat damage in first floor

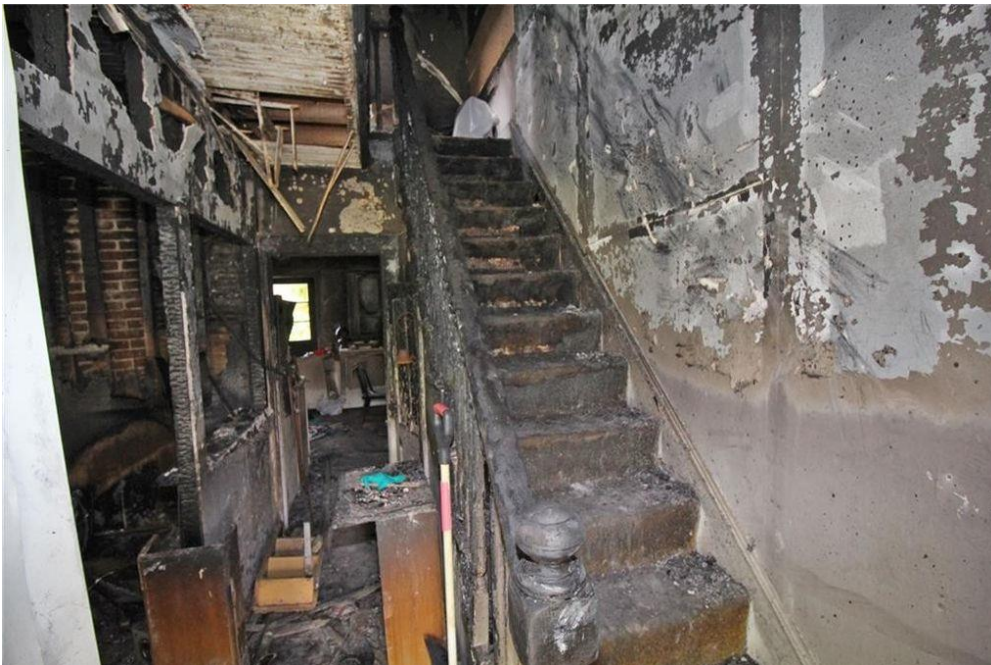
Interior smoke / fire / heat damage in first floor hallway
Note tight steep main stairwell

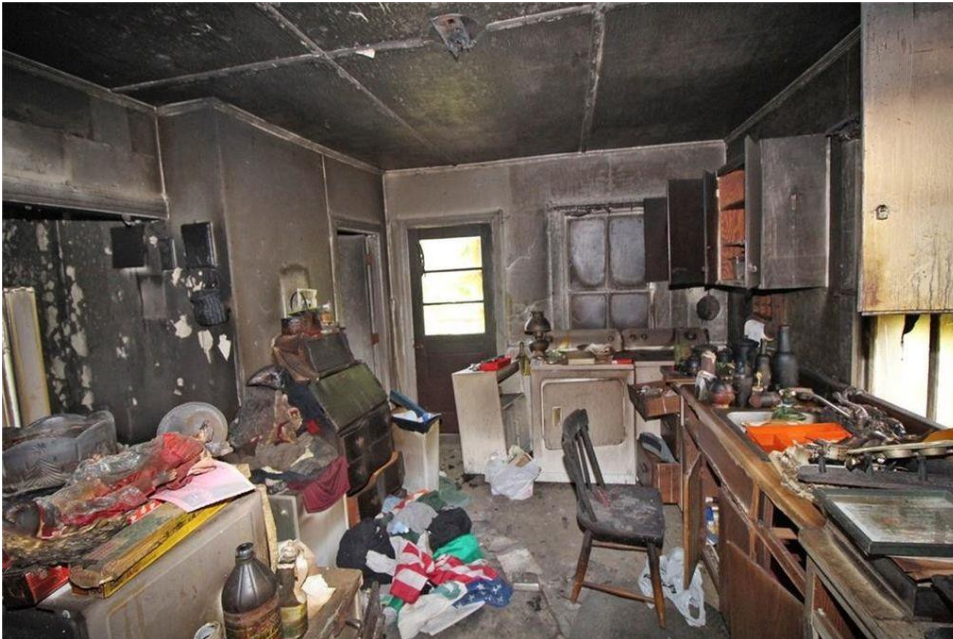
Interior smoke / fire / heat damage in first floor

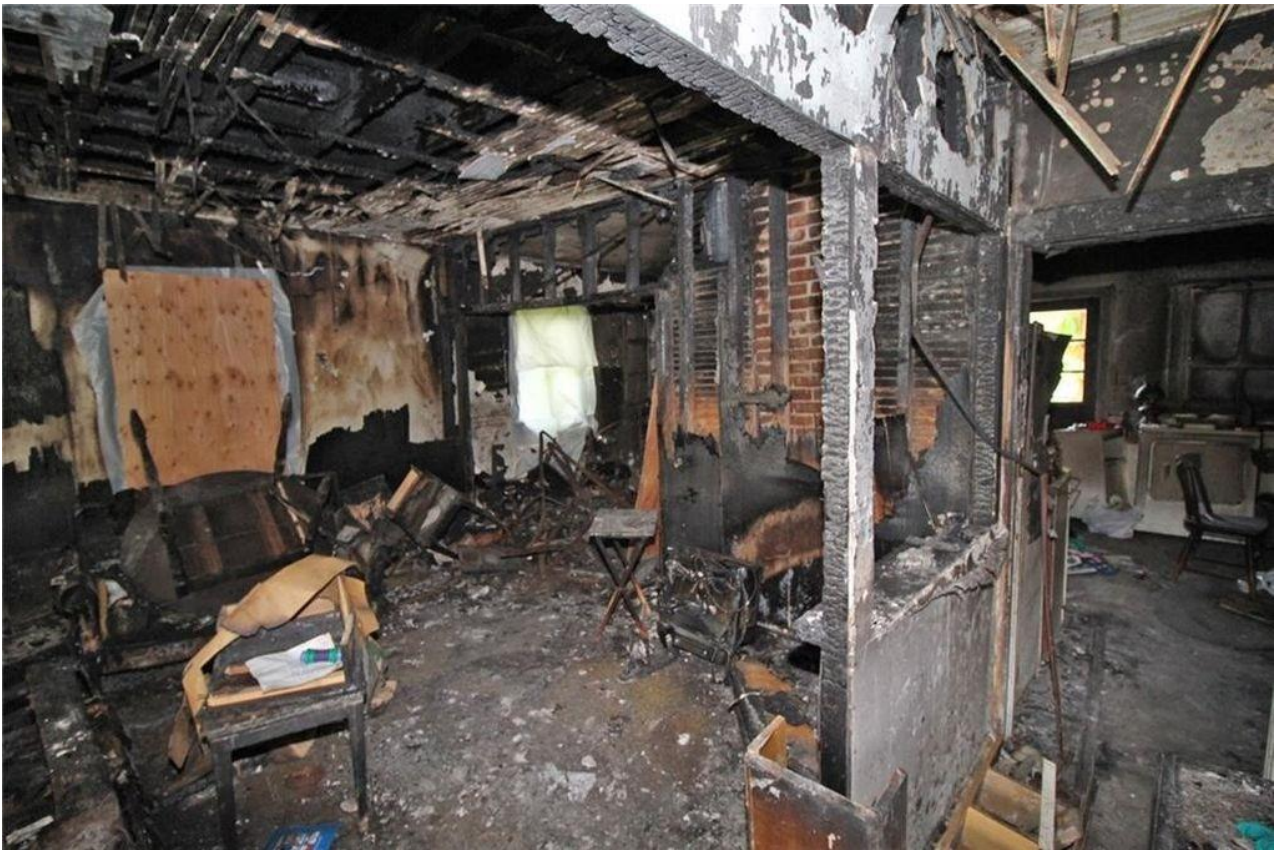
Interior smoke / fire / heat damage in first floor
Note fire damaged 2nd floor joists
