### Structural Inspections and Evaluation, Waites Wharf buildings - Crawford Building

# Crawford Building

Subject 3: Property Record 20 West Extension Street, Newport, RI Plat: 32, Lot: 267

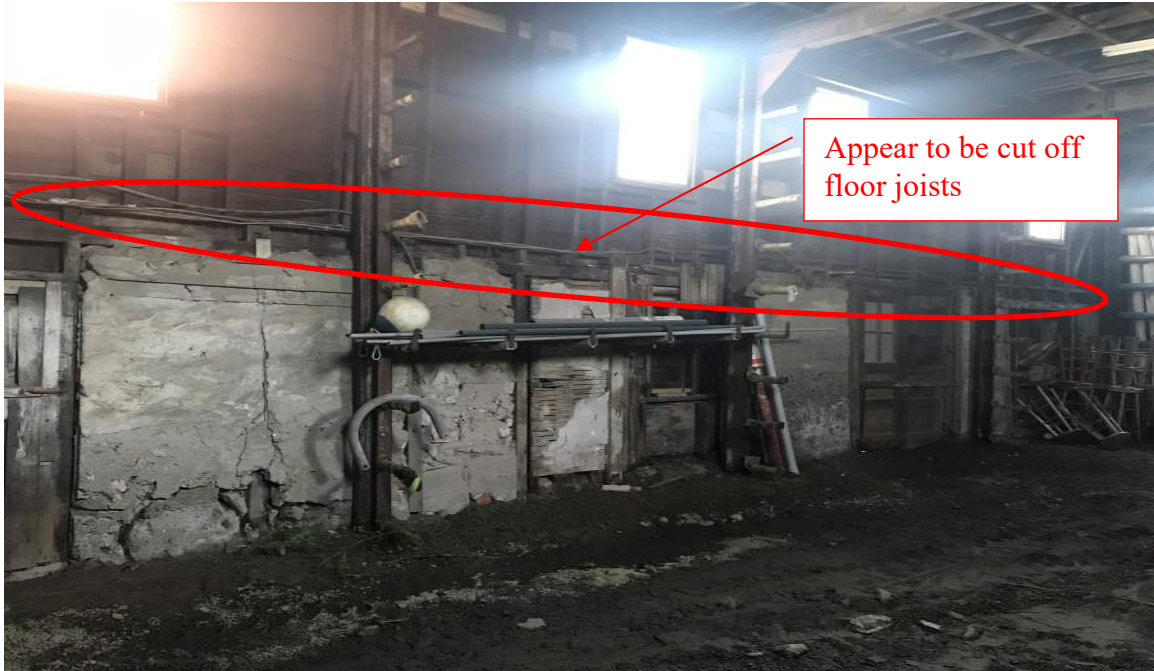
Photo 1: This photo shows the northern wall of building section A. The existing wall is comprised of multiple materials including concrete and wood. The wood framing is in direct contact with the dirt floor and this appears to be the cause for much of it to have deteriorated. The concrete portions of the wall are in significant disrepair. There are evident cracks, spalls and areas of poor consolidation. The concrete is also in direct contact with the wood framing. The existing wood framing is not rated for direct contact with concrete or soil. Finally, there appears to be evidence this building had an additional floor that was removed at some point in time. If it existed, the floor was providing bracing for the perimeter wall studs. Removal of the existing floor results in a hinge point in the wall and renders the wall deficient to resist wind loads.

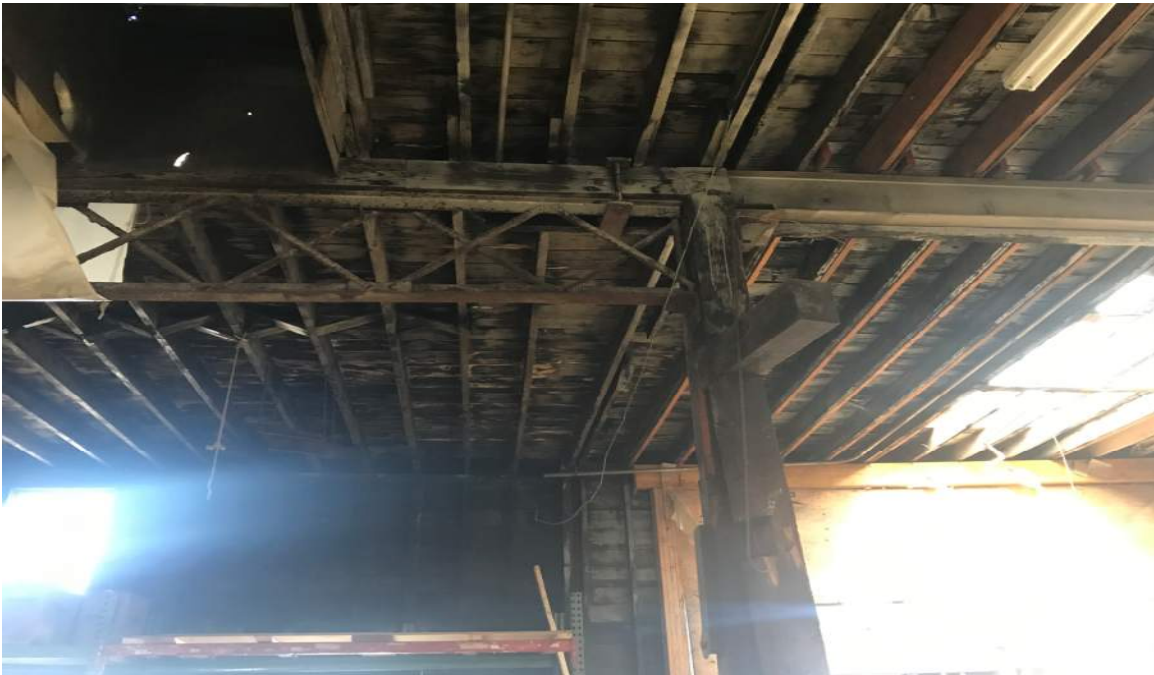
Photo 2: This photo shows a portion of the roof framing in section C. Large portions of the roof decking appear to be rotted along with a many of the roof joists. The sistered roof joists are a clear indication there was significant deterioration to the roof framing at some point. Additionally, as a

general comment, the overall methods of construction appear quite poor in this section of the building.

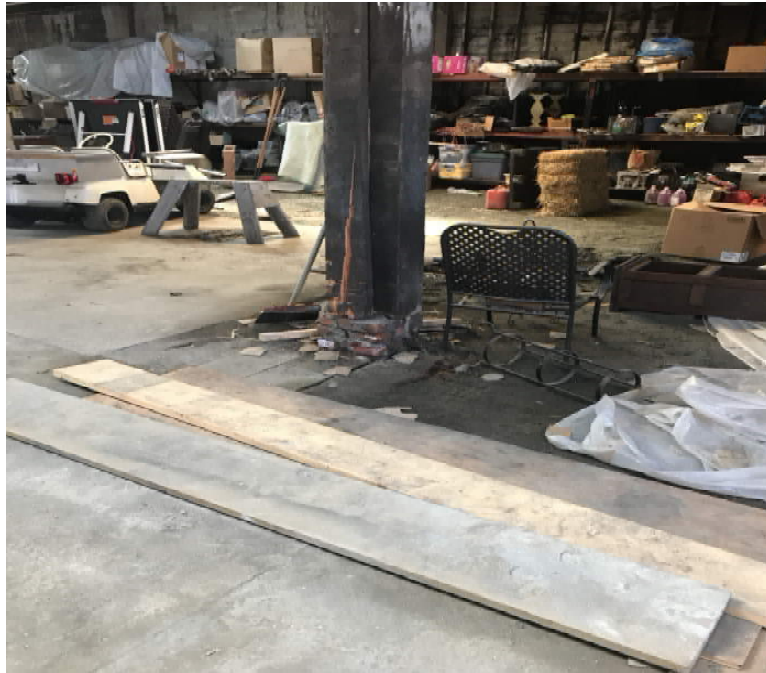
Photo 3: The photo shows the base of a wood column in section C. The wood post has a substantial crack in its base and it is also bearing on a poorly constructed brick masonry pier.

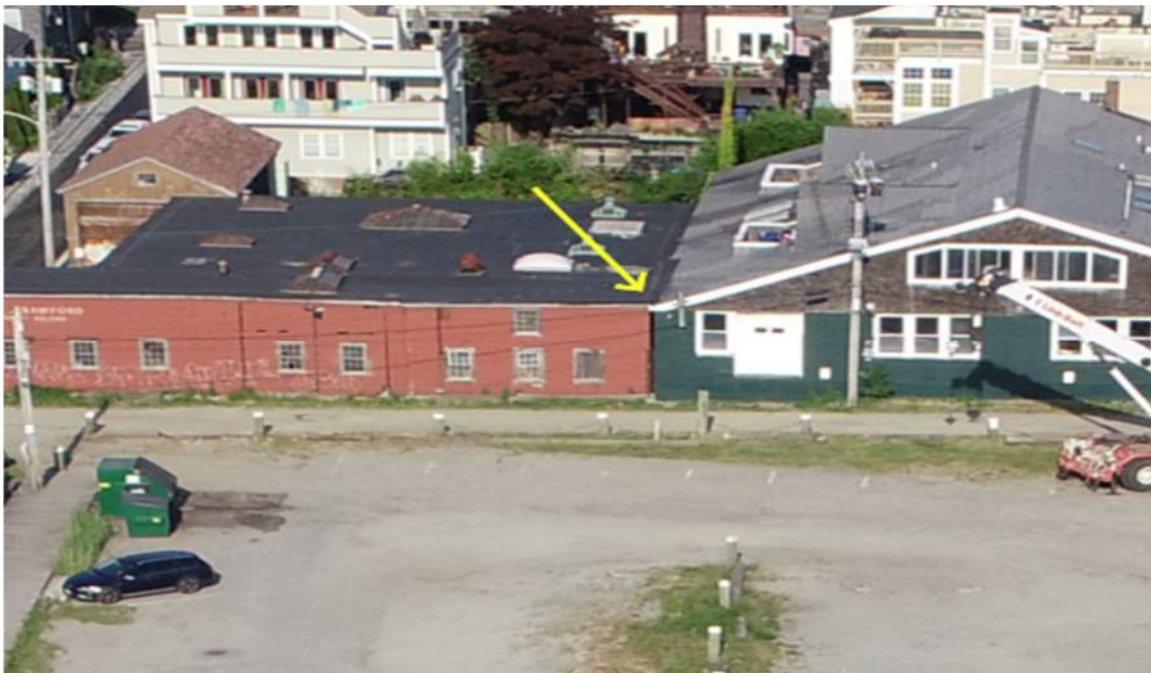
Photo 4: This photo shows the roof sheathing of sections B and C is connected to the adjacent “Casey” building. Although the sheathing is connected, this is a “non-structural” connection that can be easily severed prior to site demolition. While caution is required to demolish the Crawford The building, with respect to the Casey building, there are not physical or structural entanglements and demolition can be undertaken by a qualified contractor.
