March 21, 2019

RE: Pre-Demolition Asbestos Survey – Multiple Buildings Waites Wharf Newport, Rhode Island SAGE Job No. A044

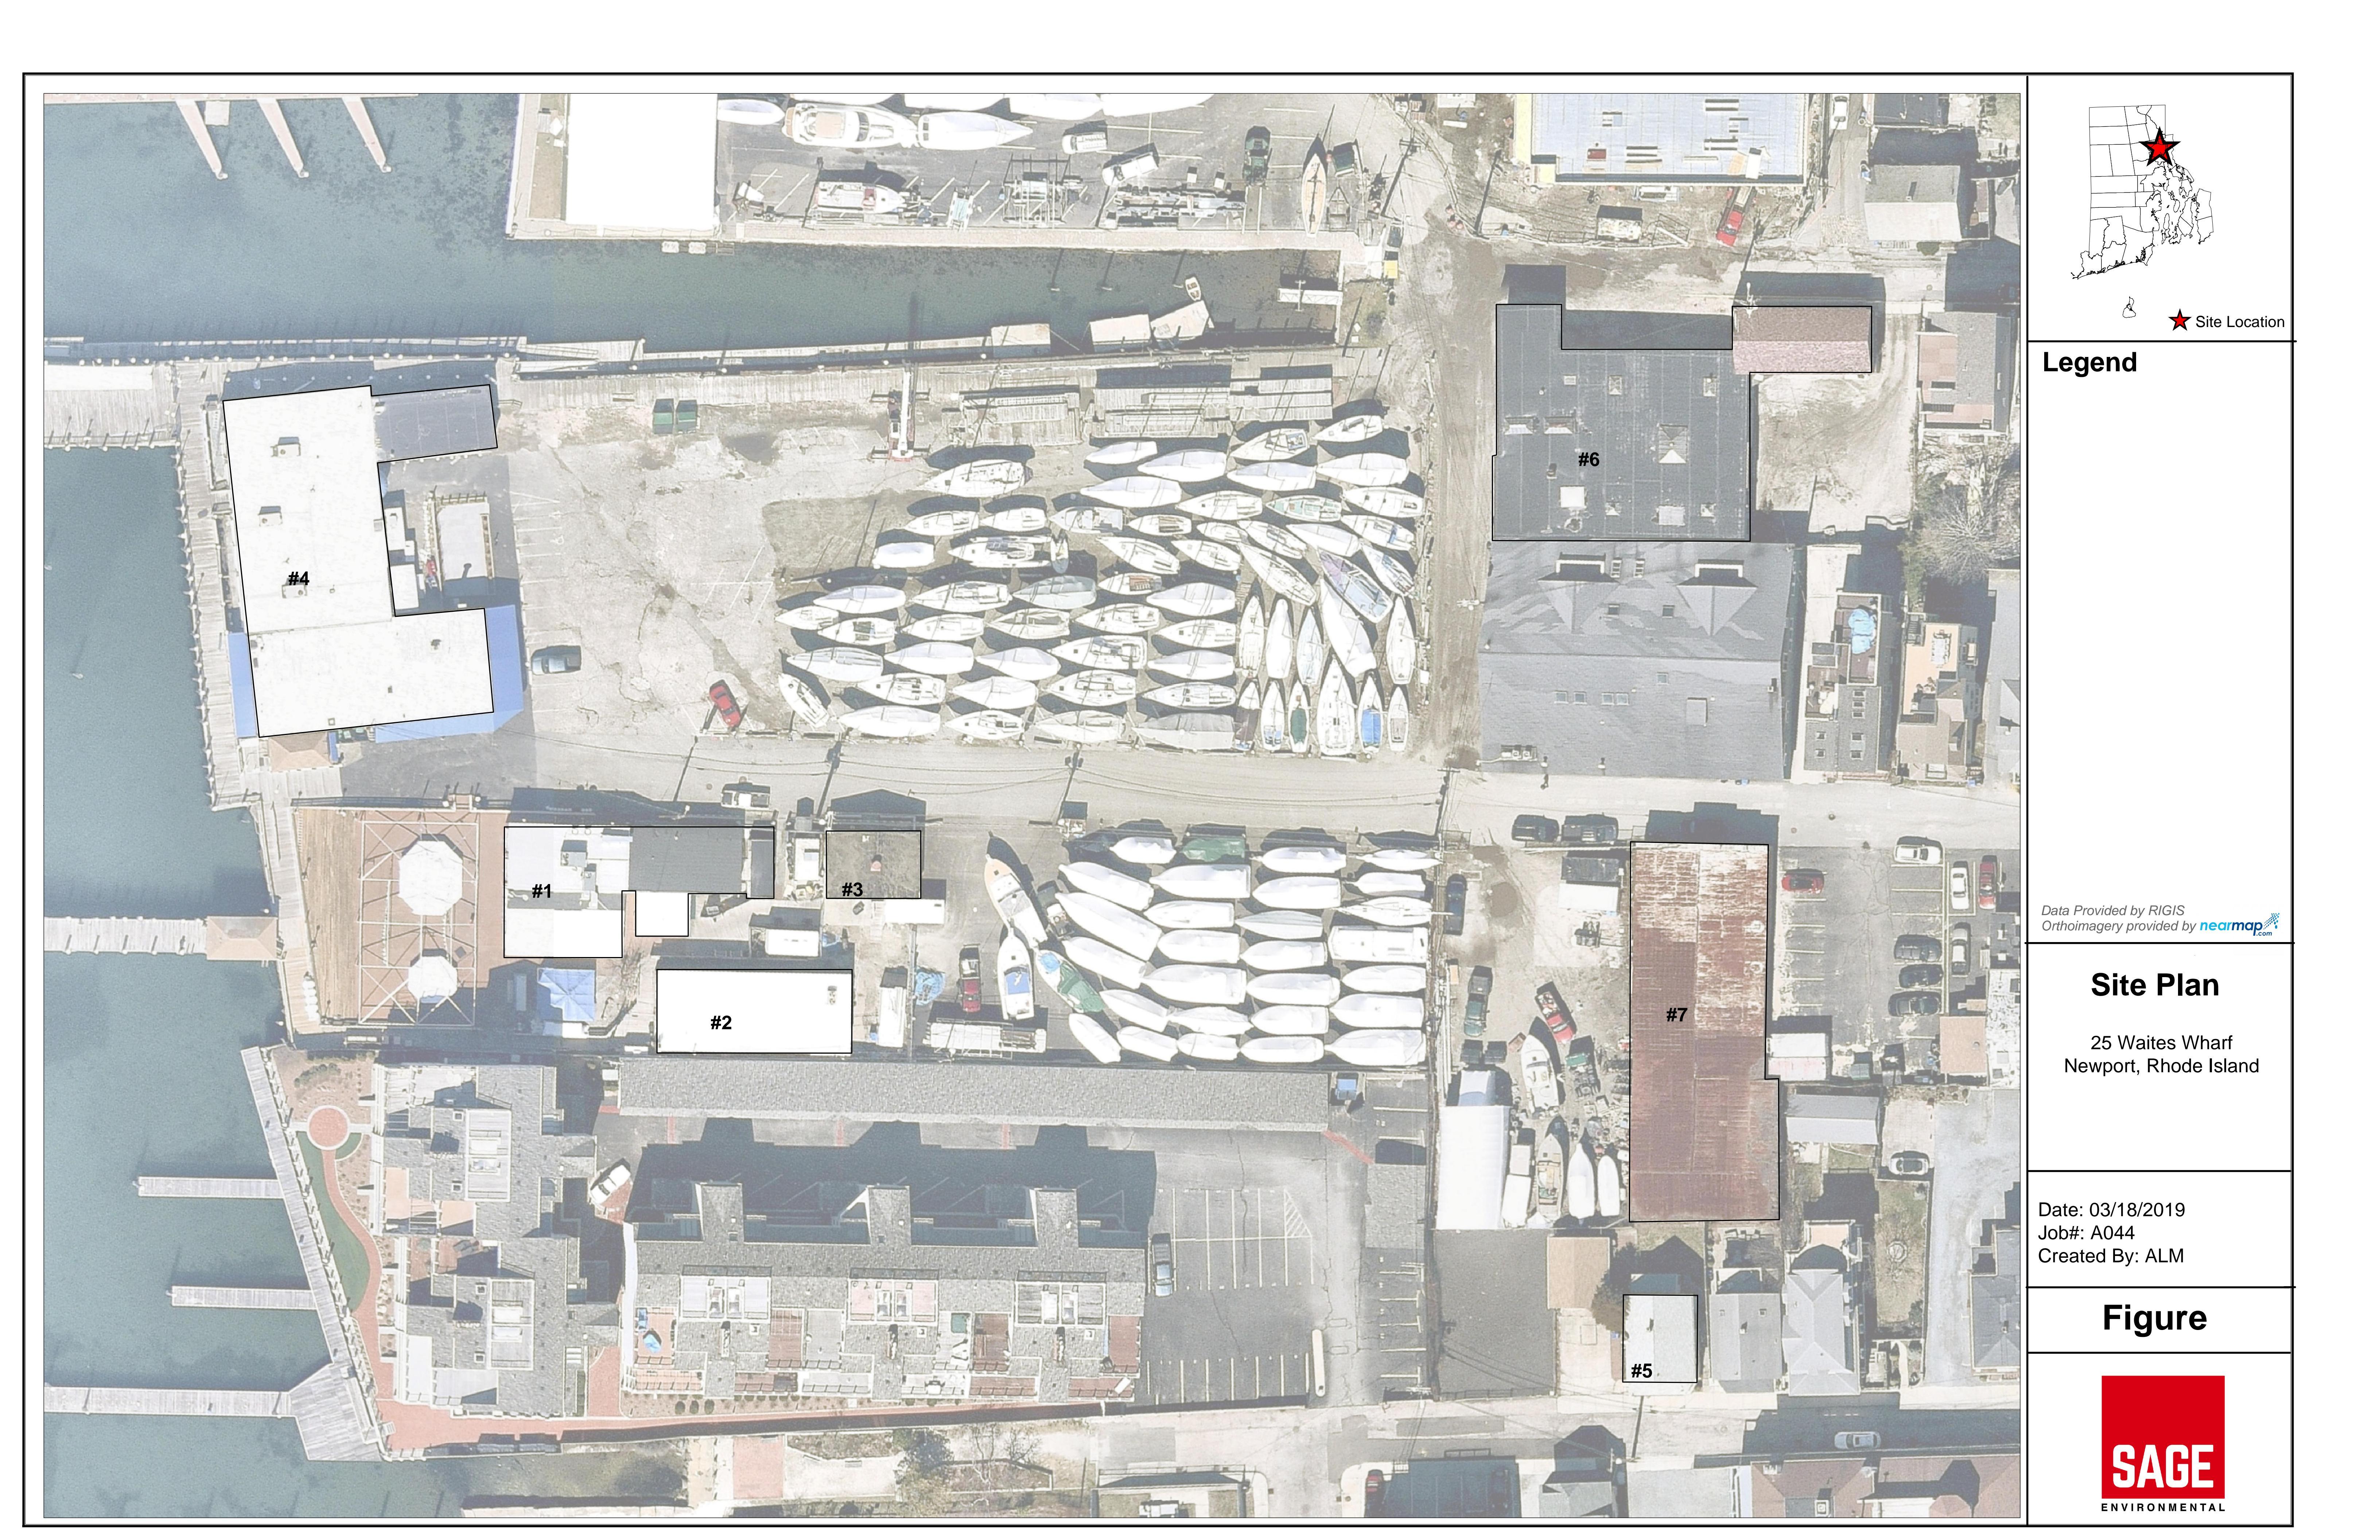
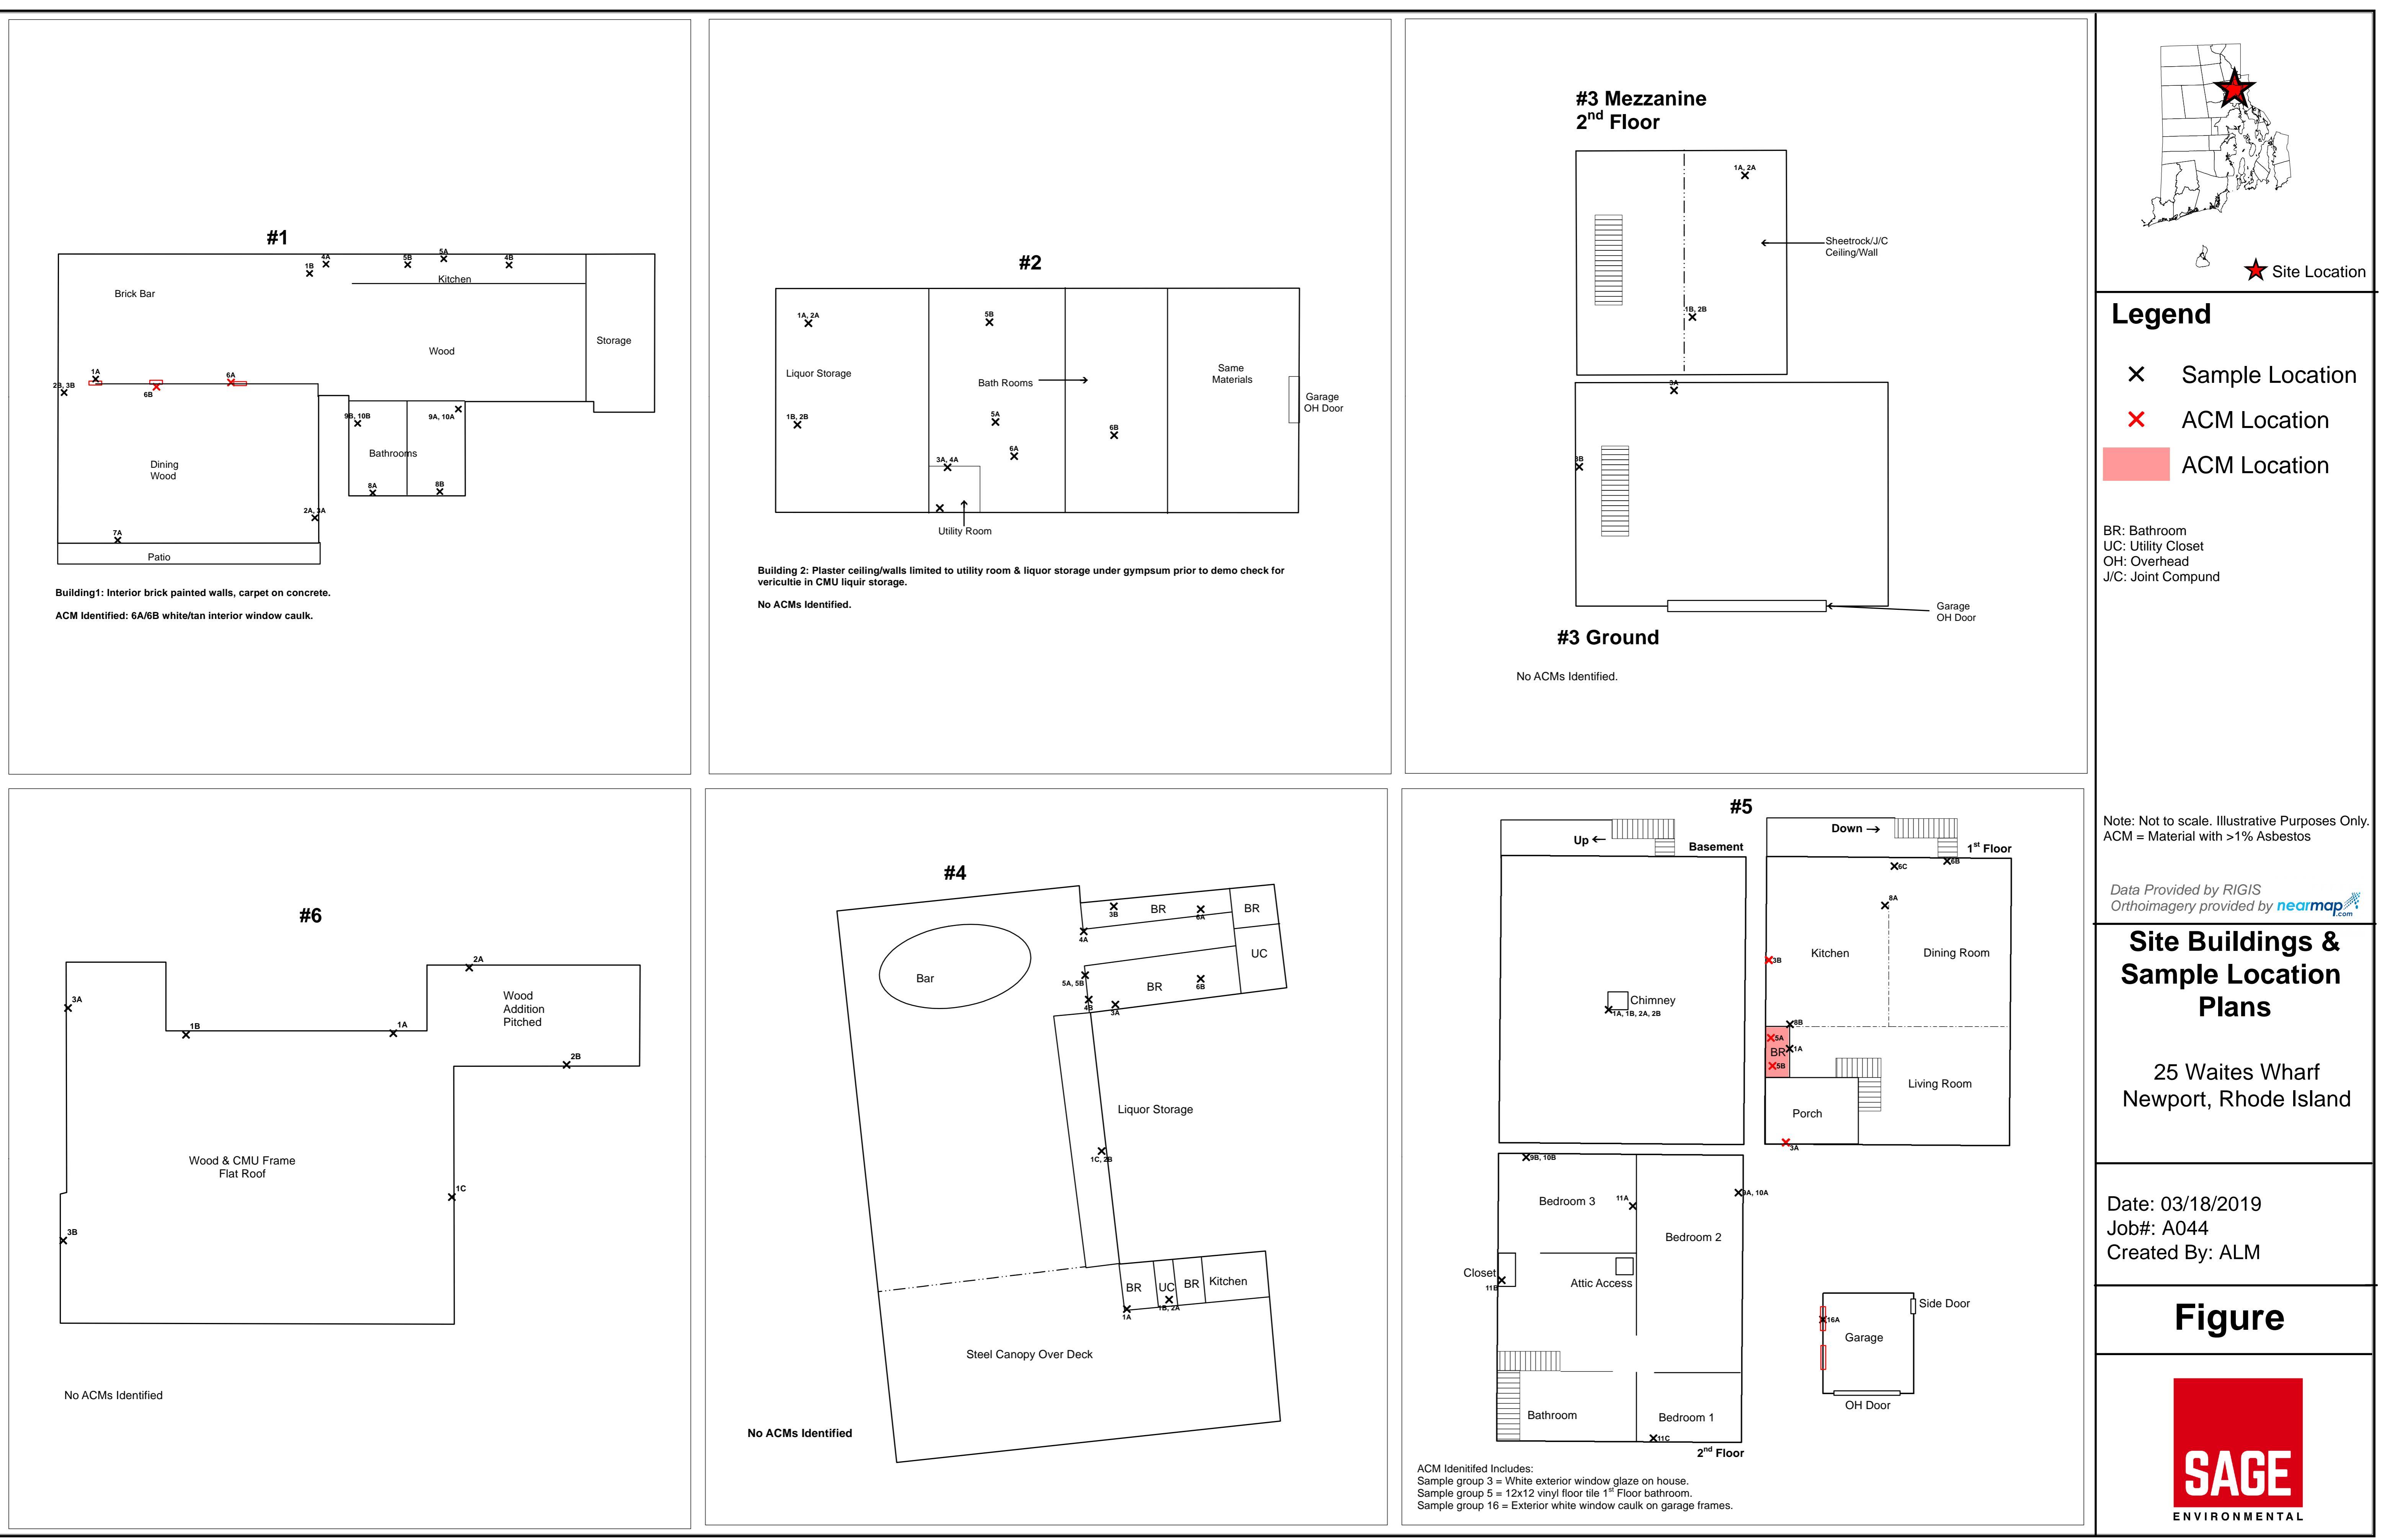
Attachment 1 - Annotated Drawings

Building locations are identified on **Figure 1.** Sample locations and areas of ACM are identified on the annotated drawings in **Attachment 1**.

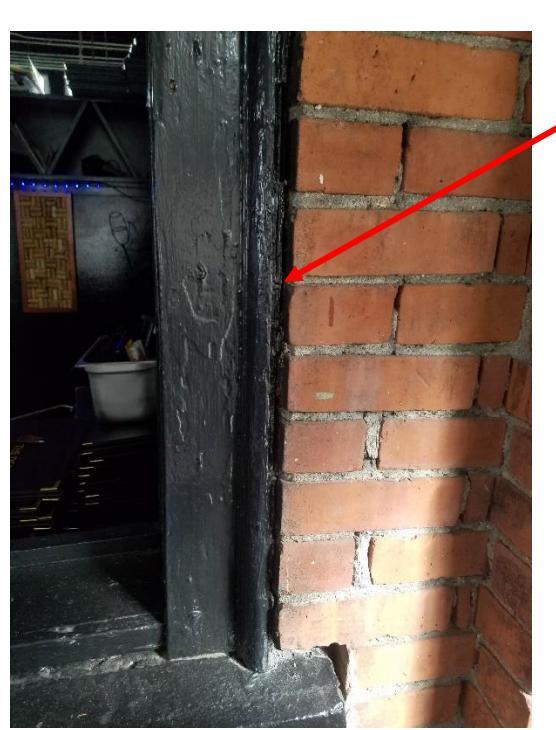
• Approximately 3-4 windows present along the interior of the dining/bar area with ACM white/tan, caulking where the frames meet the masonry brick.

ACM caulking between wood frame and masonry interior windows of Building 1.

The quantities noted herein are approximated estimates and should be verified by the contractor bidding the work. The ACMs noted in here require proper abatement in accordance with applicable regulations, prior to demolition. An asbestos abatement plan must be prepared by an RIDOH licensed and EPA accredited project designer. Work should be conducted by a RIDOH licensed and EPA accredited asbestos abatement contractor. Prior to work, notification must be made to the EPA and RIDOH by the contractor. Following completion of asbestos abatement visual clearance of the abated area and clearance air monitoring must be performed by a EPA accredited asbestos project monitor.

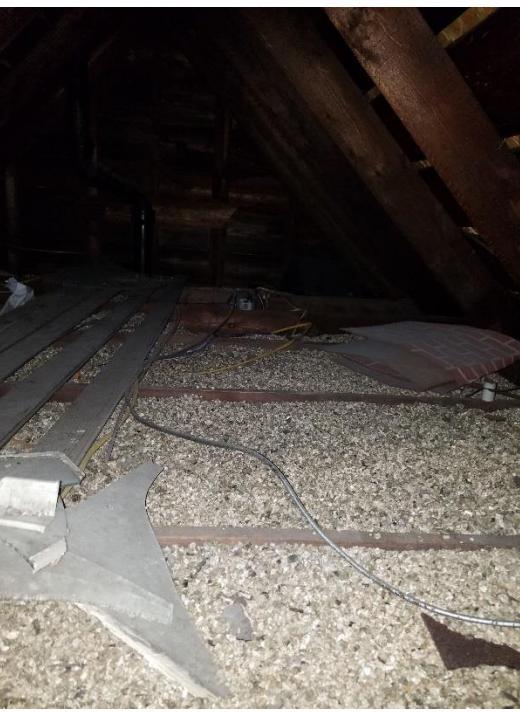
Additionally, vermiculite granular insulation material was identified in the attic of Building 5 the residential dwelling. This material was not sampled for asbestos content, as current analytical methods prove that results can be erroneous. Therefore, the EPA and the RIDOH view this material as assumed containing asbestos. *Additional Vermiculite Discussion included in Appendix A.*

Vermiculite insulation observed in the attic space of Building 5 (residential house).

If vermiculite removal is necessary by a licensed asbestos abatement contractor, there is an established trust, which will reimburse a portion of the abatement costs generated for vermiculite removal. The trust is known as the <u>Zonolite Attic Insulation (ZAI) Trust</u>. According to the ZAI Trust, qualified claimants may receive a reimbursement contribution of up to 55% of the abatement costs, with a maximum reimbursement amount of \$4,125.00. More information regarding this is included in the link below. It should be noted that during the inspection SAGE identified bags of Zonolite in the attic space, indicating that the vermiculite located in the attic of the dwelling likely comes from this mine, and is potentially reimbursable, through the trust.
