City of Newport, Rhode Island

Application for State Assent: Vegetative Clearing & Stabilization Plan for Old Sediment Basin (North & South Easton Pond)

DAM SAFETY: INTERIM STABILIZATION REPORT

North & South Easton Pond in Vicinity of Old Sediment Basin

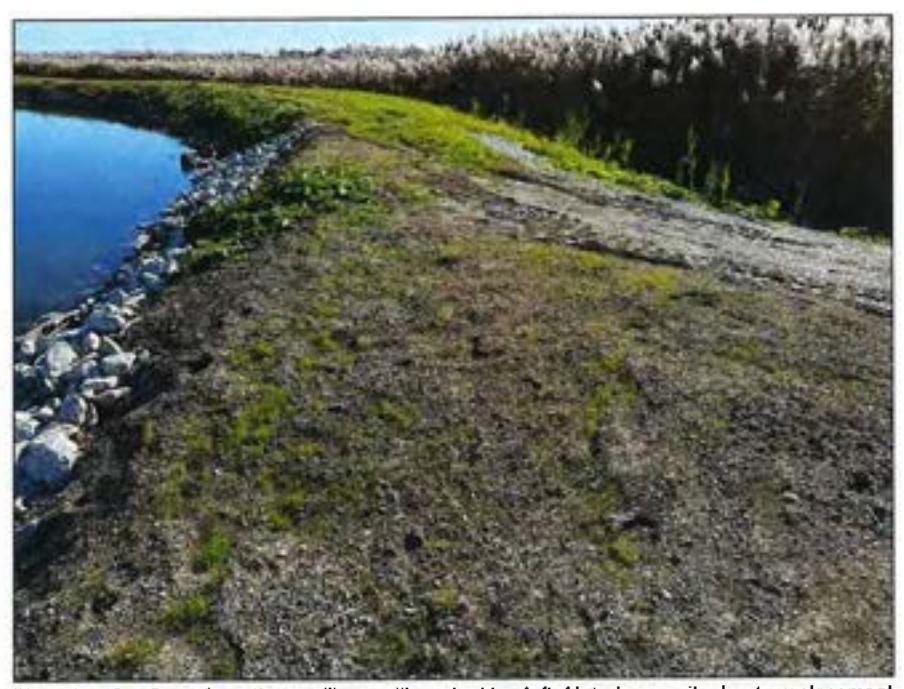
Photo No. 9.: Crest from the auxiliary spillway looking left. Note bare soils due to replacement of the auxiliary spillway.

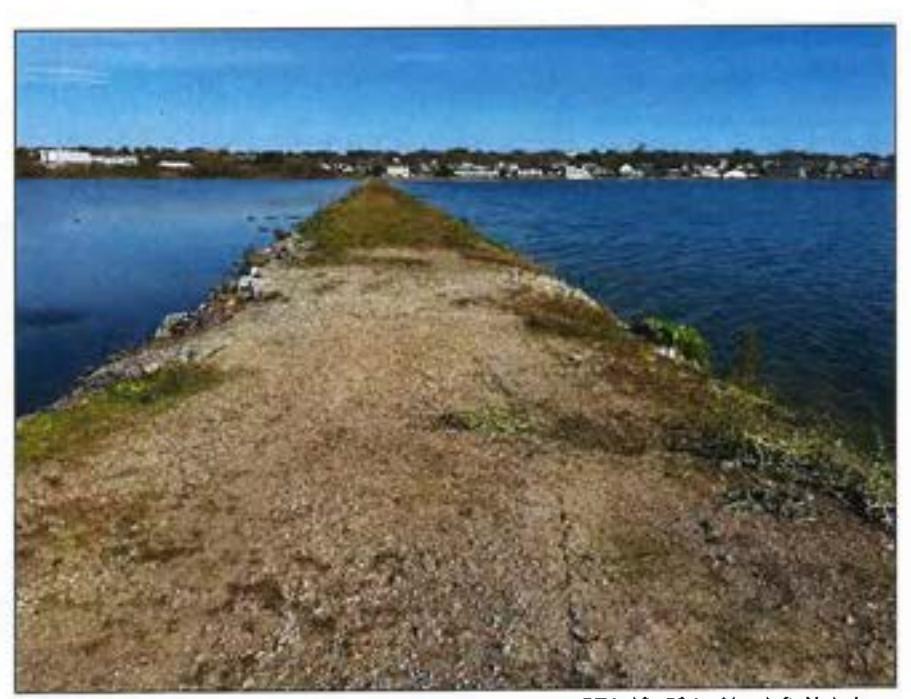
Photo No. 10.: Crest from the bend in the embankment near STA 10+50 looking left. Note bare soils at the bend.

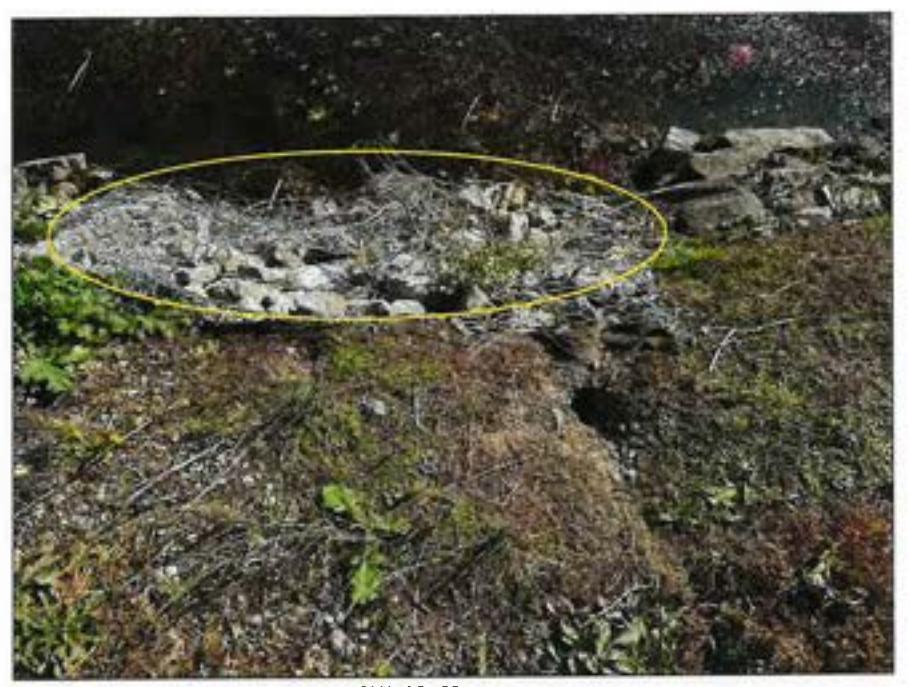
Photo No. 17 .: Broken gabions near STA 16+50.

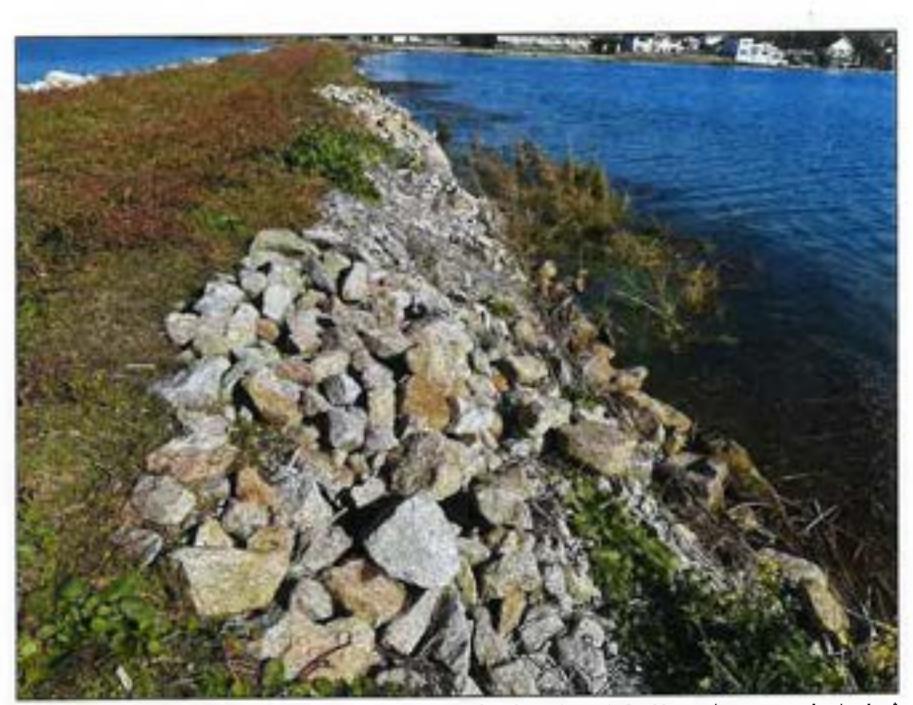
Photo No. 18.: Downstream slope near STA 18+50 looking left. Note riprap repair, typical throughout the slope.

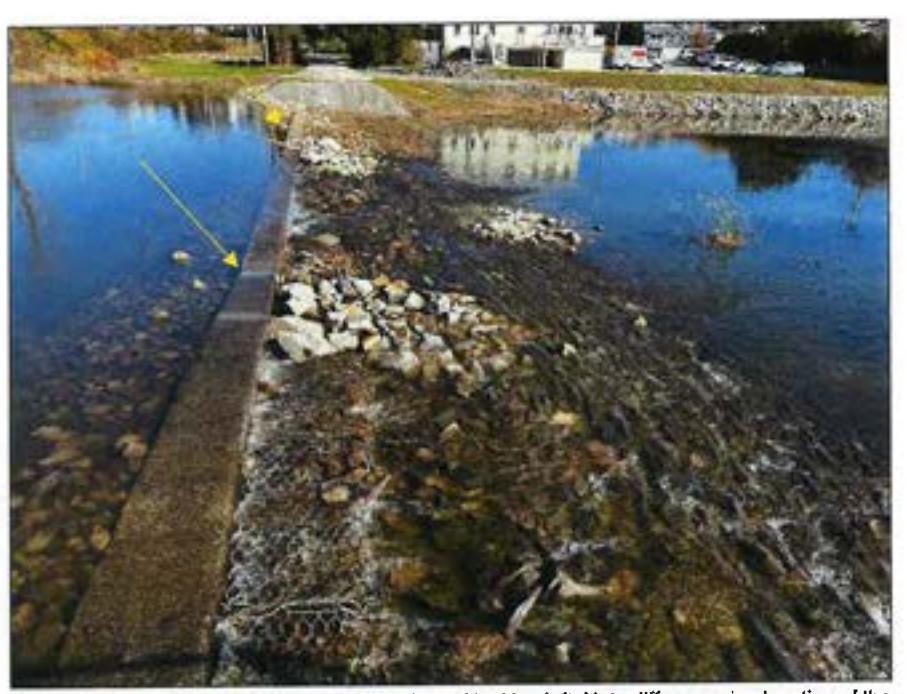
Photo No. 21.: Primary spillway from the right end looking left. Note difference in elevation of the spillway crest.

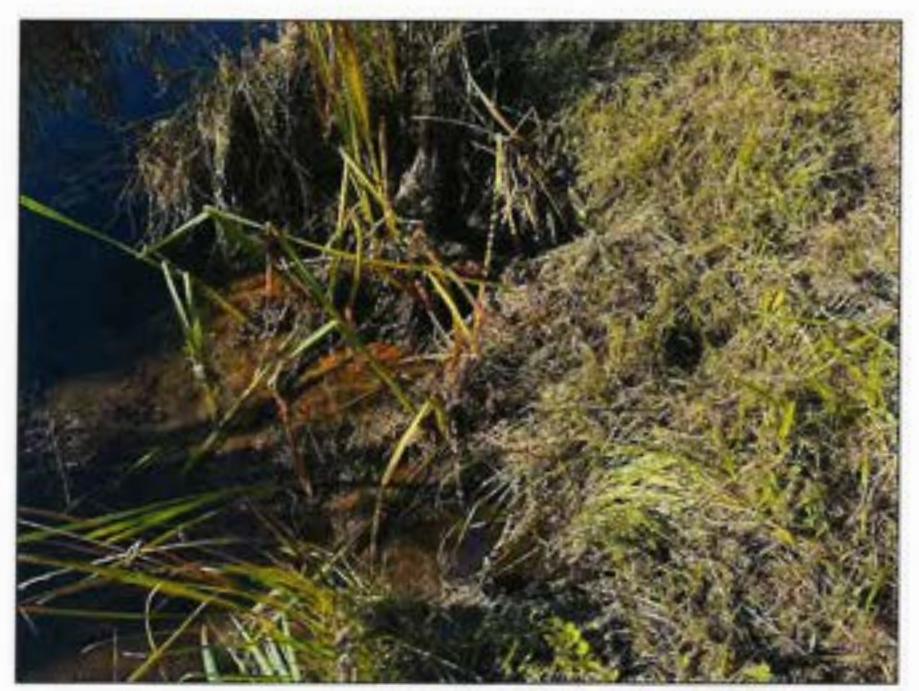
Photo No. 14.: Iron oxide stained seepage from the moat bank near STA 12+90.

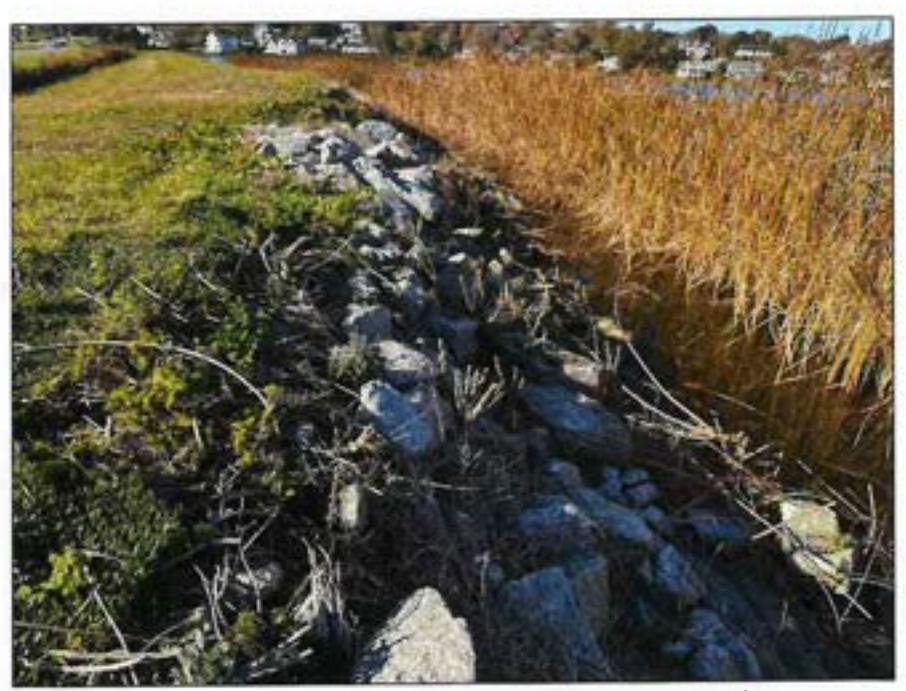
Photo No. 22.: Upstream slope from STA 18+00 looking right. Note riprap repair.

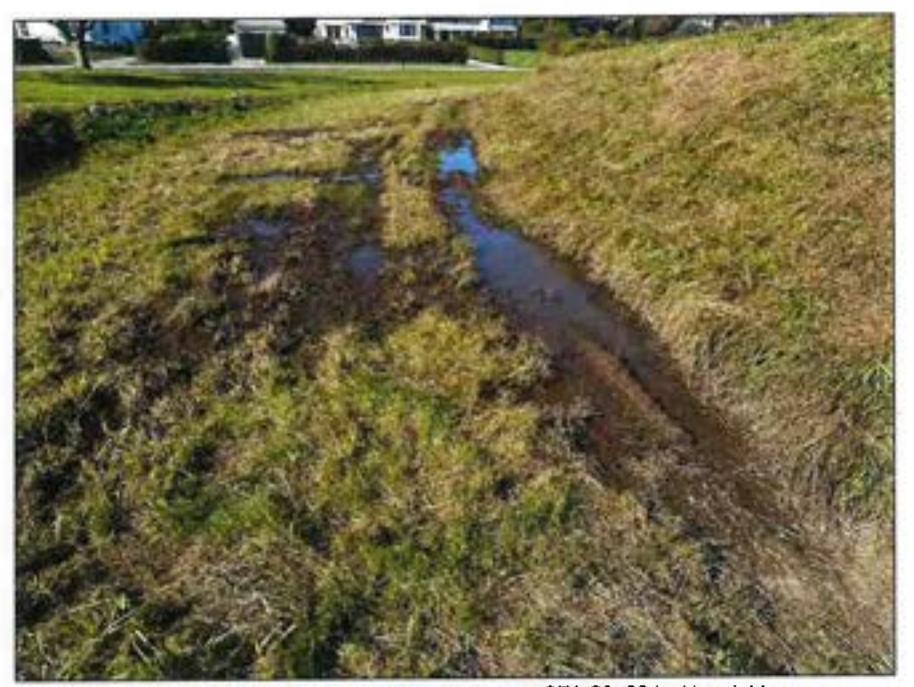
Photo No. 25.: Saturated toe and downstream area near STA 28+00 looking right.

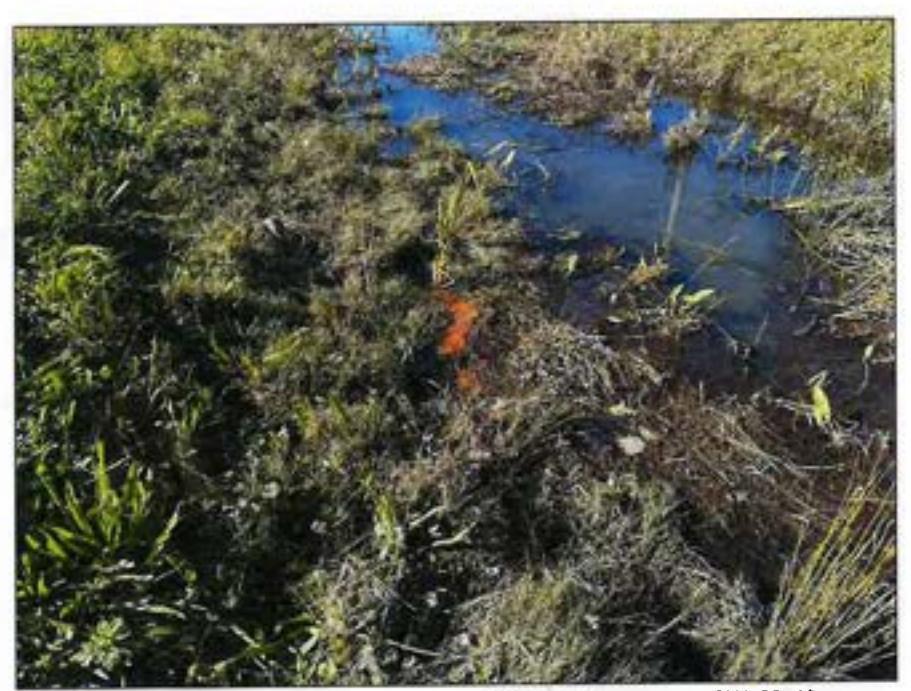
Photo No. 42.: Iron oxide staining at the tow of the downstream slope near STA 63+10.

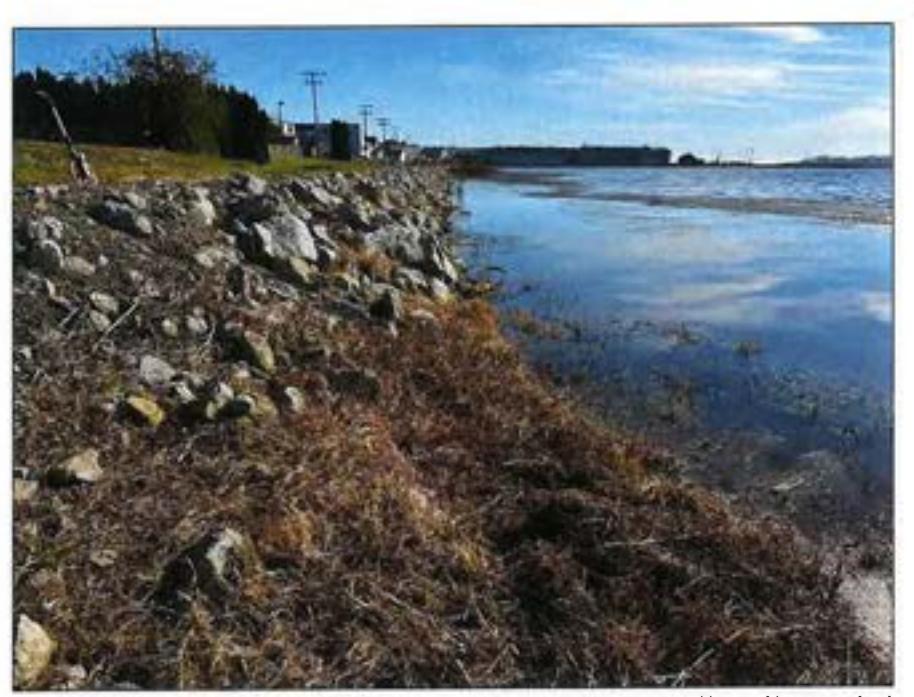
Photo No. 54.: Upstream slope of the embankment to the left of the spillway. Note repaired riprap.

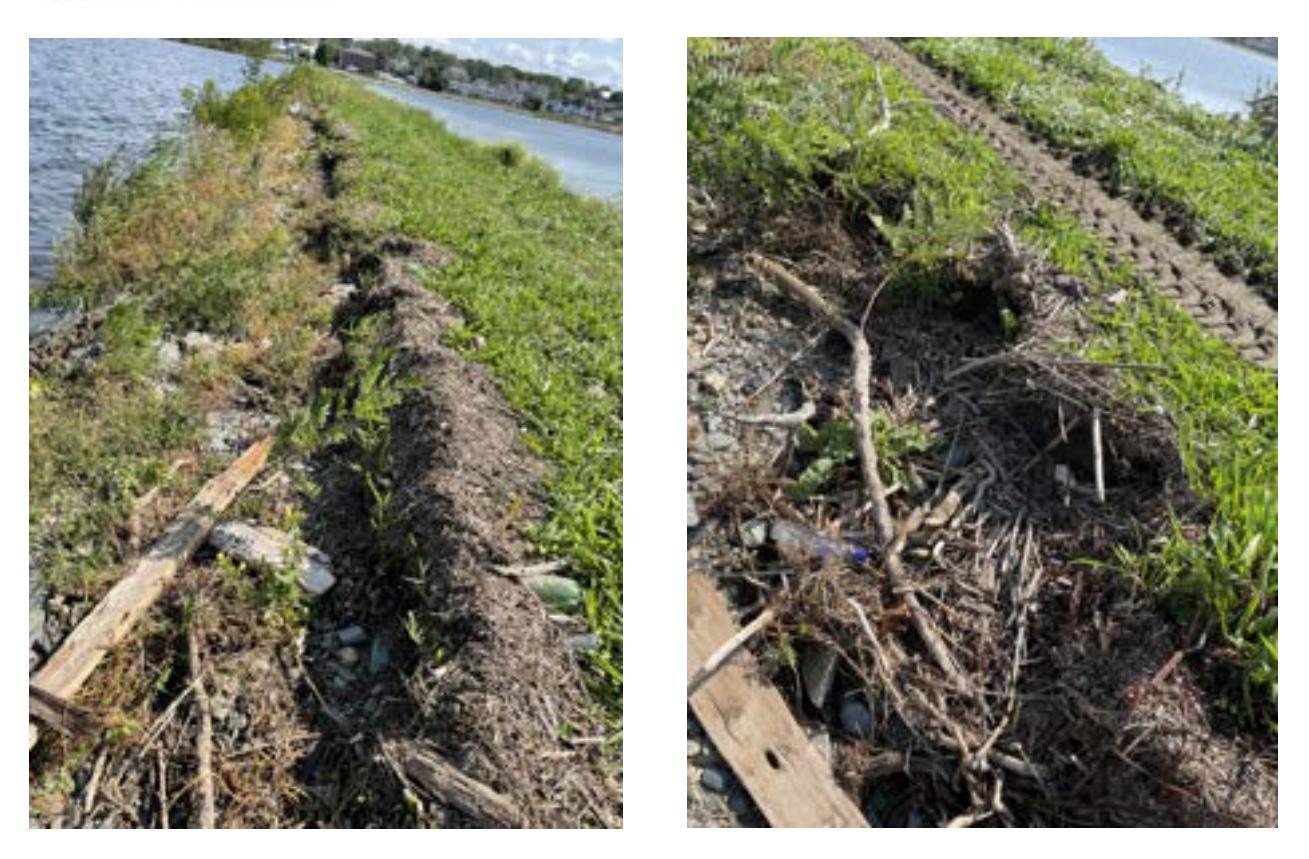
Figures 1 and 2: Embankment damage following Hurricane Ida on the NEP embankment (Photo provided by City)

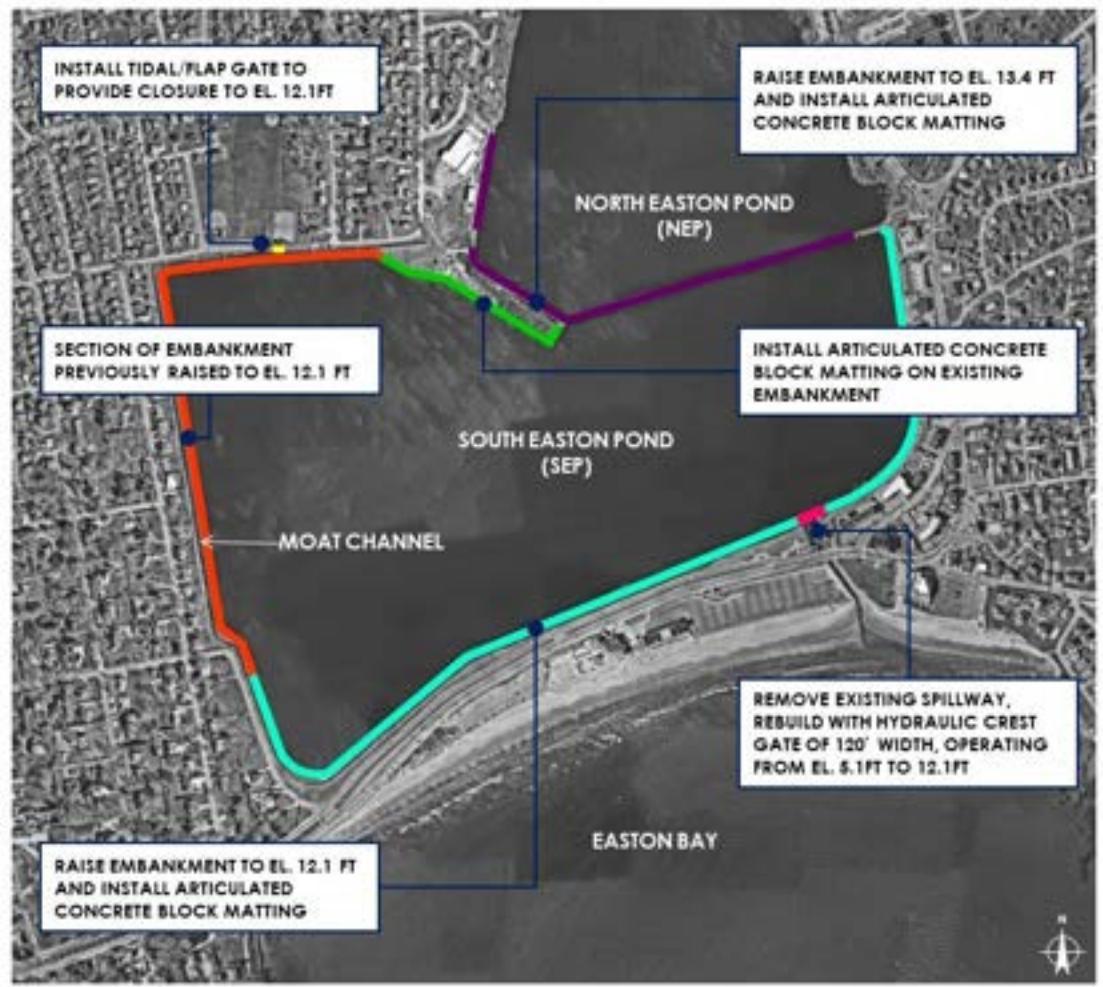
Figure 4: Recommended improvements to NEPD and SEPD.

• Constructing a tidal/flap gate in the Moat near J Paul Braga Jr Memorial Field to prevent saltwater intrusion through the NEP auxiliary spillway. The SEP embankment east of the gate will remain at existing conditions to allow stormwater from surrounding neighborhoods into SEP and prevent increased water surface elevations in the moat and surrounding area.

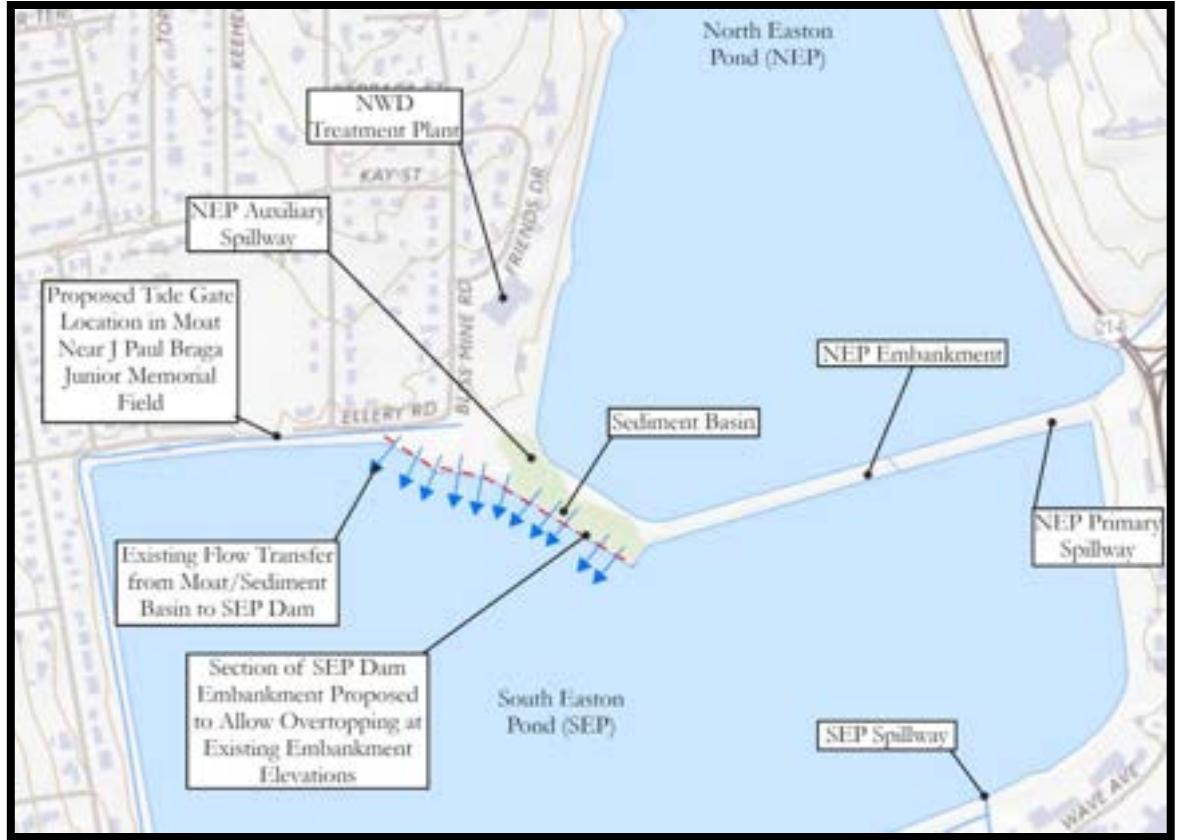
Figure 7: Existing flow transfer near sediment basin and proposed tidal/flap gate near J Paul Braga Memorial Field

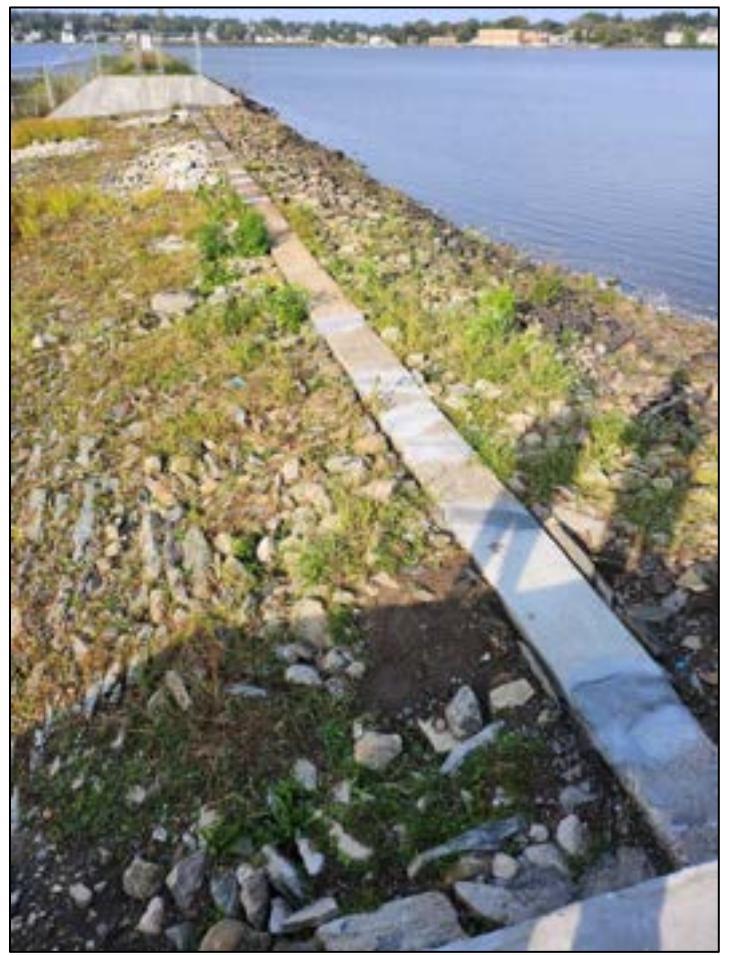
Photo 8: Overview of Repairs to the Primary Spillway
