HISTORIC DISTRICT COMMISSION  
**POLICY STATEMENT ON WINDOW AND DOOR REPLACEMENTS**

CITY OF NEWPORT

DEPARTMENT OF ZONING AND INSPECTIONS

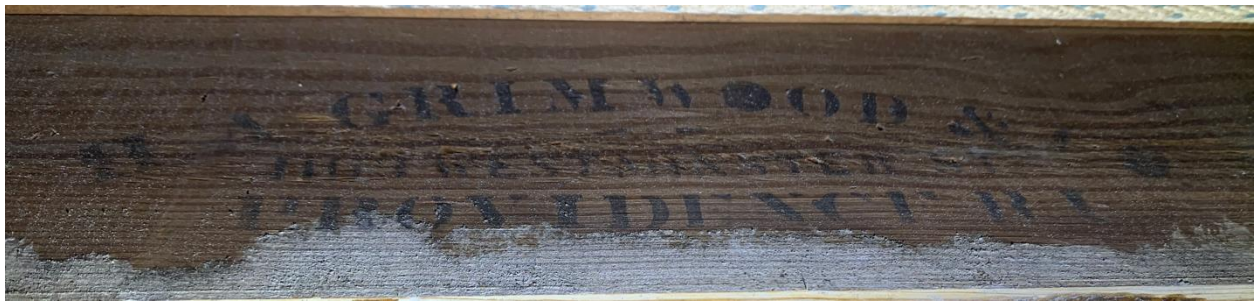
The house has 13 double hung windows, weight and pulley window units, and one fixed window with a close in transom above. The windows are original to the building, with a stamp on the windows from *H.A. Grimwood and Co. Wesminister St, Providence R.I.*, a popular milling and lumber company at the turn of the 20<sup>th</sup> century.

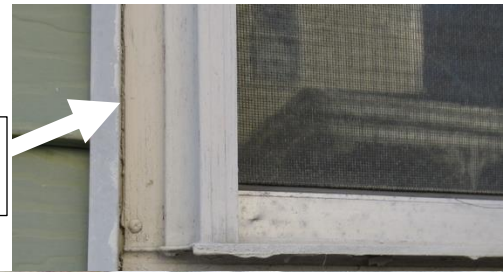
The exterior of the house has been heavily modified, where the aluminum siding definitely removed parts of the window frame (horns), and potentially some of the window trim and other house details. The storm windows are in poor condition.

Missing window sill horn

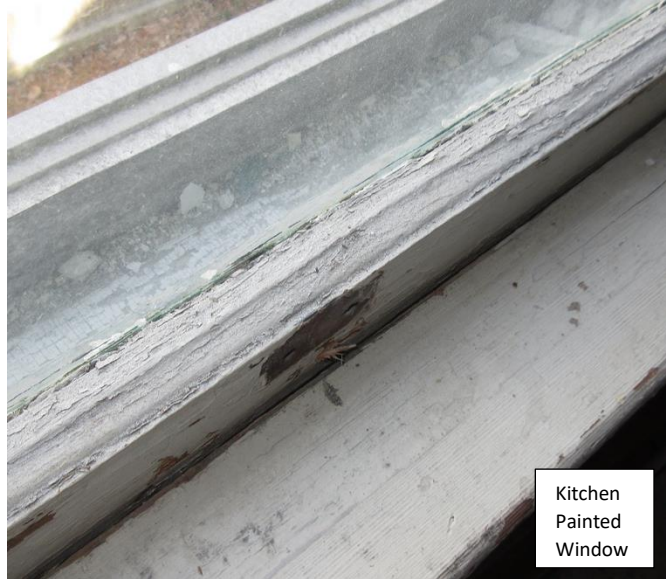
The sash's interior was a pleasant surprise. While the interior is gutted and there is quite a bit of accumulated dust, the windows operated flawlessly. Many of the windows remain a natural finish (SEE image right) without much, if any, friction from overpaint and the few that were painted (3 in kitchen, and 1 in bathroom) didn't have much paint but the paint was failing pretty bad. Many of the muntins and rails were worn from sun and condensation damage(SEE image below).

Kitchen Painted Window

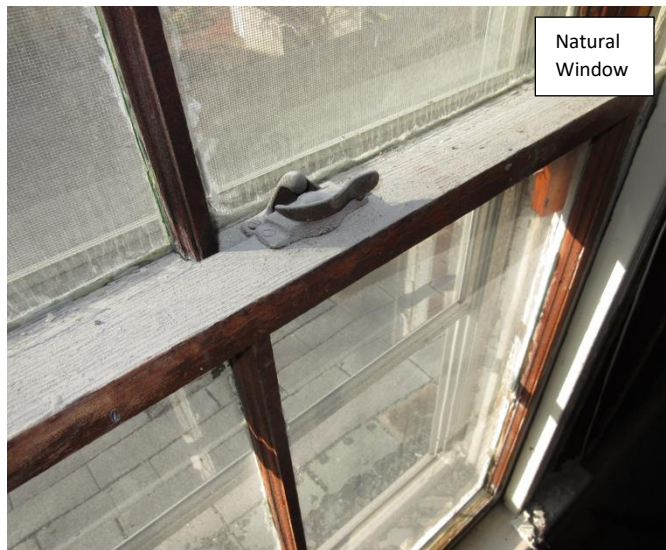
Natural Window
