3.0 FIELD INVESTIGATIONS AND DATA COLLECTION

FIGURE 3.2
FLOW METER LOCATIONS
AND SEWER CATCHMENTS
PHASE I PART I CSO CONTROL PLAN

FIGURE 3.3
THAMES STREET INTERCEPTOR
MANHOLE INSPECTION LOCATIONS
PHASE I PART I CSO CONTROL PLAN

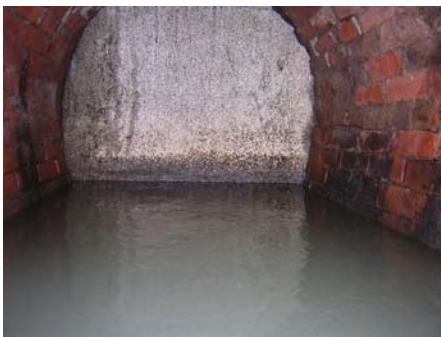
PHOTOGRAPH 3.1: Upstream view of 42-inch Restrictor Plate at Wellington Avenue Diversion Structure

- As shown in the following photographs, the inspections of the diversion structures at Wellington Avenue, at Franklin Street, and Young Street confirmed that flows were restricted using inverted weir plates and at two additional locations flows were restricted by cast iron pipes penetrating the interceptor.

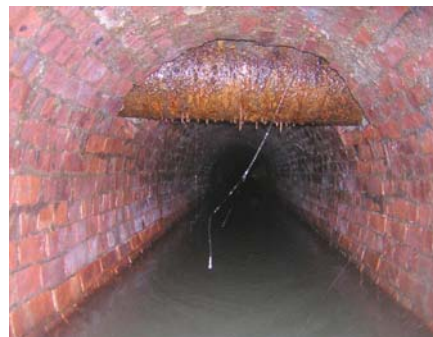
PHOTOGRAPH 3.2: Upstream view of a cast iron pipe running through the crown of the interceptor at Dean Street.
