### Structural Inspections and Evaluation, Waites Wharf buildings - Dockside

Narragansett Engineering Inc (NEI) and Merk Structural Consulting are pleased to present for your review our inspection of the aforementioned structures located on Waites Wharf in Newport, RI (Subject Properties). An on-site structural survey of the above referenced property was conducted by Narragansett Engineering Inc. (NEI) on August 8, 2019.

## Dockside

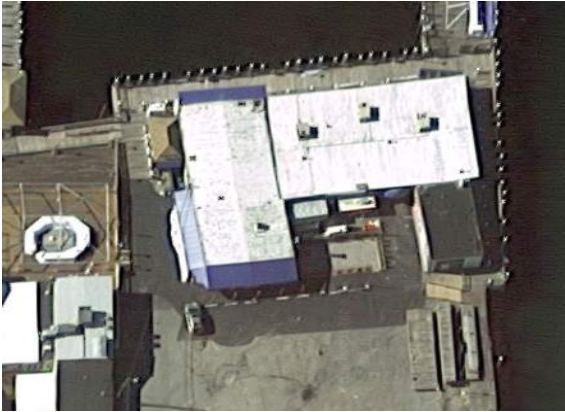
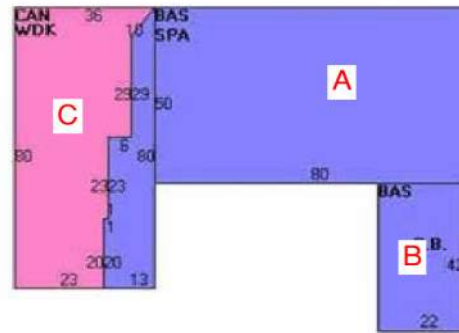
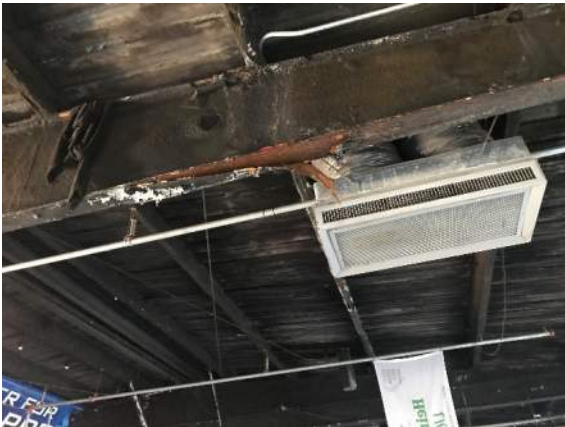
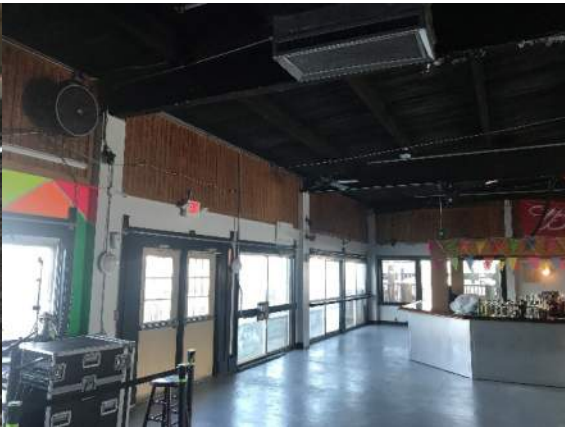
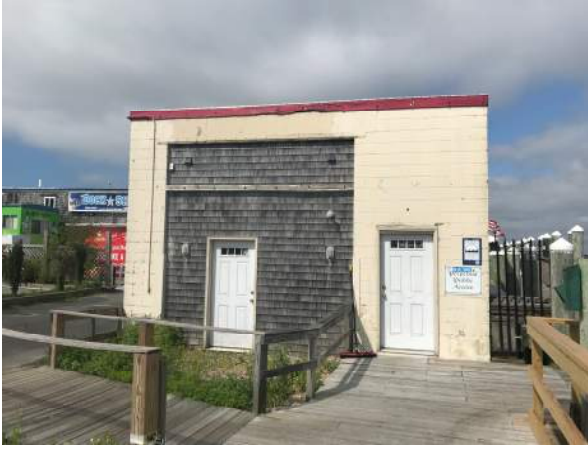
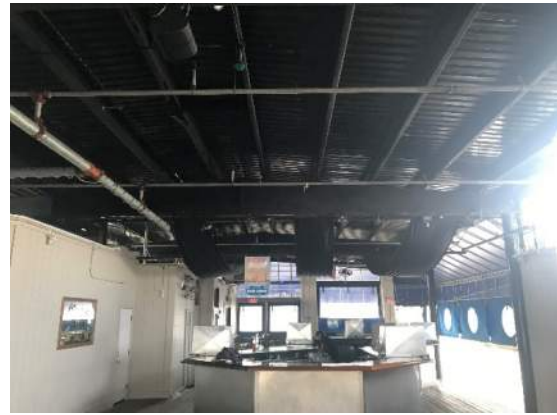
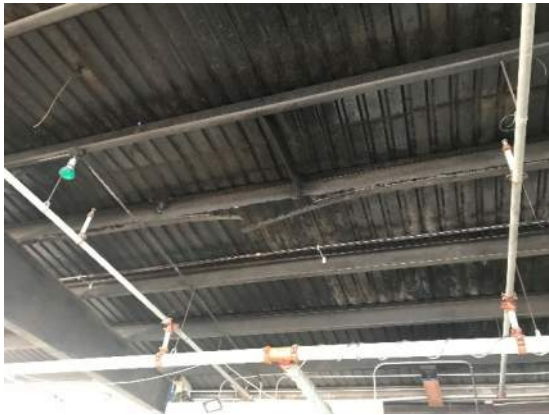
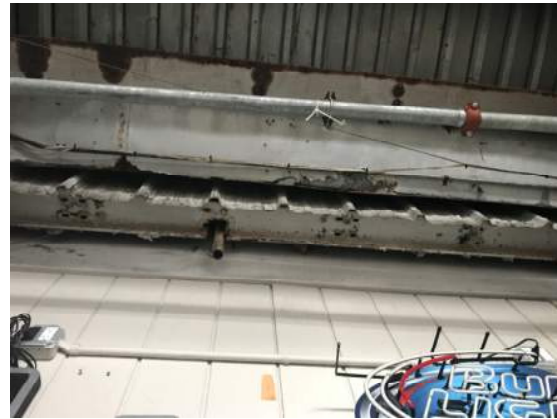
Subject 1 is comprised of three sections (denoted A, B, C above). Section A is a pre-engineered metal building consisting of wide flange main frames, light gauge "Z" purlins and metal deck. The ground floor appears to be a slab on grade with a perimeter concrete foundation. Section B is constructed with concrete block walls that support open web steel bar joists and metal deck. The floor is a concrete slab on grade and the building appears to have a concrete foundation. In general, this section is in sound condition. Section C is a pre-engineered metal building as well, consisting of round steel columns, wide flange beams, light gauge "Z" purlins and metal deck. This section appears to have been modified significantly as large portions of the exterior walls are open to allow for small awning type additions to the building. The ground floor is partial slab on grade that has wood decking supported by sleepers and a small portion of the building appears to be supported on wood dock pilings.

The Dockside building is well into its useful life, being built in 1966 (per assessor). Sections A and C have evident steel corrosion and delamination throughout. It would most likely be cost prohibitive to salvage the building if substantial improvements are to take place. Additionally, the building's utilized space is below the Design Flood Elevation and it does not meet the current FEMA standard for flood resistant design and construction. Relocating the existing building outside the flood zone is not possible on the site and moving it off-site seems very impractical due to the congestion of adjacent structures and the lack of infrastructure capable of handling the relocation of a building of this size. It is highly unlikely the building is robust enough to handle additional loads, e.g. is not suitable for the basis of additions or enlargements. In short, this building is of little to no value with respect to future improvements, and it seems prudent it be demolished if new, conforming structures are to be built.
