### Structural Inspections and Evaluation, Waites Wharf buildings – Lynch Stables

# Lynch Stables-Masonry Storage Building (Private)

Subject 2: Property Record 16 Waites Wharf, Newport, RI Plat: 32, Lot: 248

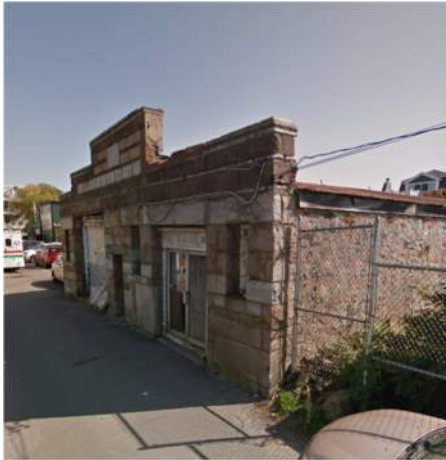
**Building Layout**

Subject 2 is a single story building with stone and brick masonry exterior walls. The majority of the building is a concrete slab on grade but has small areas of dirt floor as well as a section that is wood decking on wood sleepers. The roof is constructed with heavy timber wood trusses spaced approximately 15'-0" on center with transverse 2x purlins spaced approximately 24" on center that support board sheathing. Please see the following photos and captions for additional commentary regarding the existing conditions.

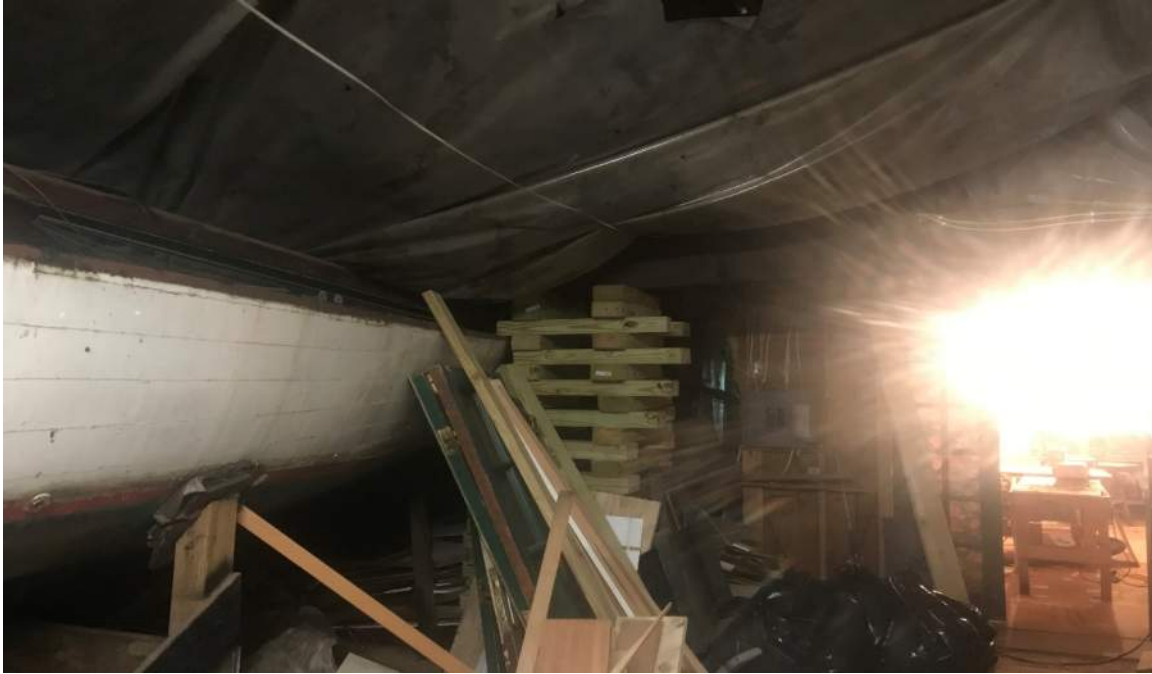
Photo 1: This photo shows cribbing supporting a collapsed roof truss in the southern portion of the building. There is also a large section in this area that has a plastic covering to help mitigate the leaking roof.

The Lynch Stables is well into its useful life, being built in 1900 (per assessor). The majority of the building is in a state of disrepair and sections of the framing have even failed. The building has minimal structural integrity when gauged against today's building codes. It would most likely be cost prohibitive to salvage the building if substantial improvements are to take place. Additionally, the building's utilized space is below the Design Flood Elevation and it does not meet the current FEMA standard for flood resistant design and construction. Relocating the existing building outside the flood zone is not possible on the site and moving it off-site seems very impractical due to the congestion of adjacent structures and the lack of infrastructure capable of handling the relocation of a building of this size. It is highly unlikely the building is robust enough to handle additional loads, e.g. is not suitable for the basis of additions or enlargements. In short, this building is of little to no value with respect to future improvements, and it seems prudent it be demolished if new, conforming structures are to be built.

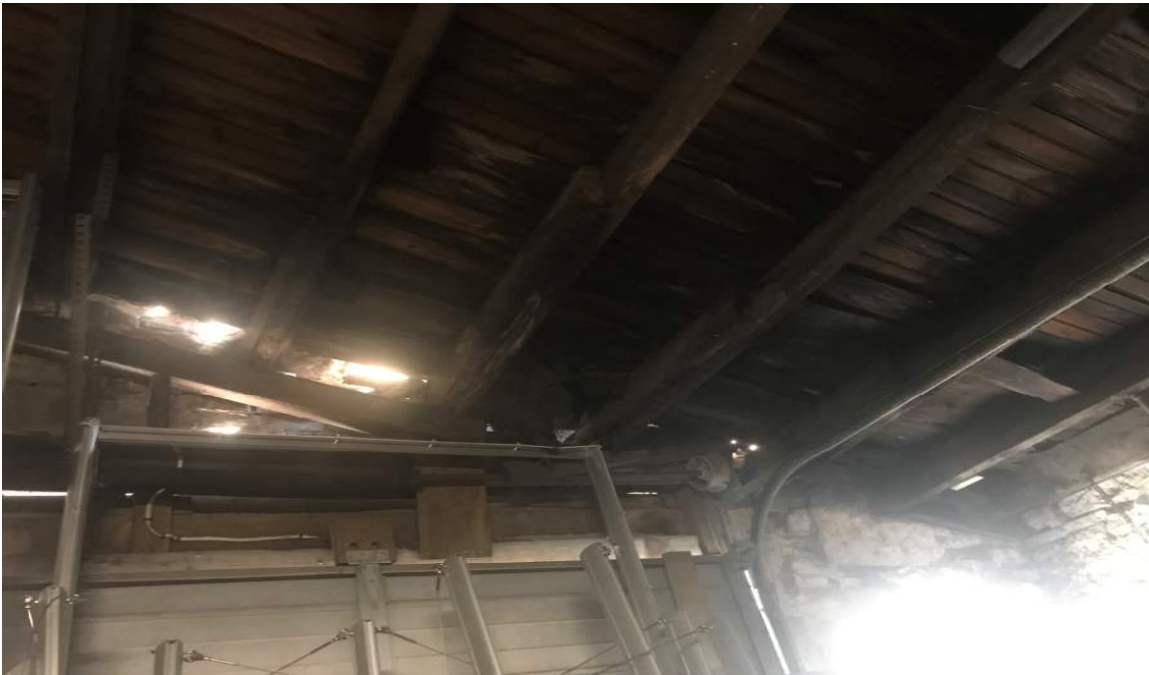
Photo 2: This photo shows northern gable end wall of the building. It is clear in this photo the building envelope is no longer in-tact and has exposed the framing to the elements. Large sections of the existing roof decking appear rotted and/or have already failed. The majority of the roof purlins also appear rotted and/or damaged. The ledger against the masonry wall has failed over the right side of the garage door opening.
