Re: Easton Pond Dam and Moat Study
Final Report

Final Report
Easton Pond Dam and Moat Study

City of Newport
Newport, Rhode Island

September 2007

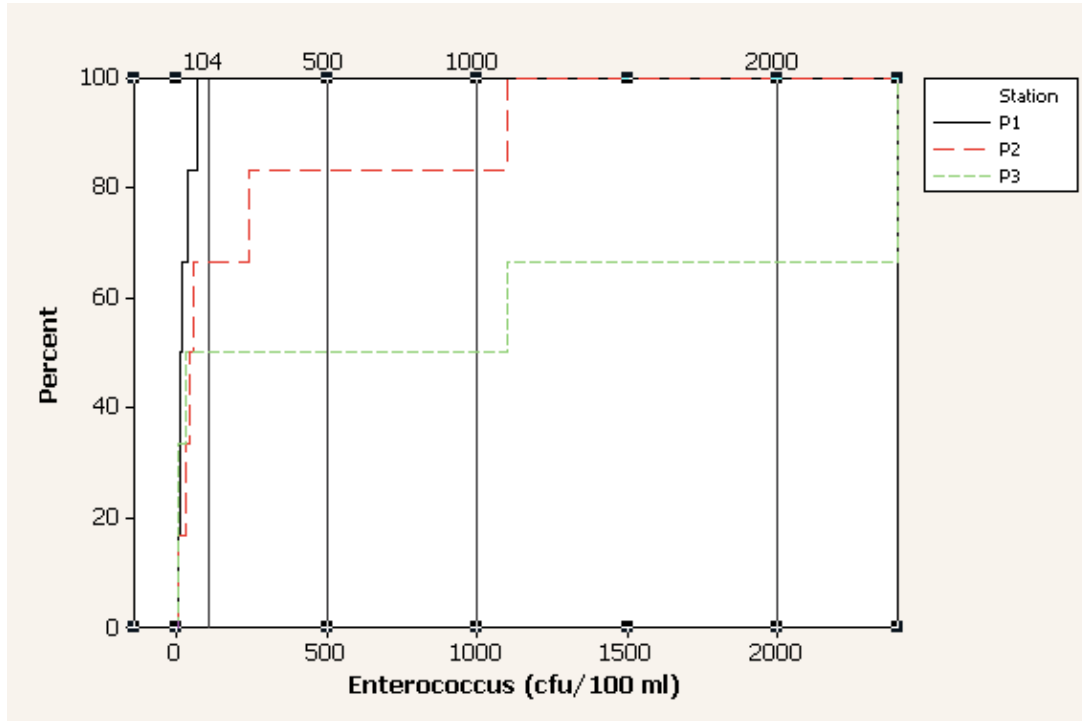
Chart 13
Cumulative Percent Curves of P Stations for *Enterococcus* for Event 1

Chart 13 demonstrates that P3 has the highest *Enterococcus* levels and that the samples are progressively cleaner as one moves downstream.

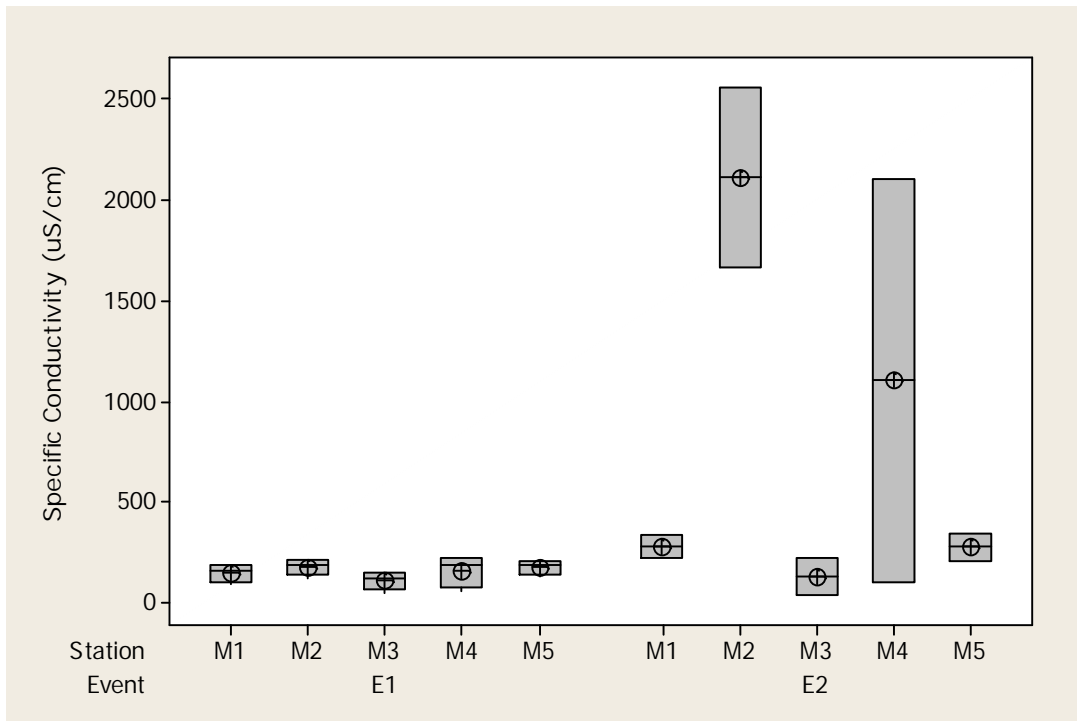
Chart 14
Specific Conductivity Results for Moat Stations for Events 1 and 2

Chart 14 shows that M2 and M4 are high. M2 is tidally influenced and therefore within a normal range for fresh water with saltwater intrusion. M4 is not in a section influenced by salt water. This high level could indicate some discharge of pollution.

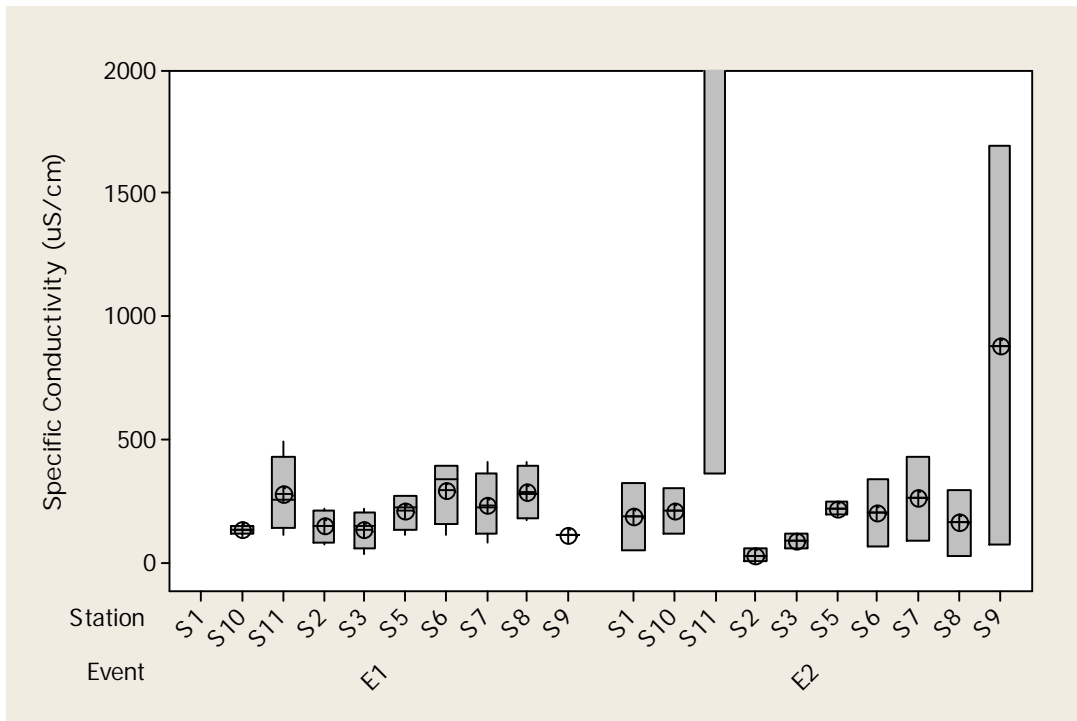
Chart 15
Specific Conductivity results for Stormwater Outfall Stations for Events 1 and 2

Chart 15 shows that discharge from S11 (Middletown outfall draining a section of the Esplanade) has high specific conductivity. High specific conductivity at the discharge point indicates that there is a potential for up-gradient source of pollution. Discharge from S9 (RIDOT owned) also shows high specific conductivity.

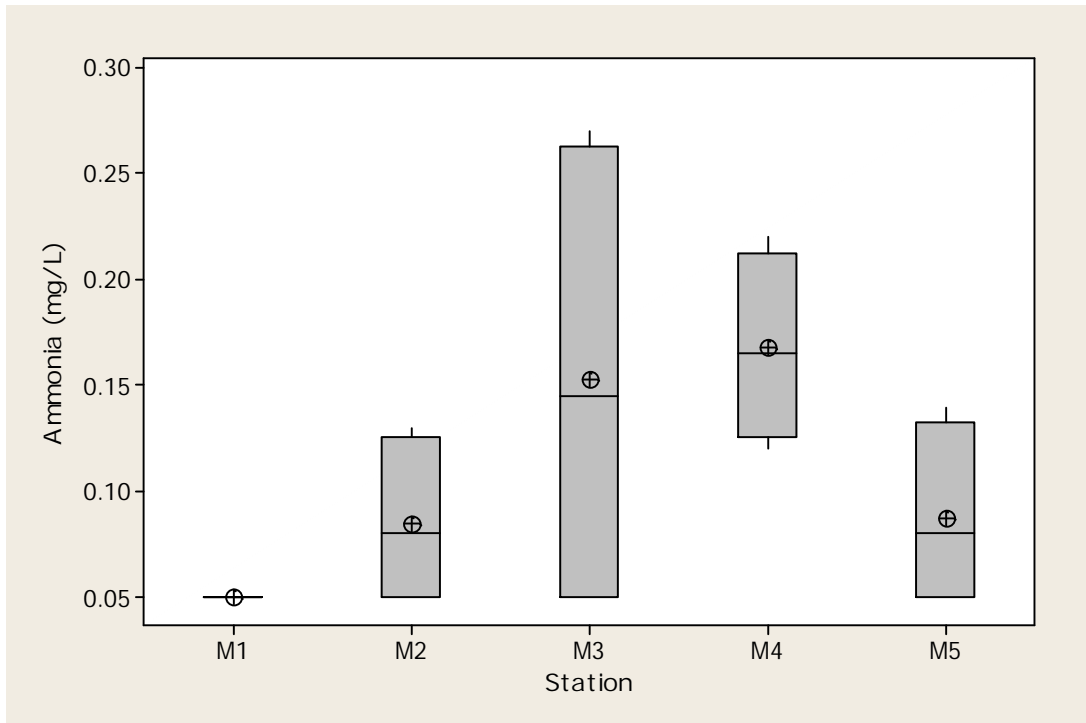
Chart 17
Ammonia Results for Moat Stations for Event 1

Chart 17 shows that ammonia levels for M4 remain steadily high throughout Event 1 while levels at M3 are also high, with more variability. Although there are relative differences in the levels of ammonia that we found at each outfall, these levels are consistent with levels commonly found in urban runoff. Therefore we conclude that based on ammonia measurements, no significant level of sanitary wastewater or animal waste is present.

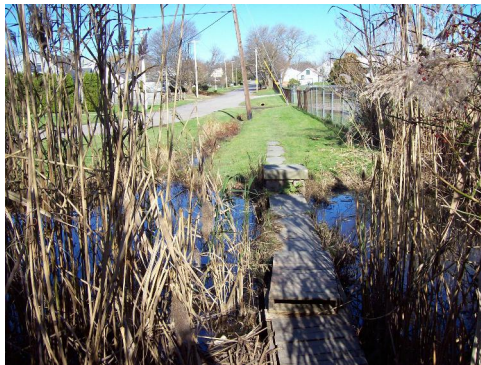
Photograph 17: Existing Wall at

Flood STA-4: Remove obstructions within the Moat adjacent to the Old Filtration Plant to improve the hydraulic efficiency – Photograph 17 shows an existing wall that bisects the Moat adjacent to Sta. 76+89. The removal of this structure will improve hydraulics. Additionally, a paved access path adjacent to the old filtration plant bisects the Moat in the vicinity of Sta. 77+65 as shown in Photograph 18. The installation of culverts to hydraulically connect the Moat upstream and downstream of this path will also slightly improve the hydraulics of the Moat.

The opinion of cost for this work is approximately \$40,000.
