November 7, 2019

Structural Inspections and Evaluation, Waites Wharf buildings

Narragansett Engineering Inc (NEI) and Merk Structural Consulting are pleased to present for your review our inspection of the aforementioned structures located on Waites Wharf in Newport, RI (Subject Properties). An on-site structural survey of the above referenced property was conducted by Narragansett Engineering Inc. (NEI) on August 8, 2019.

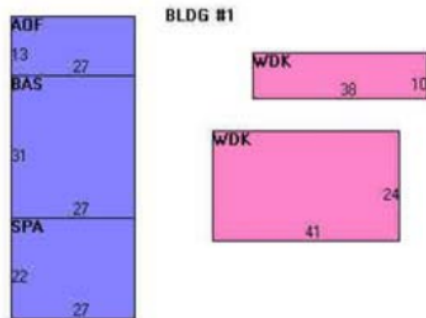
Subject 4 is comprised of three separate buildings, subjects 4A, 4B and 4C as noted above. Subject 4A is constructed with brick and block masonry walls that support heavy timber beams and heavy timber decking. The foundation walls appear to be concrete and there is a concrete slab on grade throughout the structure. Subject 4B is comprised of three sections (denoted A, B, C above). Section A is constructed with brick masonry walls that support heavy timber beams spaced approximately 10'-0" to 12'-0" on center. The timber beams support heavy timber decking. Section B is constructed with heavy timber posts supporting timber girders and beams. The timber beams are spaced approximately 8'-0" on center and support wood purlins spaced approximately 4'-0" on center. The purlins support metal roof deck. Section C is constructed with timber posts and beams that support 2X rafters spaced approximately 16" on center. The roof is sheathed with conventional plywood. Subject 4C is constructed with exterior brick masonry walls that support a loft and the roof. The loft is constructed with heavy timber posts and beams that support timber decking. The roof is framed with timber decking supported by a center heavy timber truss and the gable end walls. The floor is a concrete slab on grade. In general, the framing in these buildings appears to be in good condition but neither building meets the current FEMA regulations and minimum standards for flood zone design and construction.
