NEWPORT HISTORIC DISTRICT COMMISSION DEPARTMENT OF ZONING & INSPECTION

APPLICATION FOR CERTIFICATION OF APPROPRIATENESS

WINDOW REPLACEMENT

Window Assessment

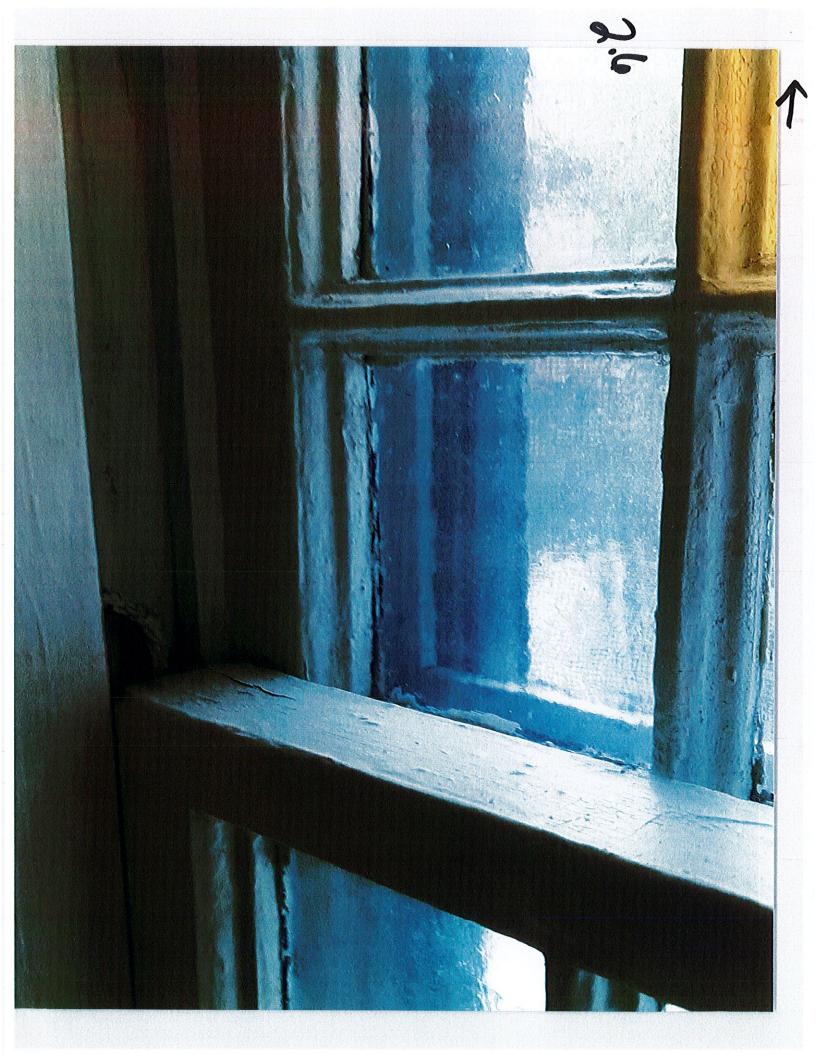
2.4	2 over 2	?	Fair	Now a fire escape, replaced
2.5	6 over 6	6 over 6	Poor	Broken glass, overpaint, failing glaze
2.6	15 over 15	15 over 15		Finishes and glaze poor
