Technical Memorandum

**Phase 1 Part 2 CSO Control Plan
Wellington Avenue CSO Facility**

**Flow Isolation and Follow Up Closed Circuit
Television Inspection**

December 28, 2006

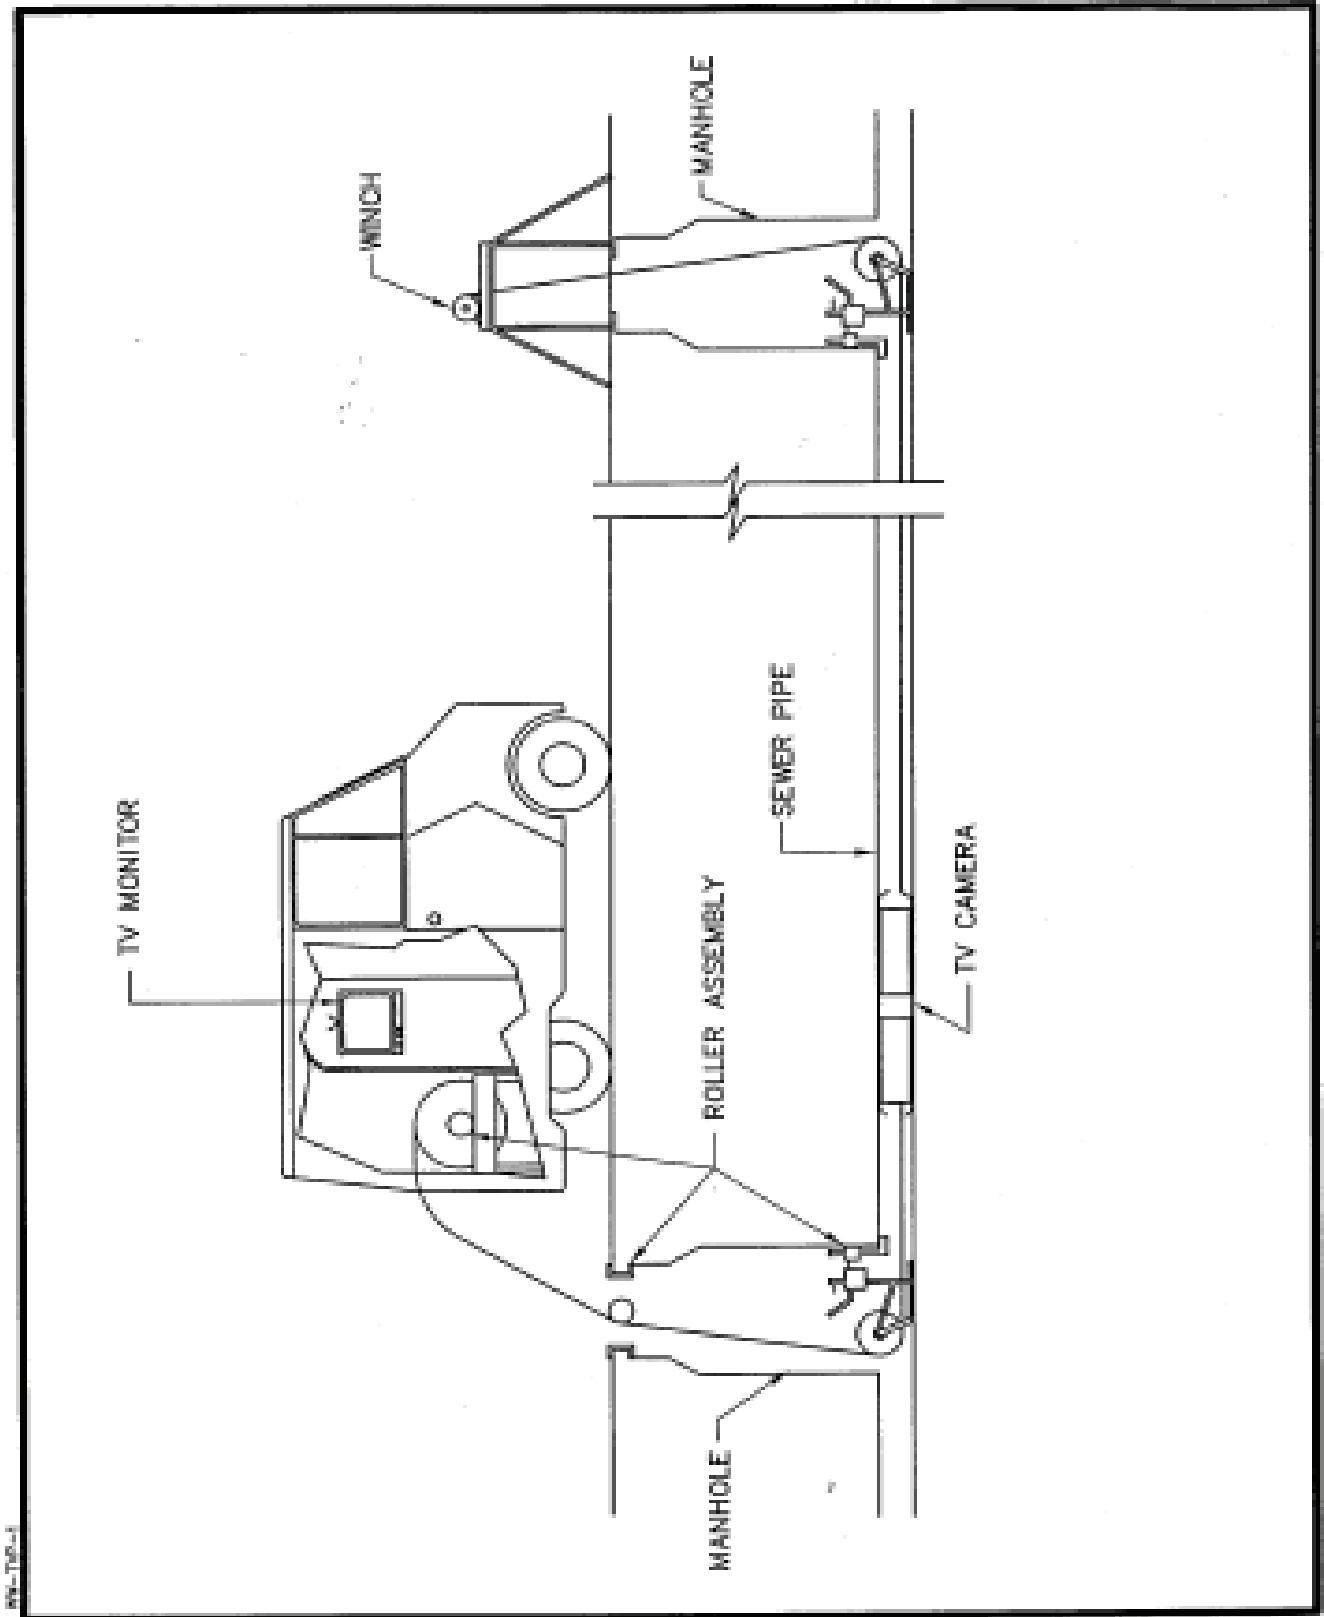
FIGURE 3
T.V. INSPECTION PROCEDURE
NOT TO SCALE

During this procedure, the sewer pipe was first pressure cleaned to facilitate the movement of the television camera through the pipe. The camera used was a track-operated device with pan and tilt capability (Figure 3). Infiltration sources in each segment were pinpointed by viewing television footage and observing leaking joints, cracked and broken pipes, leaking services, sagging pipes, mineral deposits, etc. The television inspection determined the specific location, condition and observed the estimated flow rate of the sources of infiltration within the line sections. Television inspection also allowed the estimation of flow from running or leaking services. Appendix A presents a summary of the television inspection performed showing the length of sewer televised; the major defects encountered and the infiltration found; and the individual CCTV inspection logs documented by ADS. The locations where CCTV inspections were performed are shown on Figure 4.

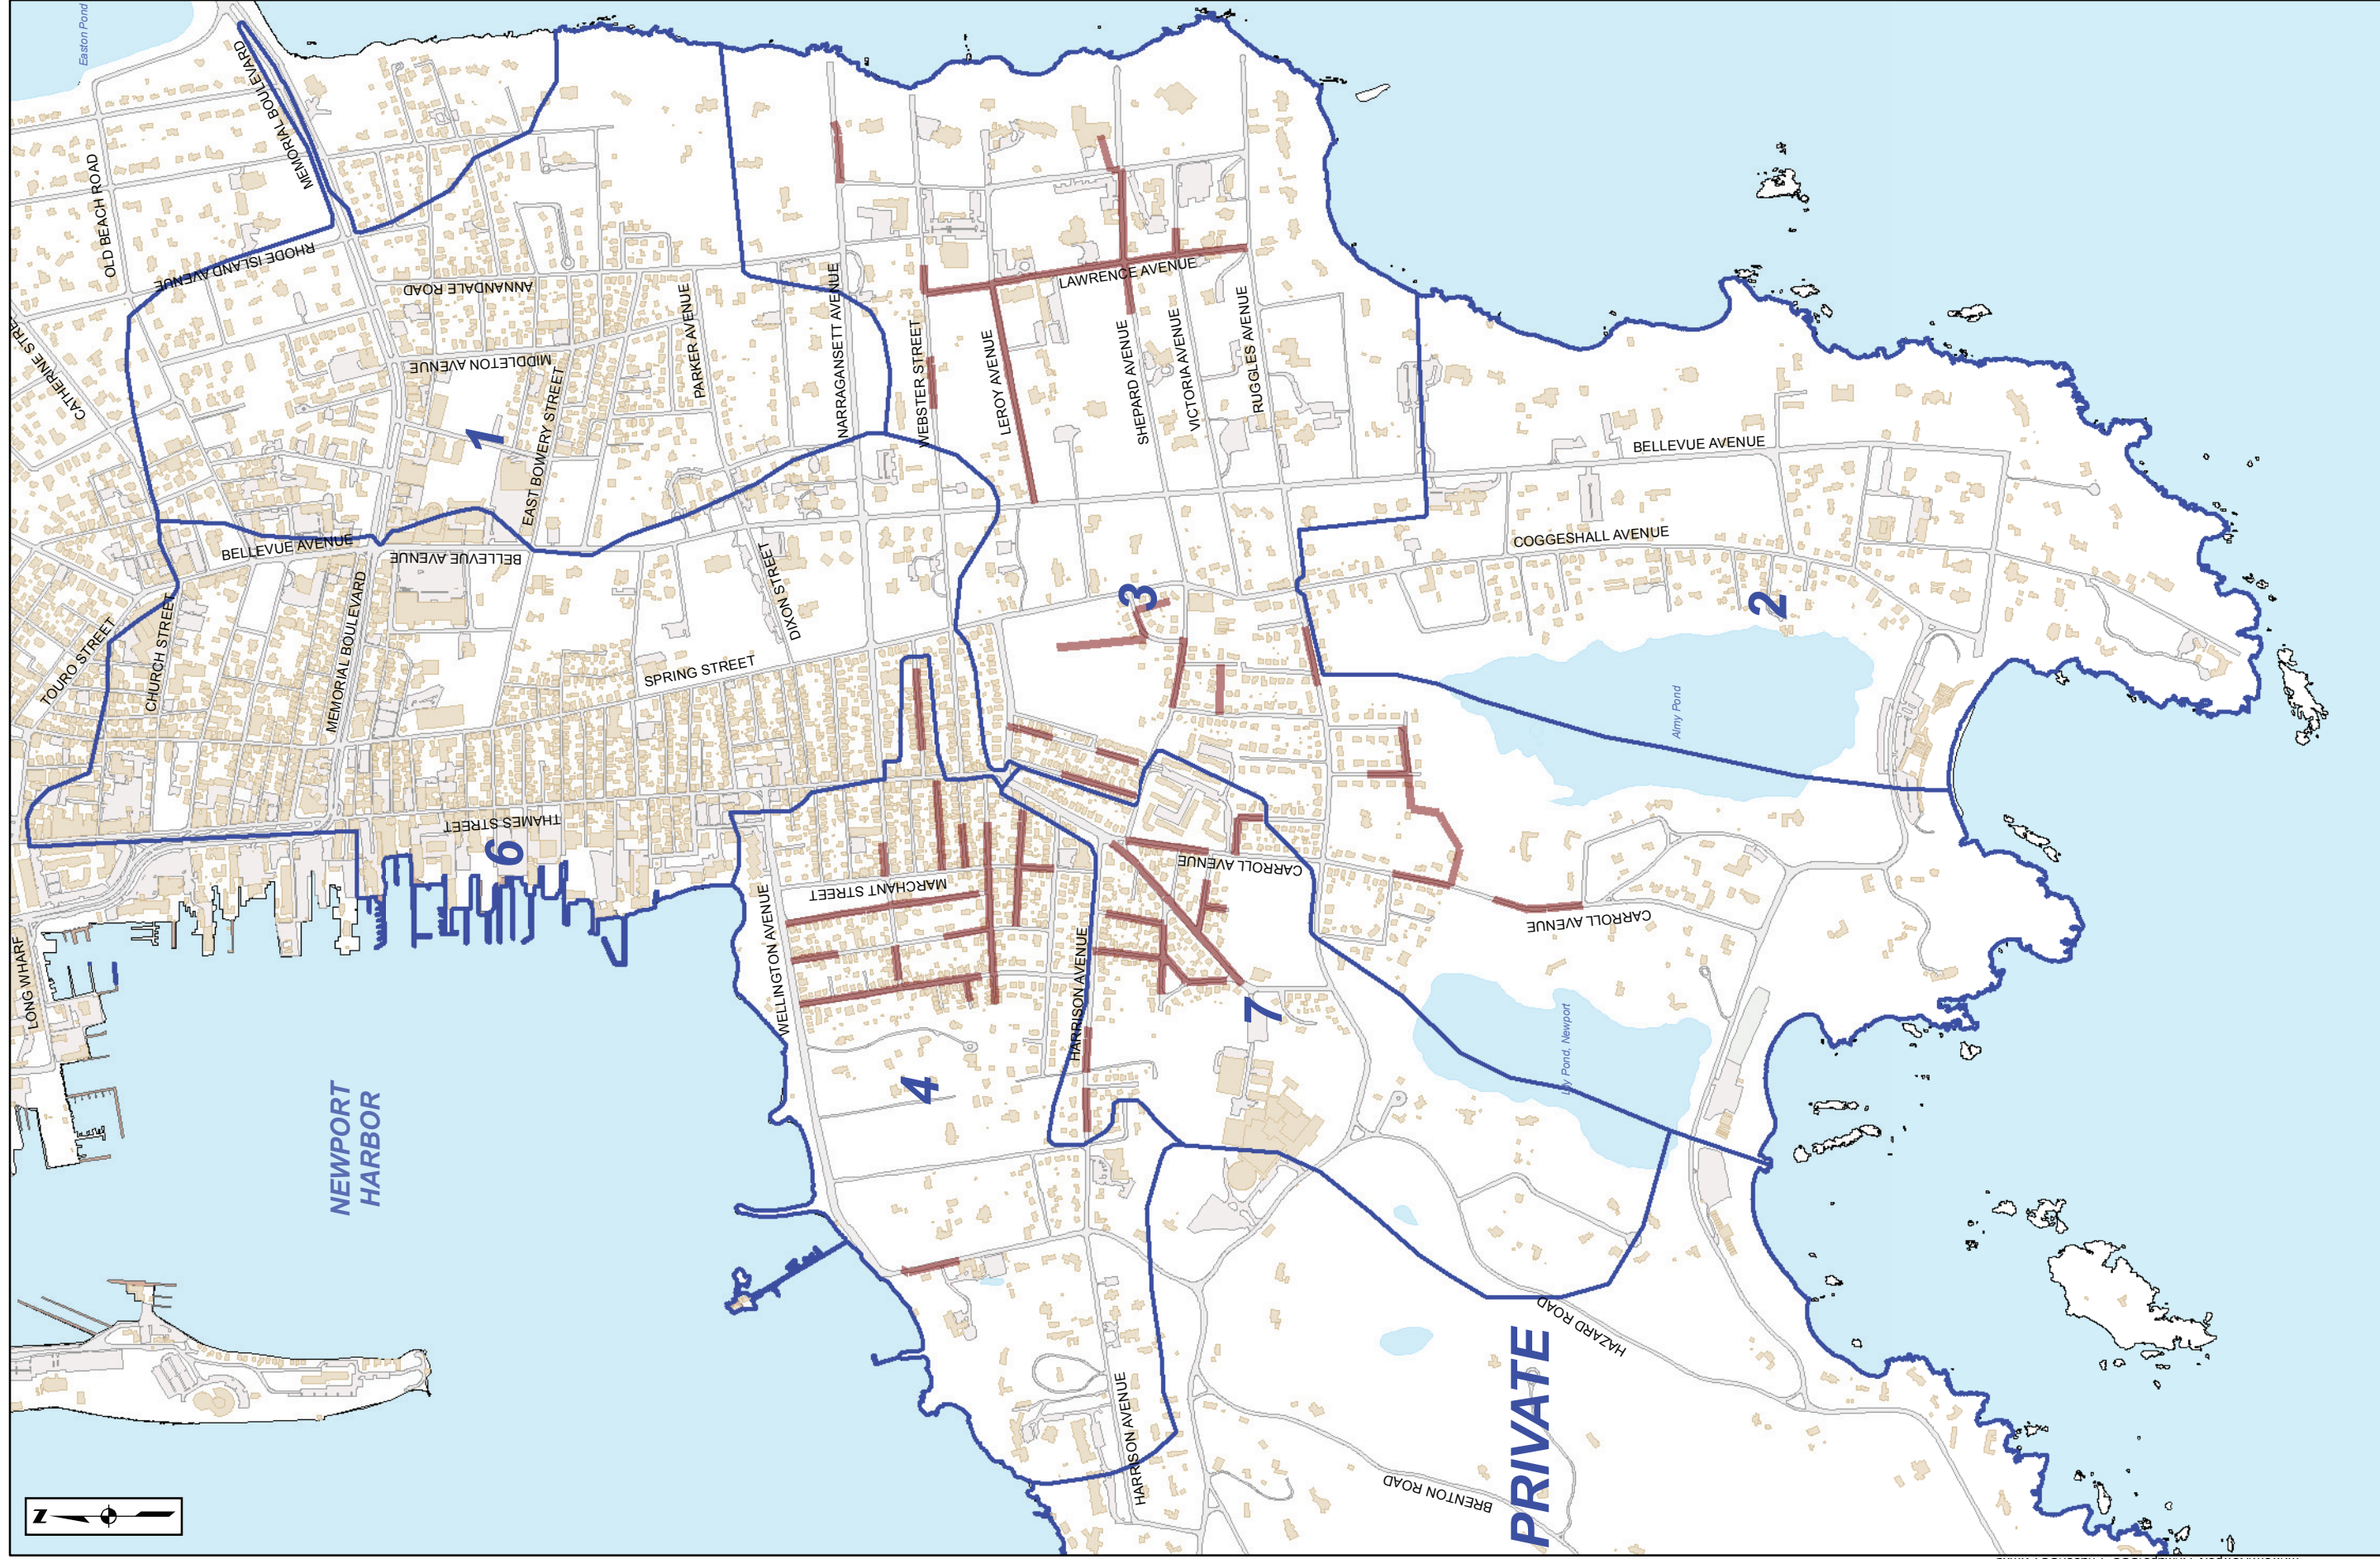
FIGURE 4
CCTV INSPECTION LOCATIONS
PHASE I PART 2 CSO CONTROL PLAN
