City of Newport, Rhode Island

Application for State Assent: Vegetative Clearing & Stabilization Plan for Old Sediment Basin (North & South Easton Pond)

DAM SAFETY: INTERIM STABILIZATION REPORT

North & South Easton Pond in Vicinity of Old Sediment Basin

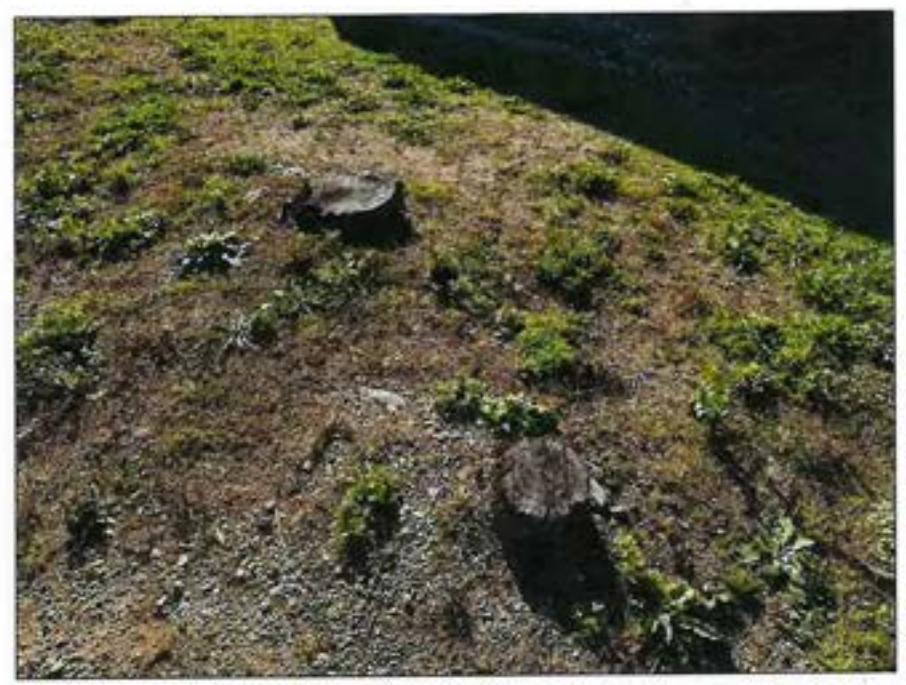
Photo No. 1.: Stumps at the right abutment.

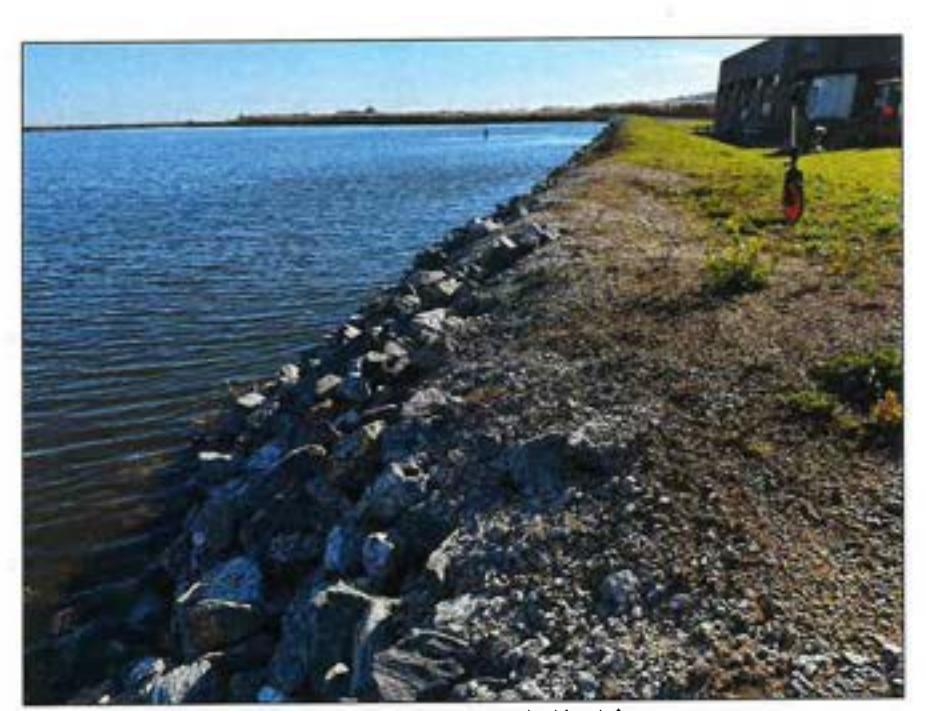
Photo No. 2.: Upstream slope from the right abutment looking left.

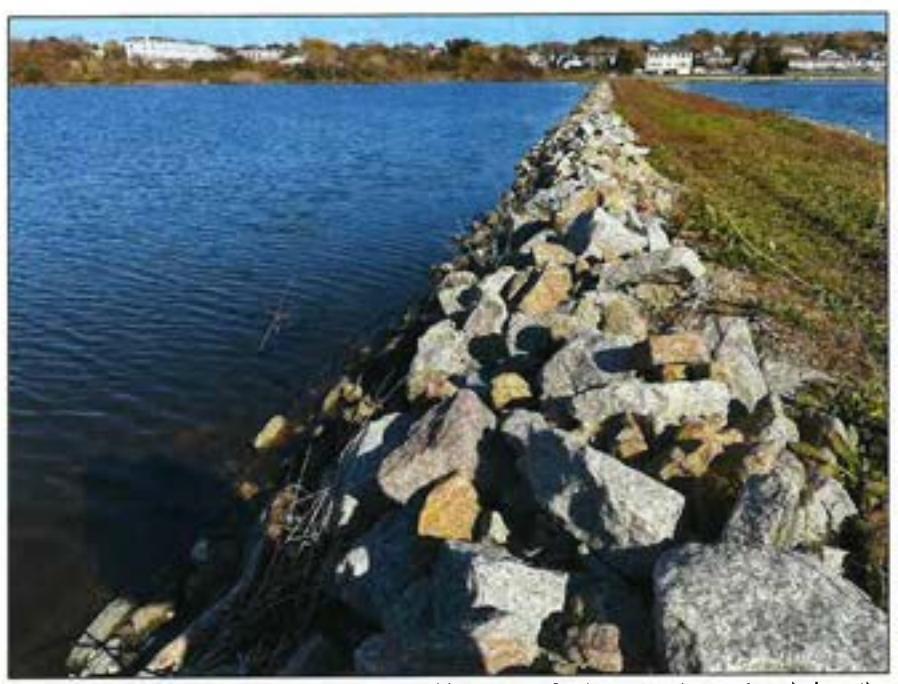
Photo No. 5.: Upstream slope near STA 18+00 looking left. Note new riprap placed along the slope.

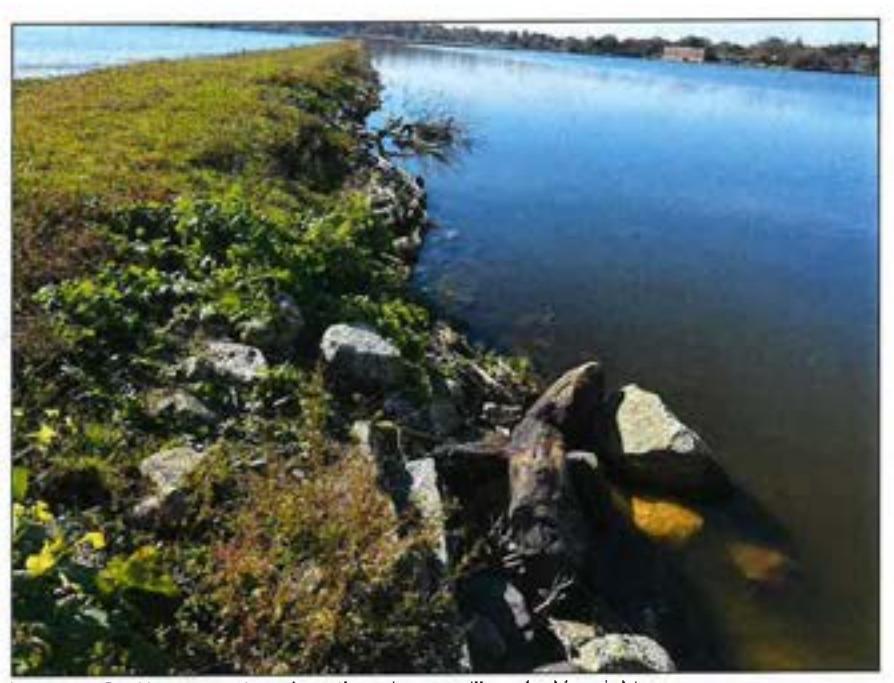
Photo No. 6.: Upstream slope from the primary spillway looking right.

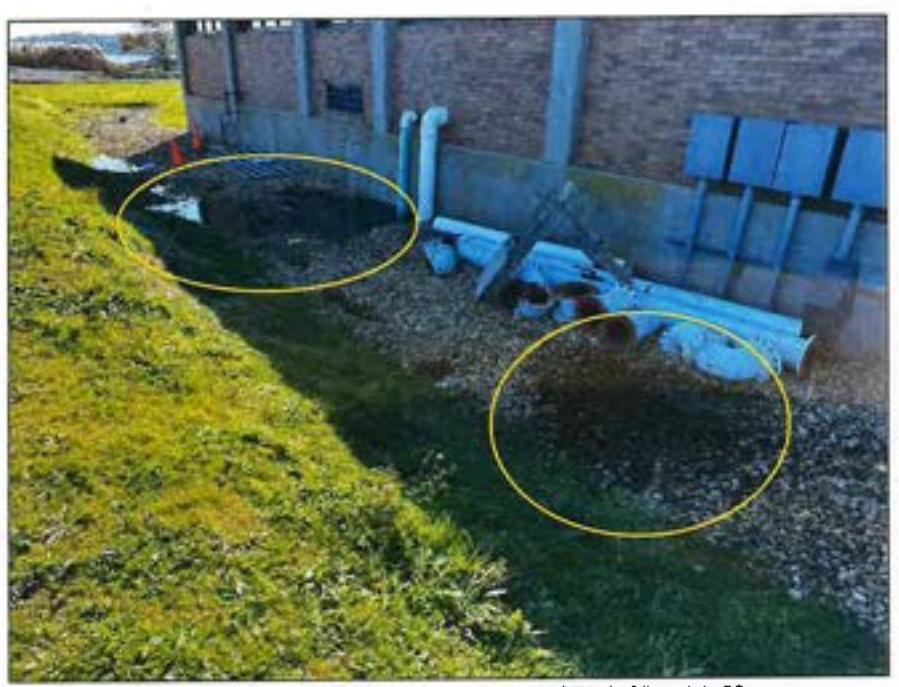
Photo No. 13.: Saturated area at downstream toe between STA 1+65 and 1+90.

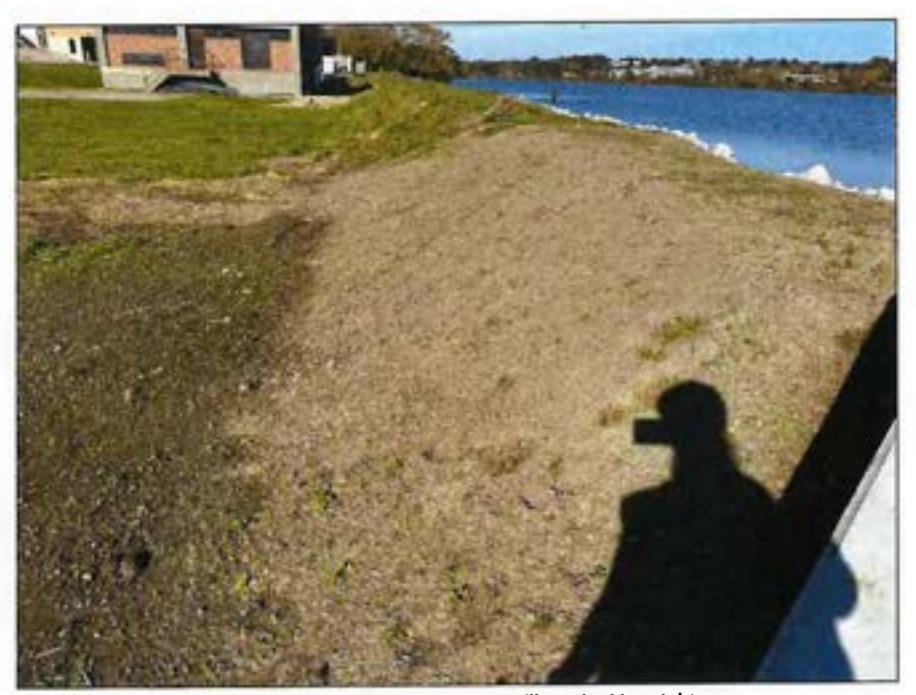
Photo No. 14.: Downstream slope from the auxiliary spillway looking right.

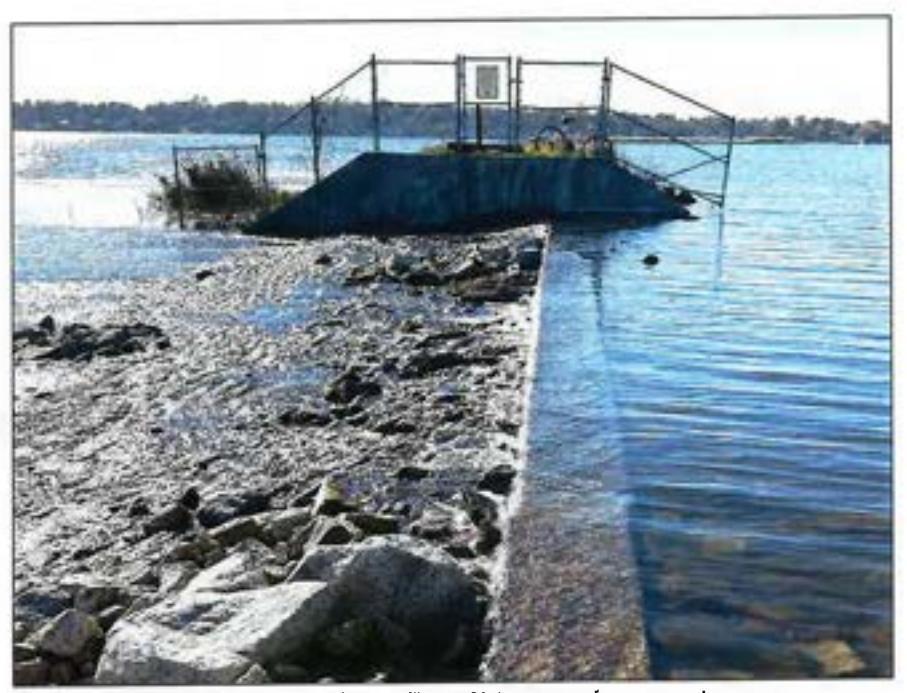
Photo No. 22.: Right training wall of the spillway. Note new surface concrete.

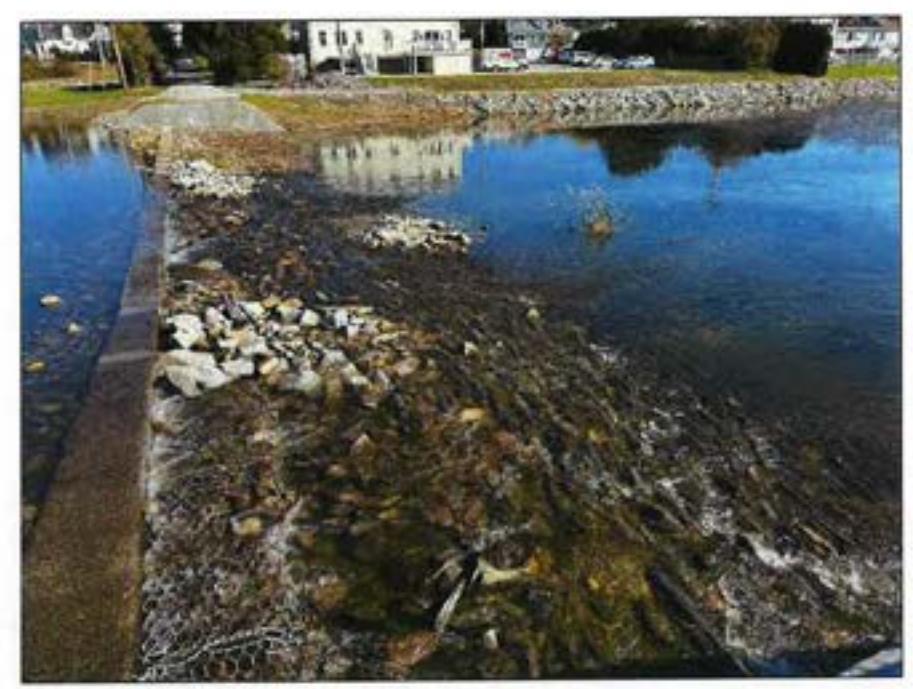
Photo No. 25.: Discharge apron of the spillway.

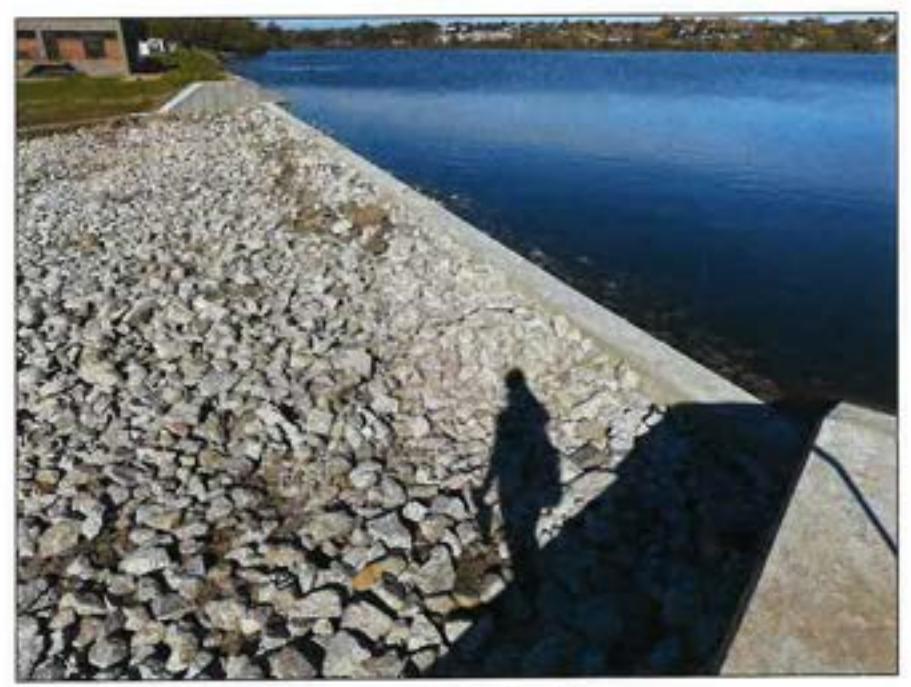
Photo No. 26 .: Auxiliary spillway from the left end looking right.

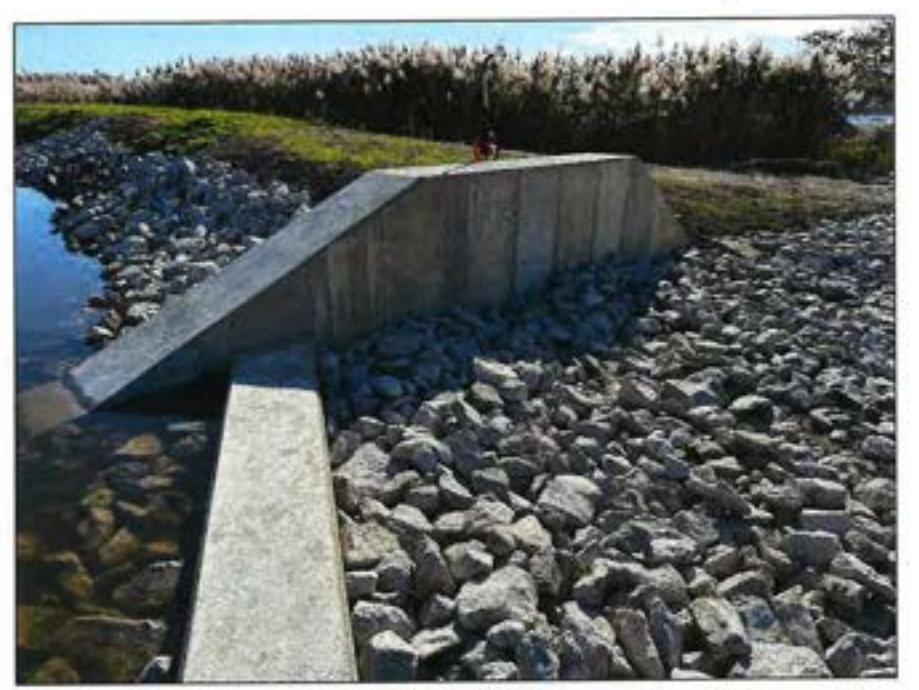
Photo No. 29.: Left training wall of the auxiliary spillway.

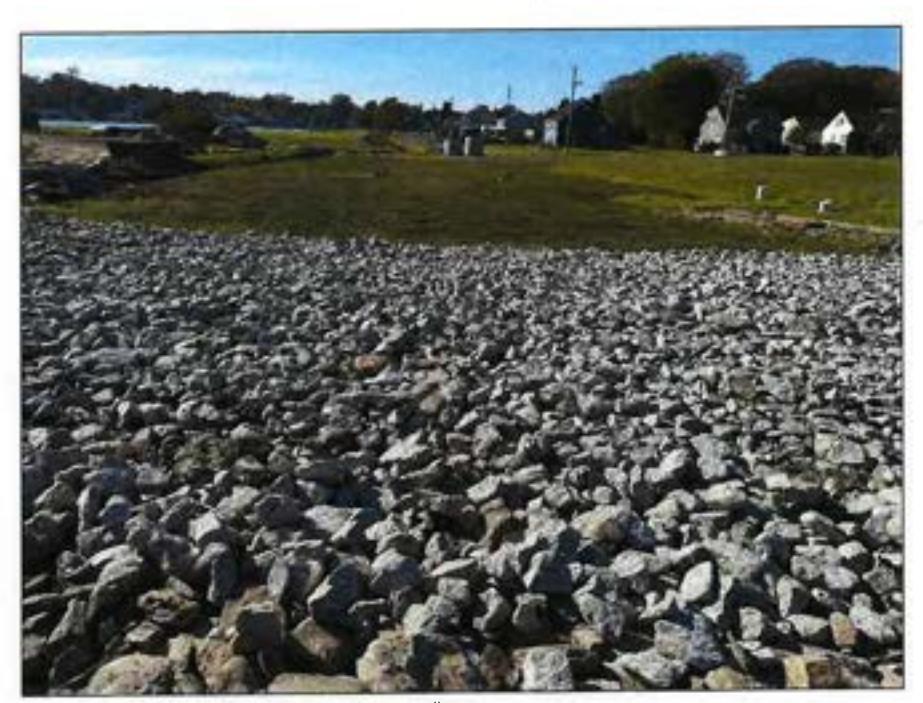
Photo No. 30.: Discharge of the auxiliary spillway.

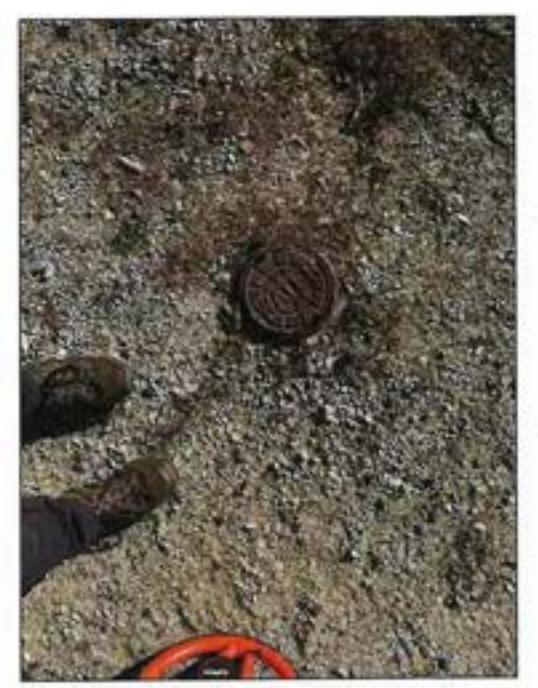
Photo No. 33 .: Low level outlet valve cover

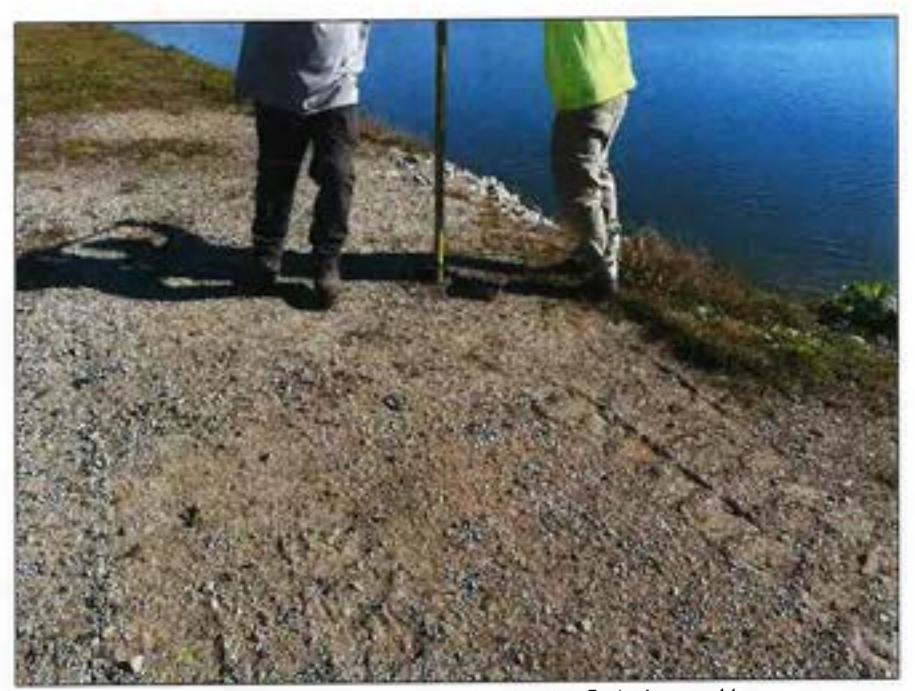
Photo No. 34.: City of Newport operating the low level outlet. Outlet is operable.

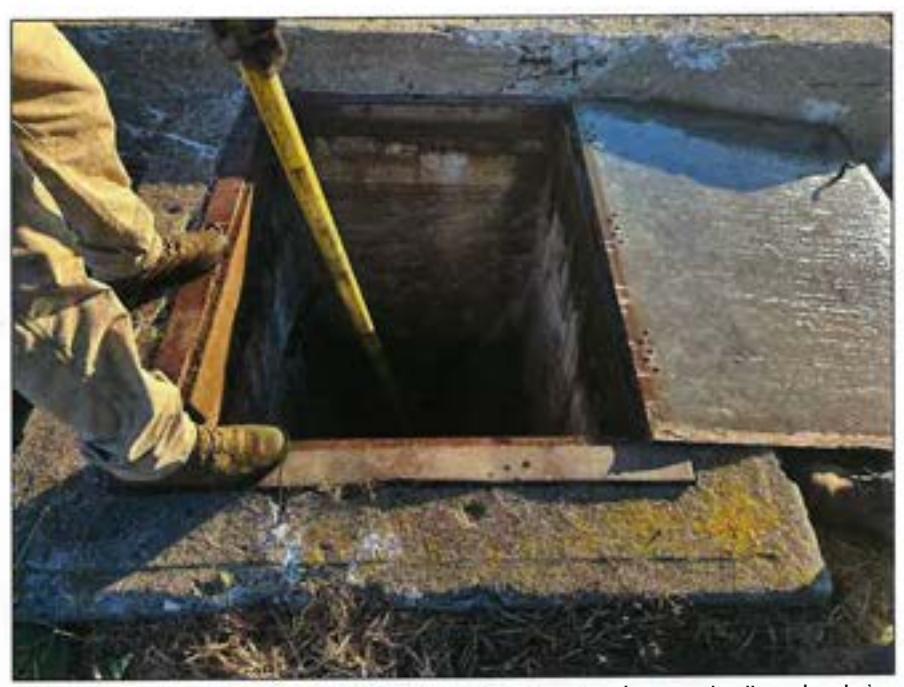
Photo No. 1.: Interior of the low level outlet chamber. Note the city operating the valve during the inspection.

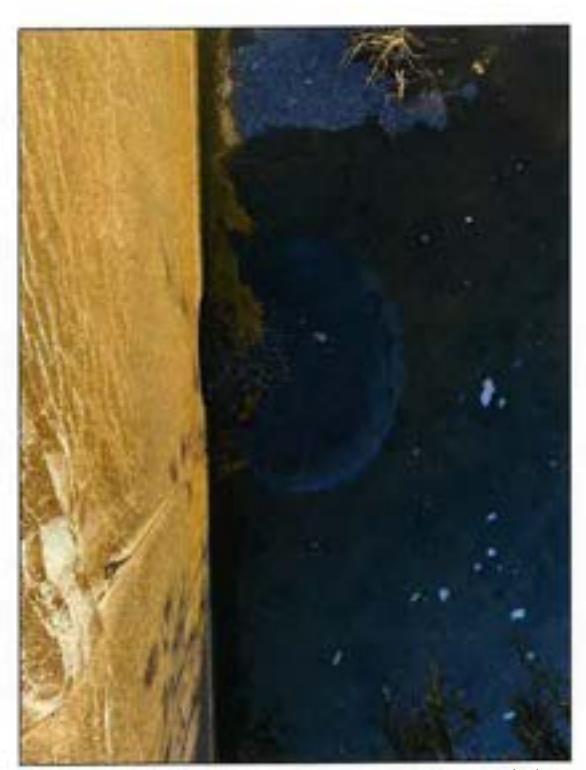
Photo No. 2.: Water flow from the low level outlet during operation.

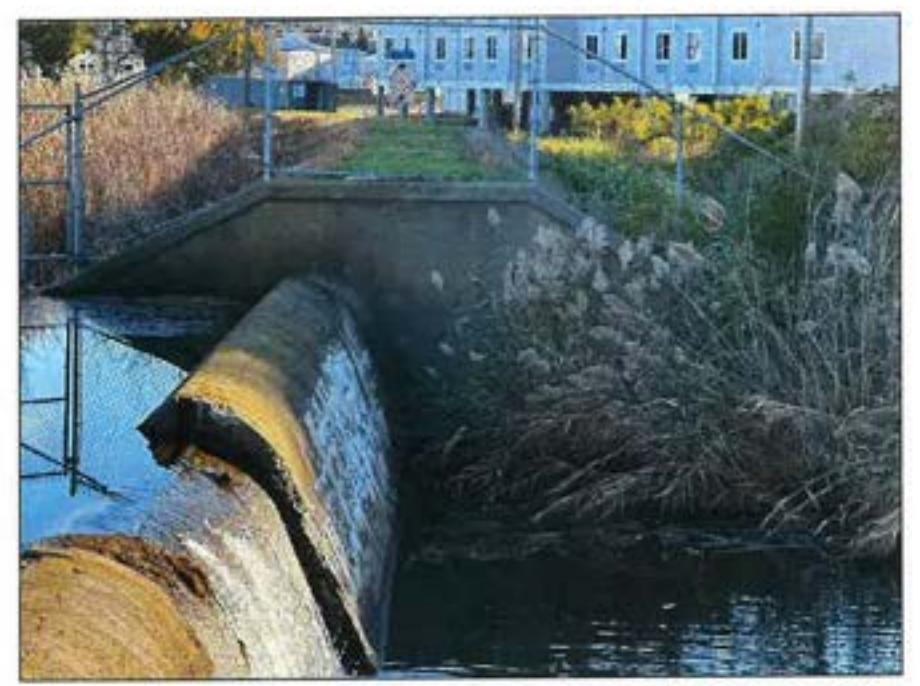
Photo No. 5.: Left training wall of the primary spillway.

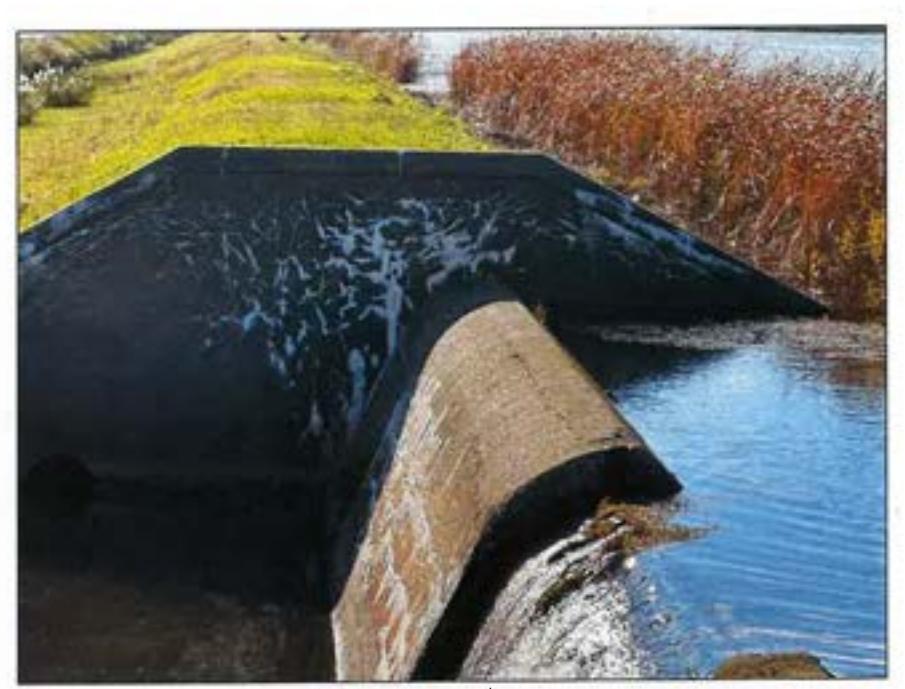
Photo No. 6.: Right training wall of the primary spillway.

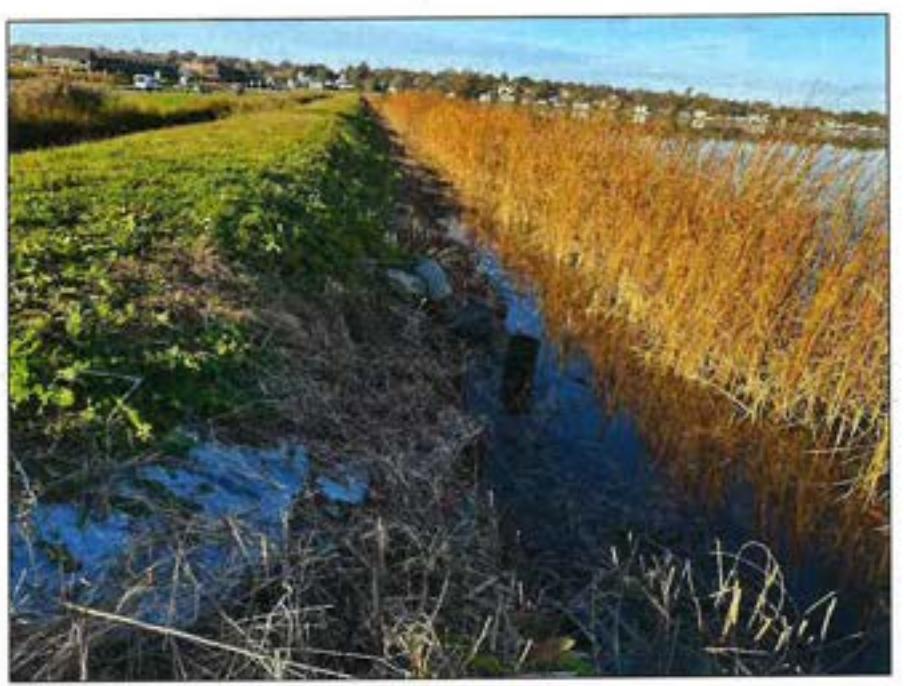
Photo No. 9.: Upstream slope from the primary spillway looking right.

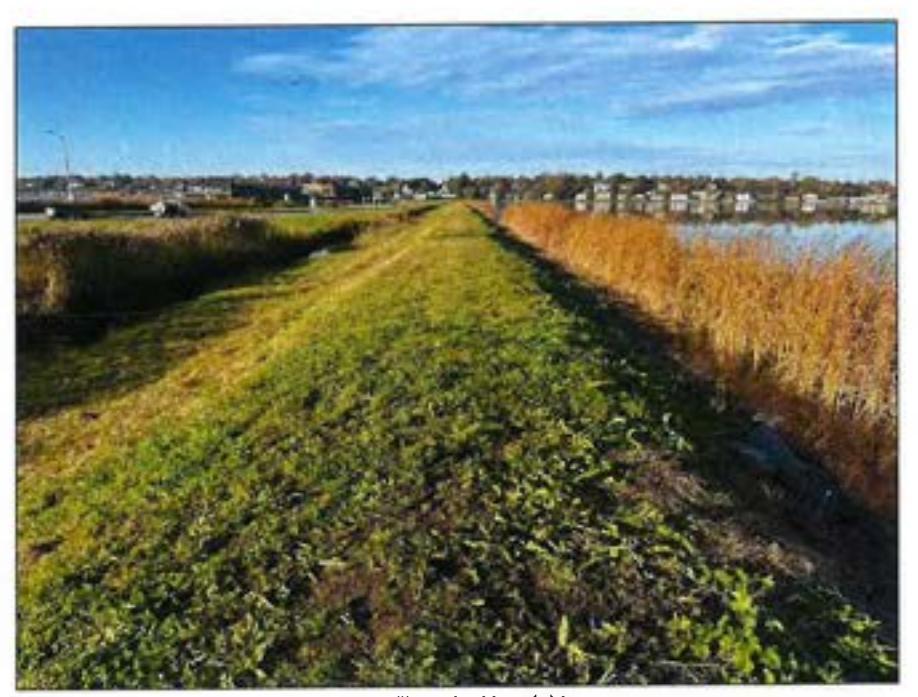
Photo No. 10.: Crest from the primary spillway looking right.

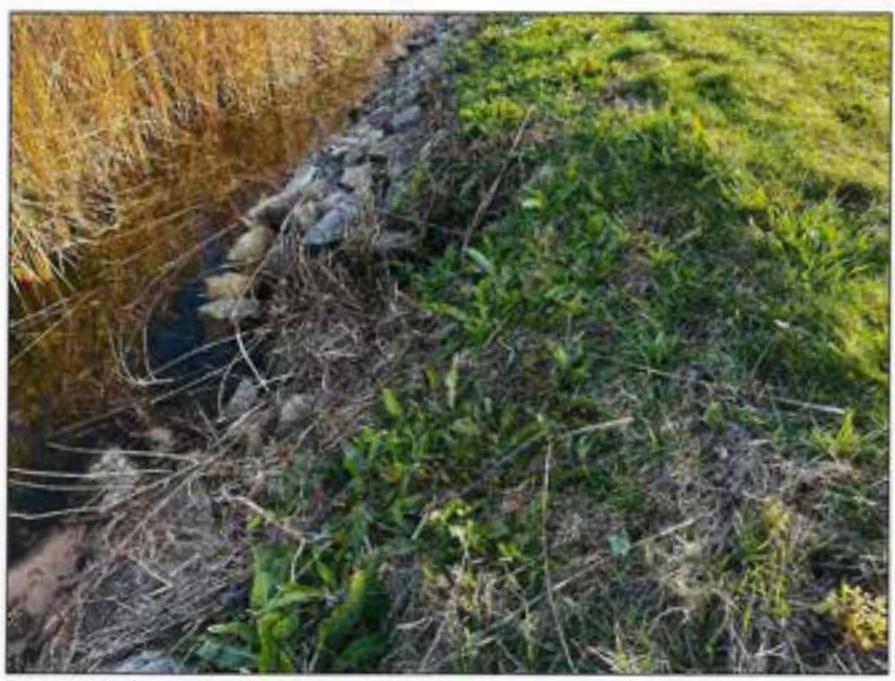
Photo No. 13.: Bowl/depression in the upstream slope near STA 10+40. Typical of the depressions throughout the upstream slope.

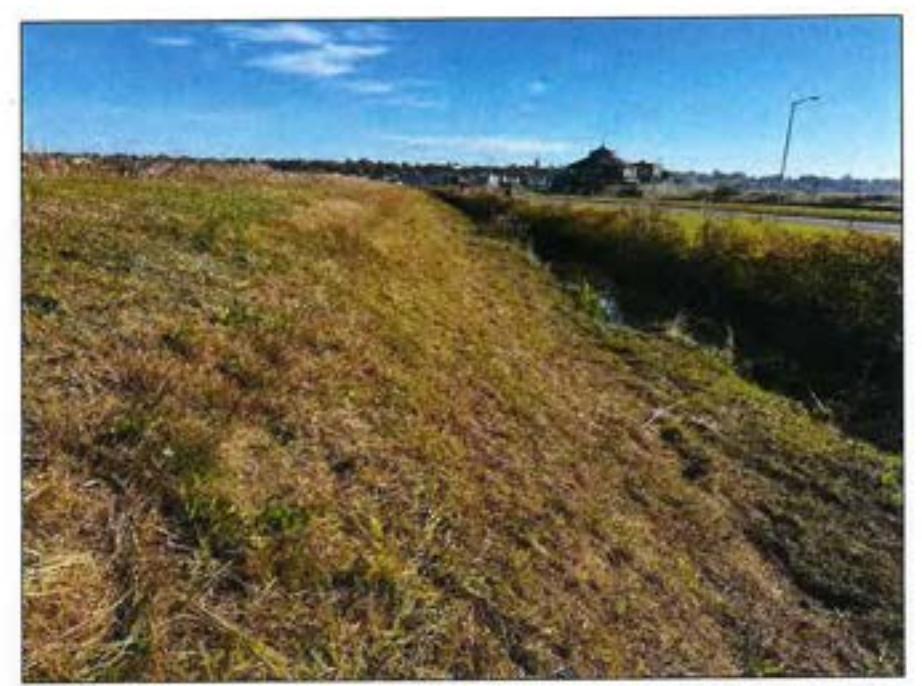
Photo No. 17 .: Downstream slope from STA 18+00 looking left.

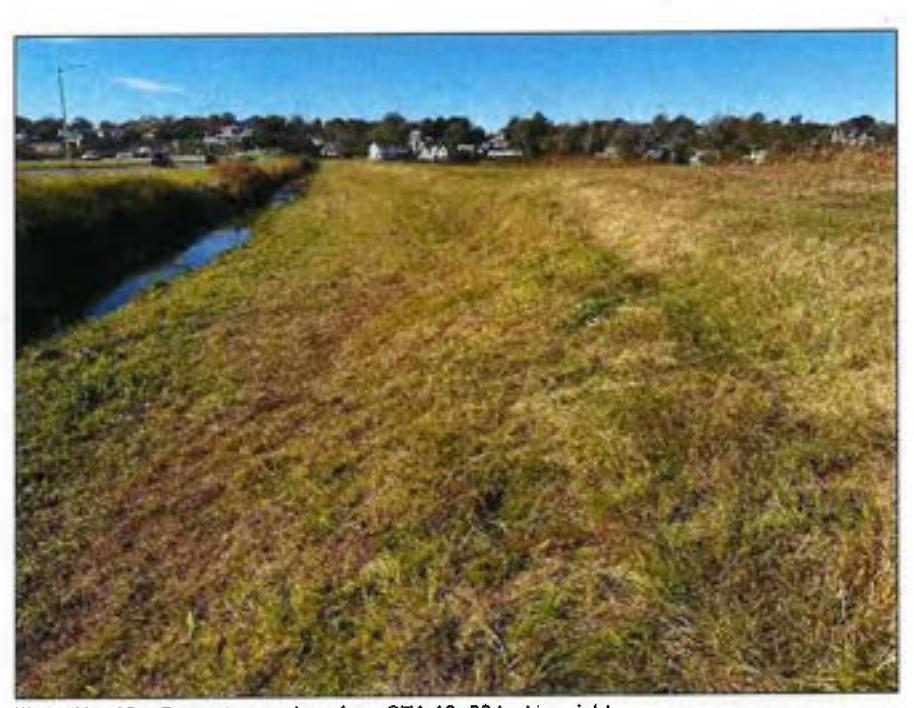
Photo No. 18.: Downstream slope from STA 18+00 looking right.

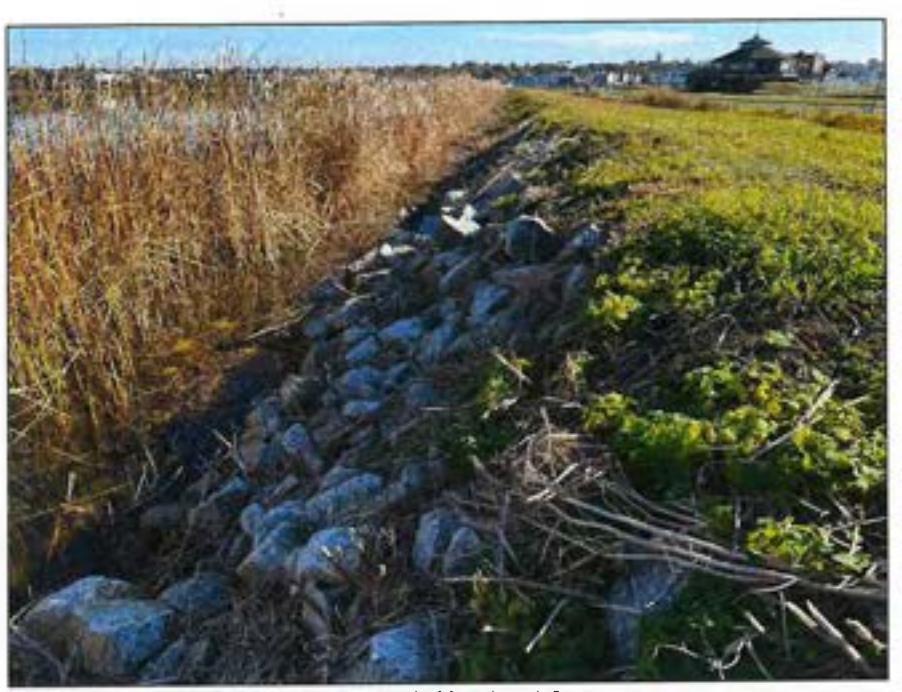
Photo No. 21.: Upstream slope from STA 18+00 looking left.

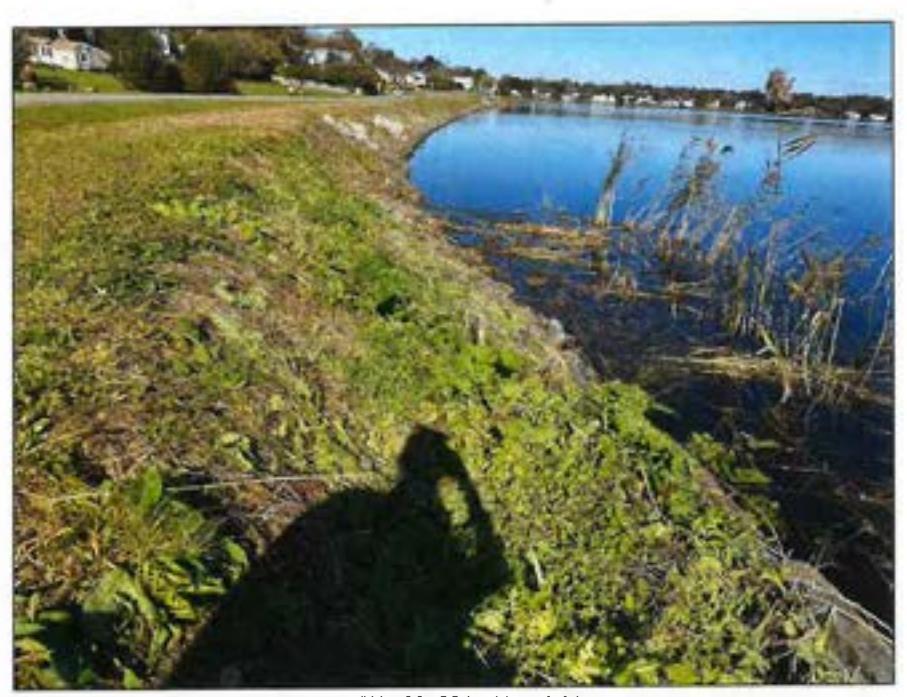
Photo No. 26.: Upstream slope from STA 30+00 looking right.

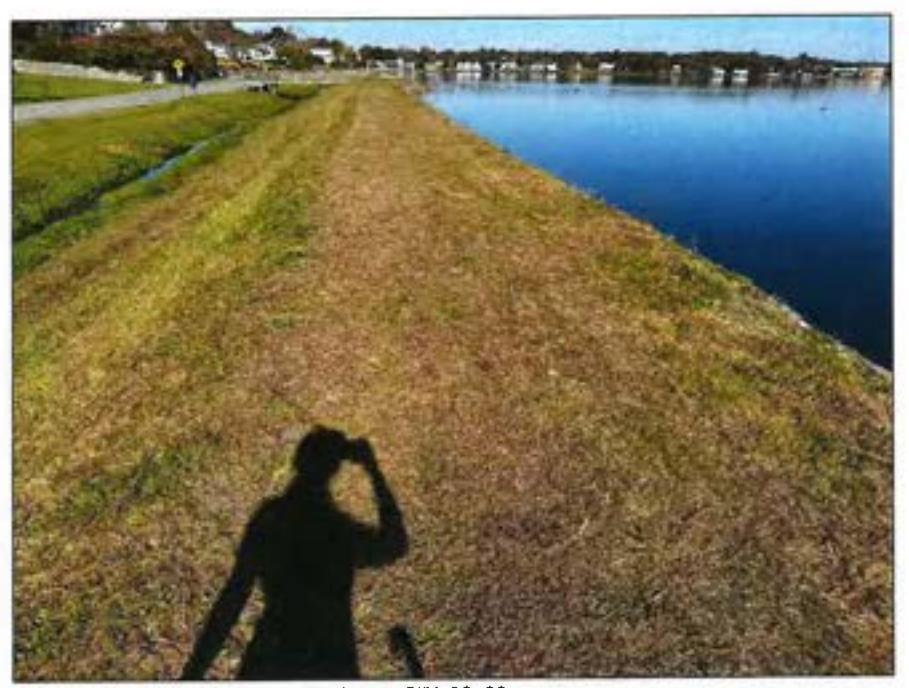
Photo No. 29.: Overview looking left near STA 32+00.

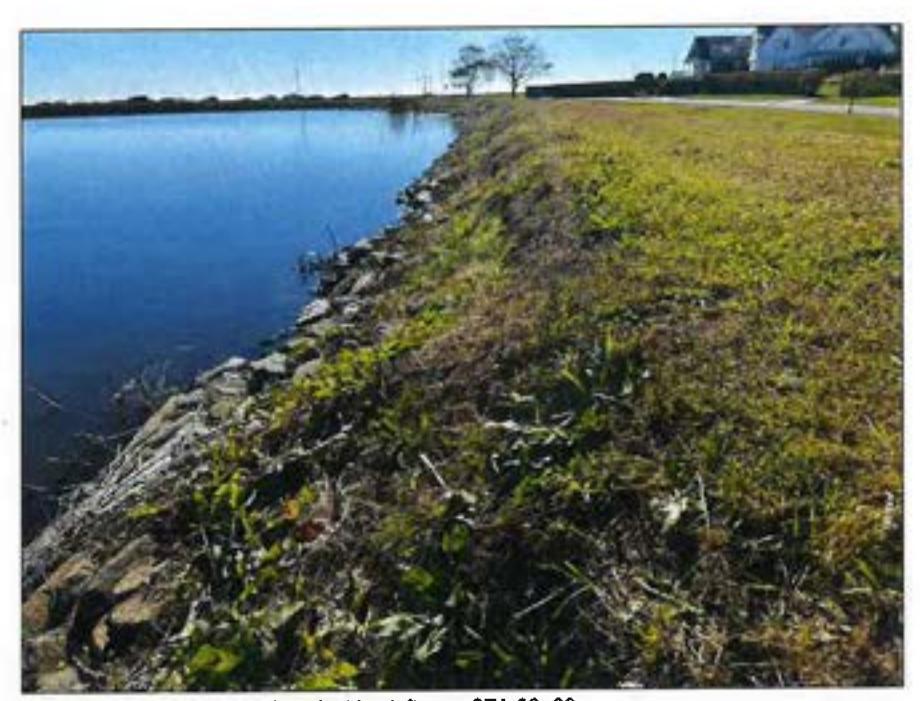
Photo No. 30 .: Upstream slope looking left near STA 32+00.

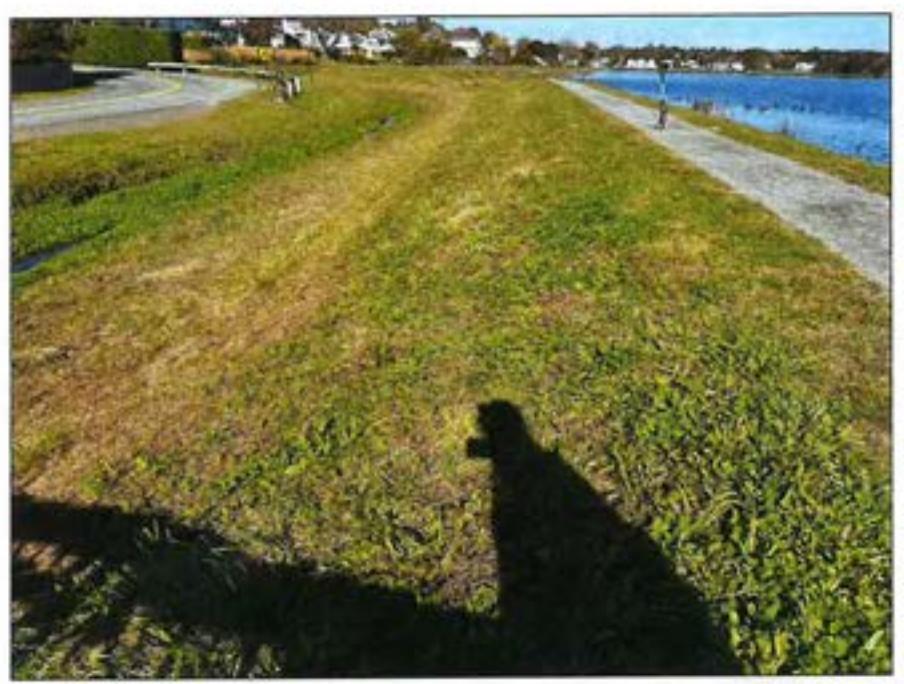
Photo No. 33.: Downstream slope from STA 37+50 looking right.

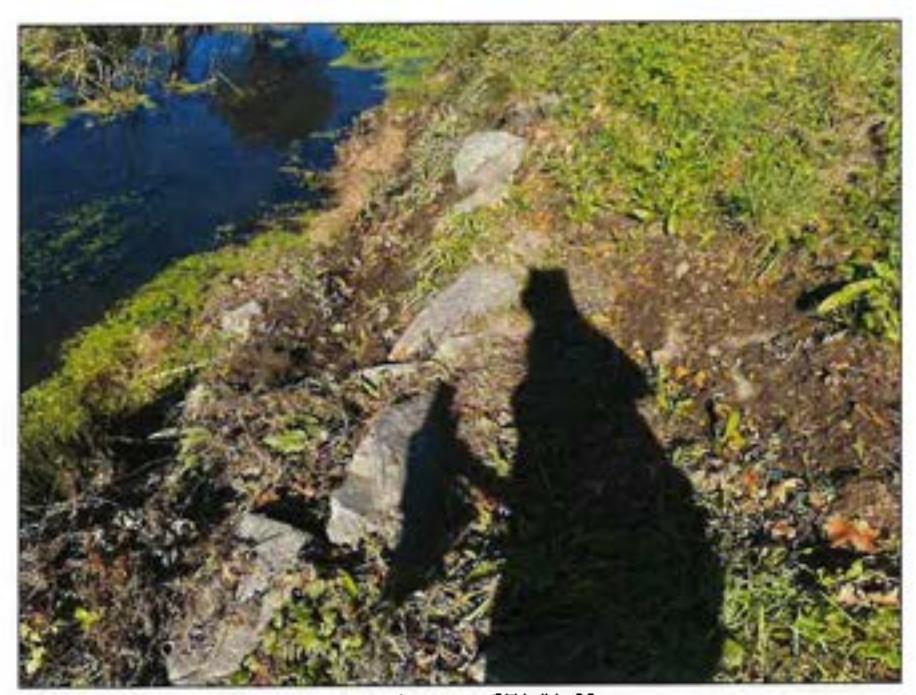
Photo No. 34.: Erosion on downstream slope near STA 54+00.

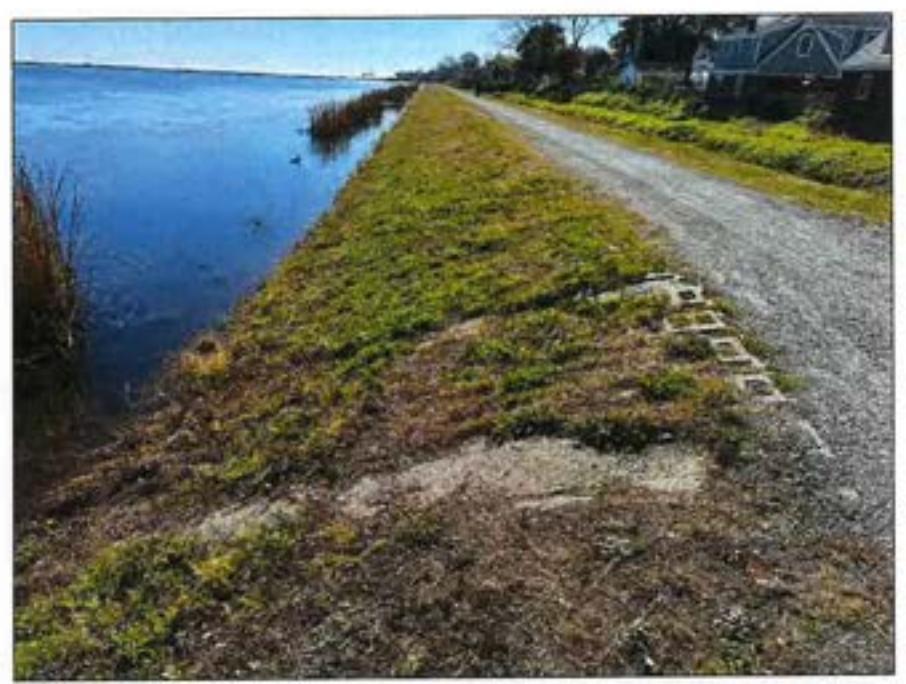
Photo No. 37.: Upstream stope from STA 57+00 looking left.

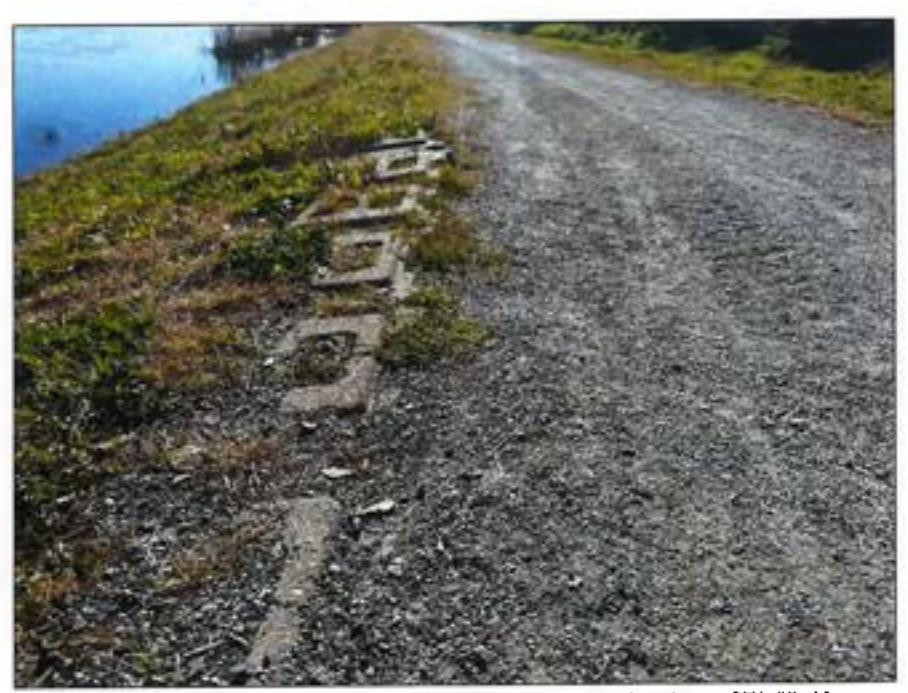
Photo No. 38.: Exposed ACBs slightly higher than the crest at the bend near STA 57+10.

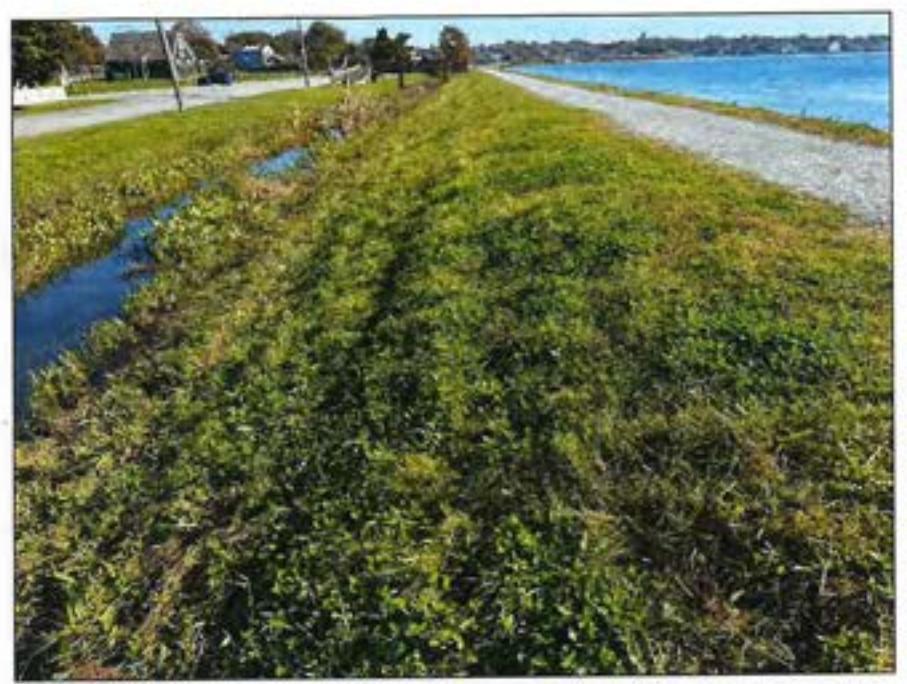
Photo No. 41 .: Downstream slope from STA 58+00 looking right.

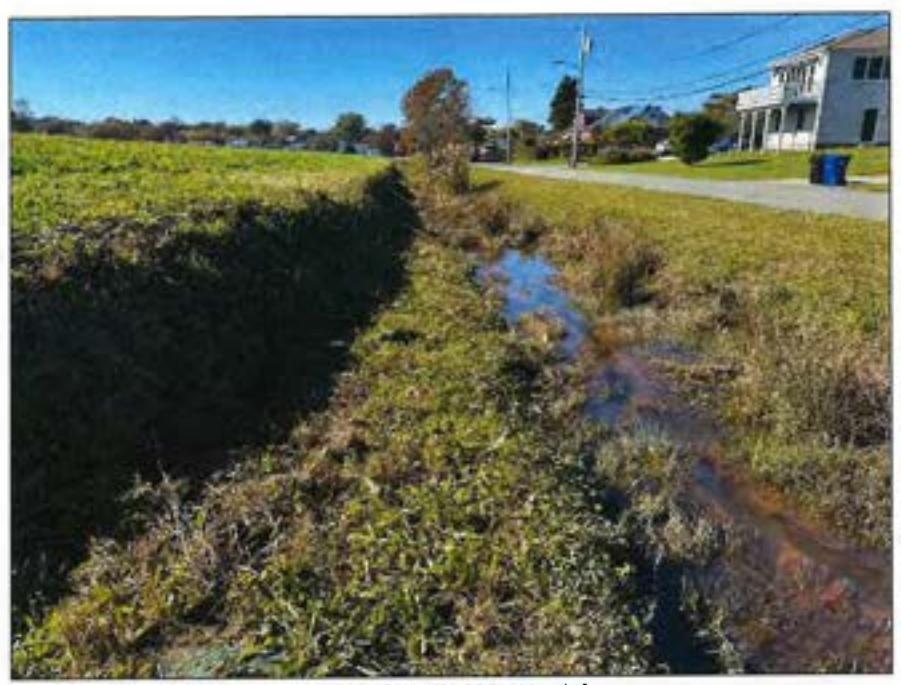
Photo No. 45.: Downstream slope from STA 70+00 looking left.

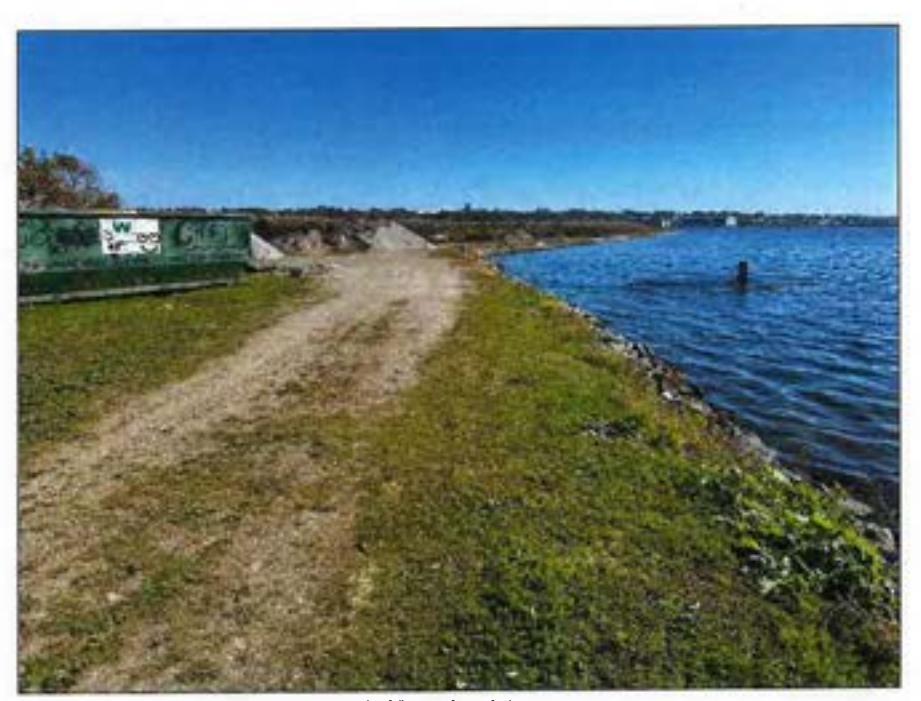
Photo No. 46.: Overview from STA 71+00 looking right.

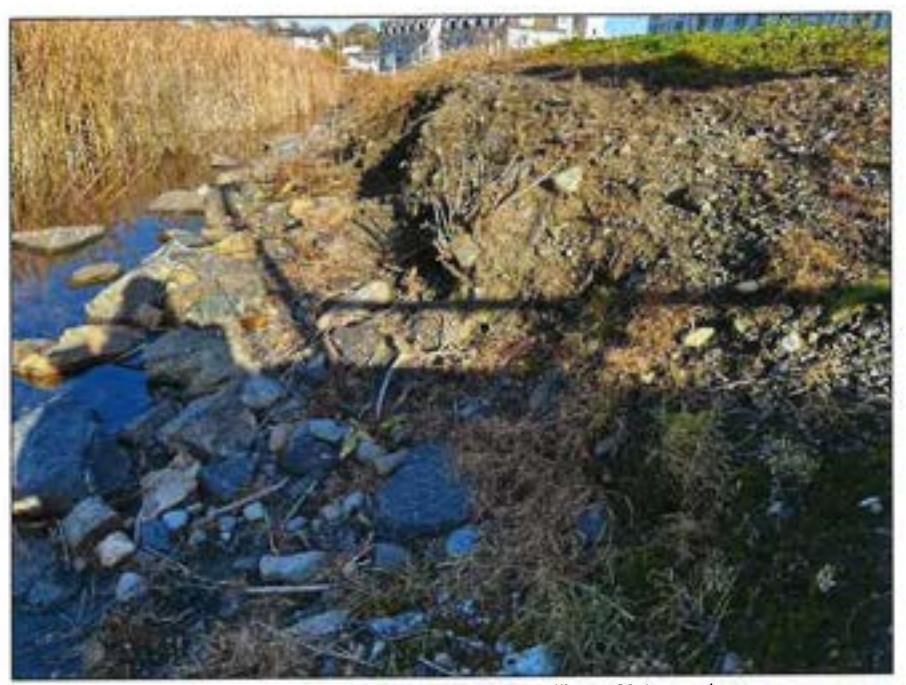
Photo No. 49.: Upstream slope to the left of the primary spillway. Note erosion.

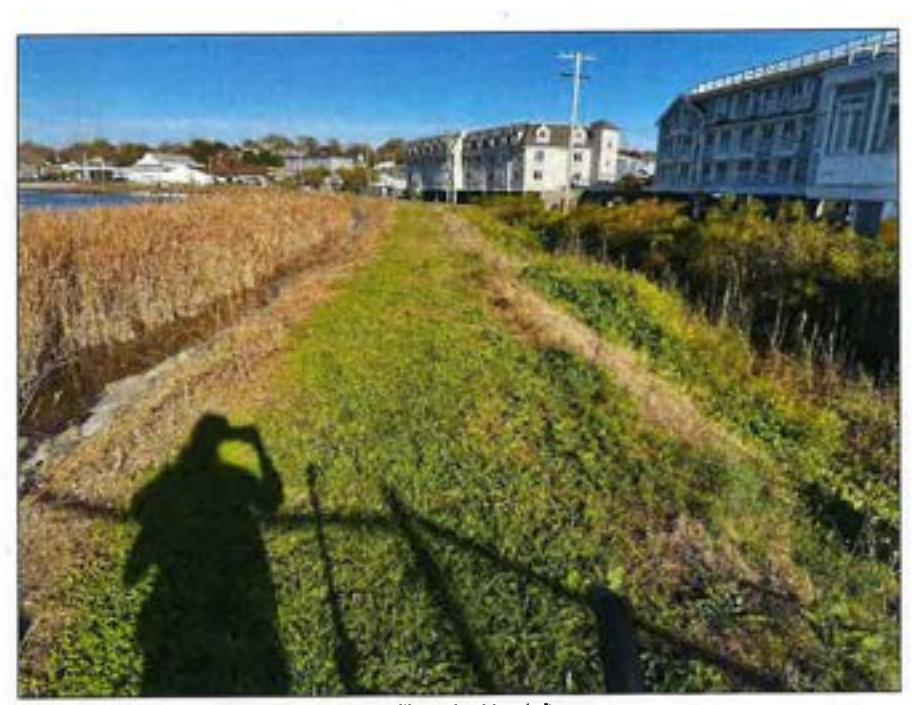
Photo No. 50.: Crest from the primary spillway looking left.

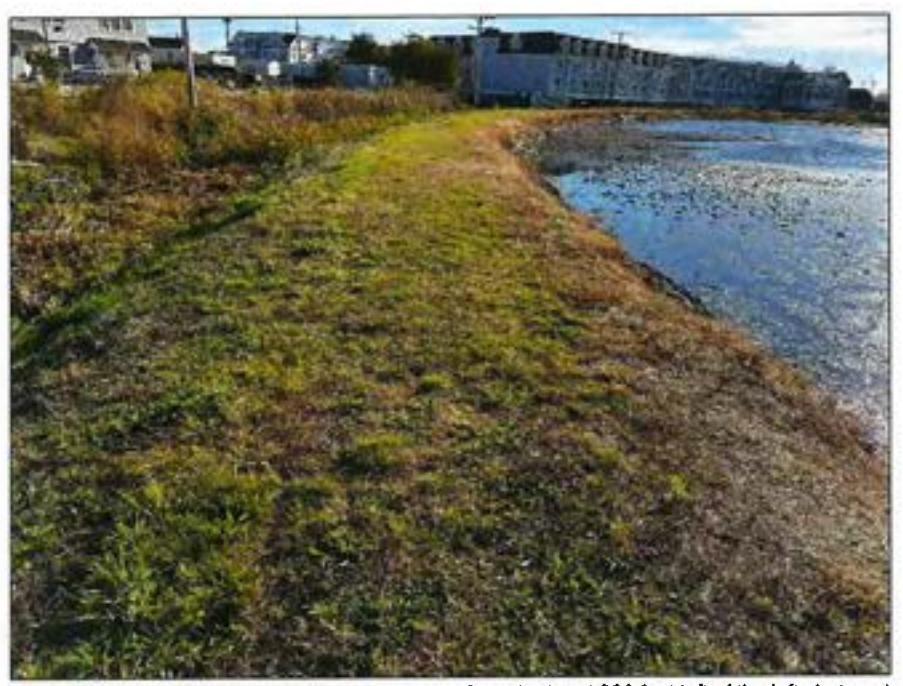
Photo No. 53.: Overview of embankment looking from the bend 900 feet left of the left abutment looking right.
