City of Newport, Rhode Island

Application for State Assent: Vegetative Clearing & Stabilization Plan for Old Sediment Basin (North & South Easton Pond)

DAM SAFETY: INTERIM STABILIZATION REPORT

North & South Easton Pond in Vicinity of Old Sediment Basin

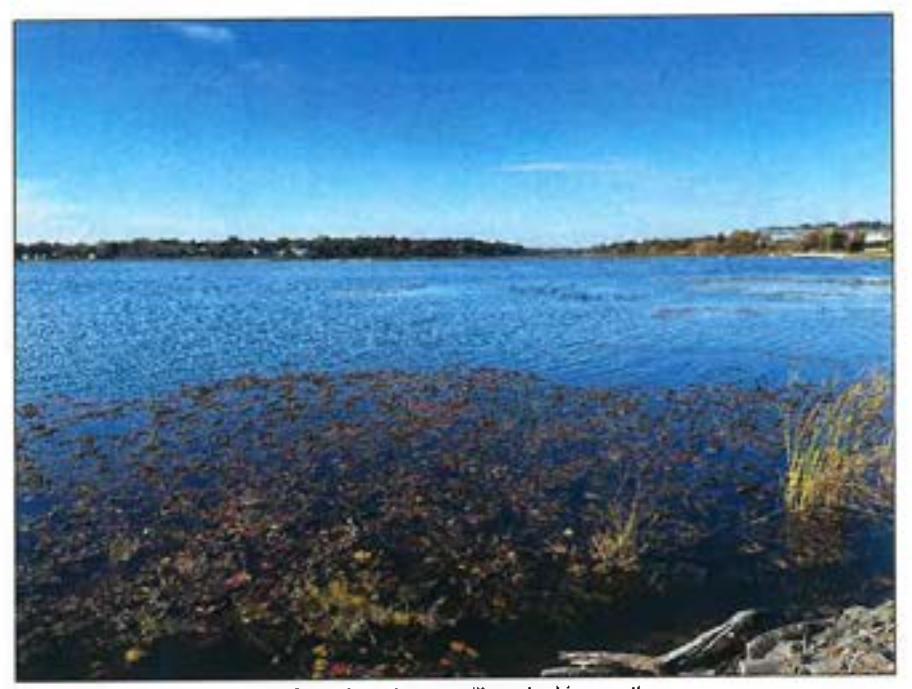
Photo No. 57.: Impoundment from the primary spillway looking north.

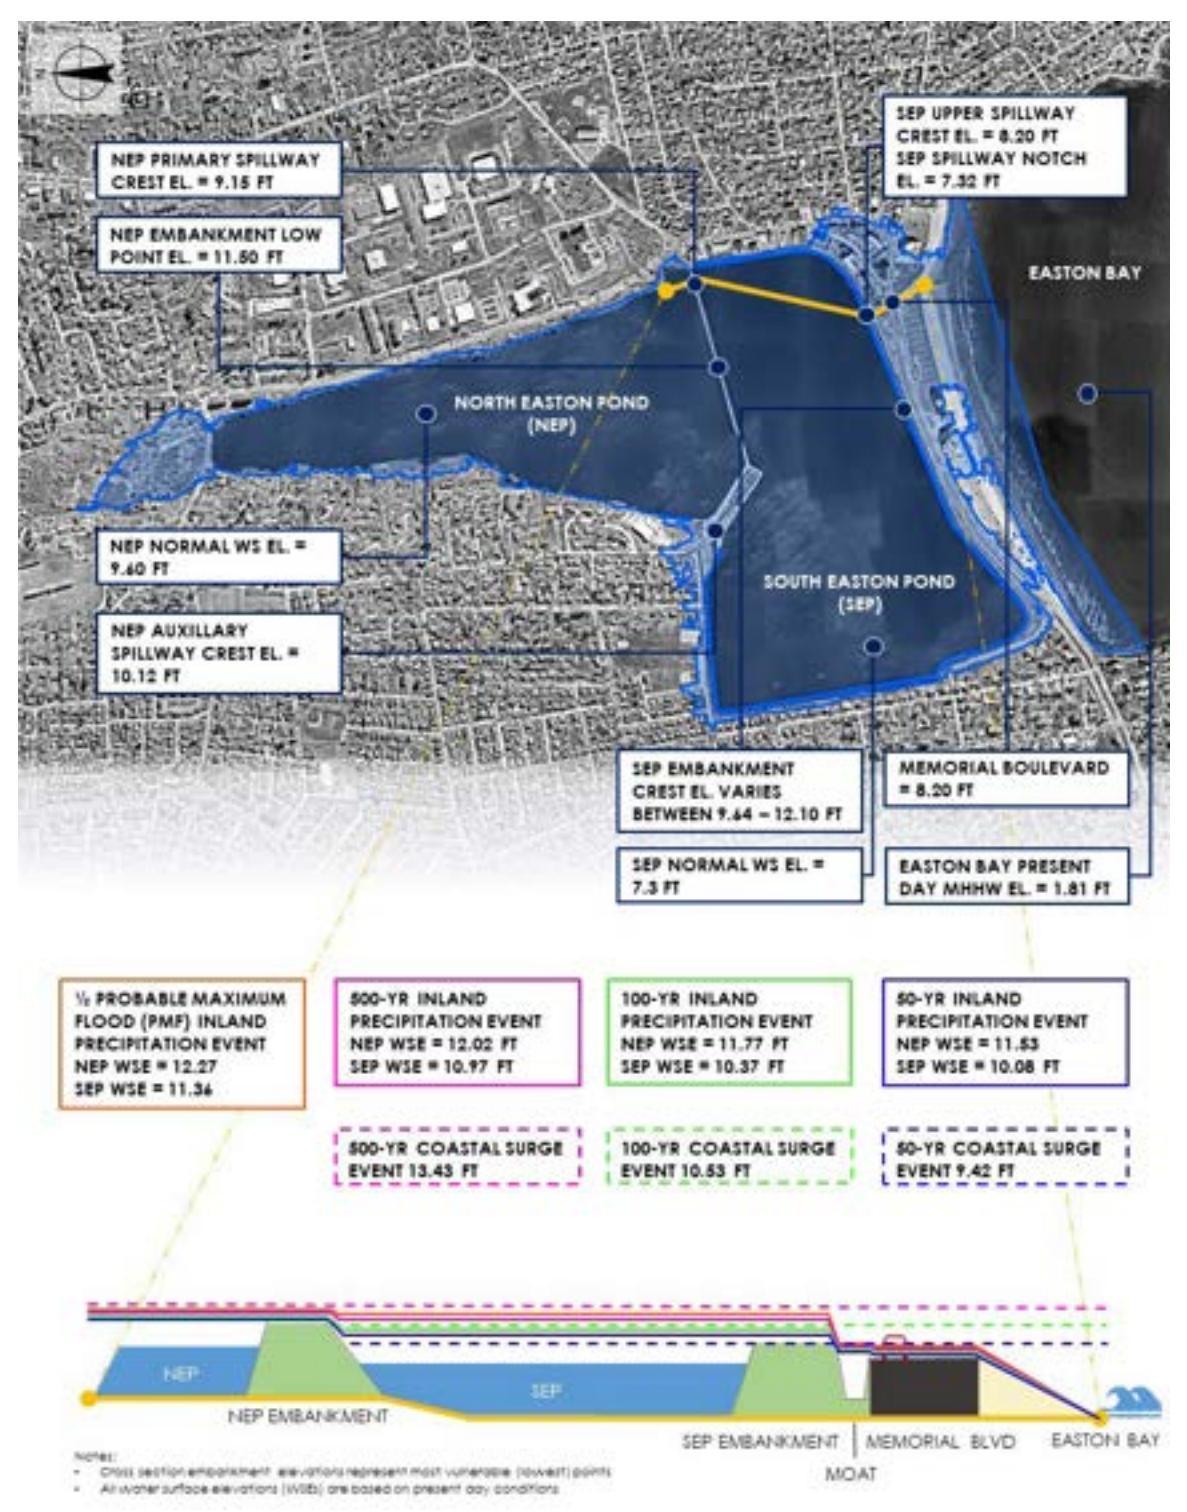
Figure 3: Peak Water Surface Elevation Plan & Profile View for Existing Conditions (Present-Day)

- The present-day 50-year inland precipitation event could exceed the capacity of both dams and overtop existing low points in their embankments. Under predicted 2070 climate conditions, the SEPD capacity may be exceeded by the 10-year inland flood, potentially resulting in overtopping and failure for what is a substantially smaller storm frequency. Overtopping and resultant erosion is a common mechanism for dam failure.

The above information is summarized in Figure 3, which displays key infrastructure elevations as they relate to inland flood elevations calculated by the Fuss & O'Neill hydraulic model and coastal surge elevations as reported by the US Army Corps of Engineers and adjusted by Woods Hole Group in the 2019 Climate Resiliency Memorandum.

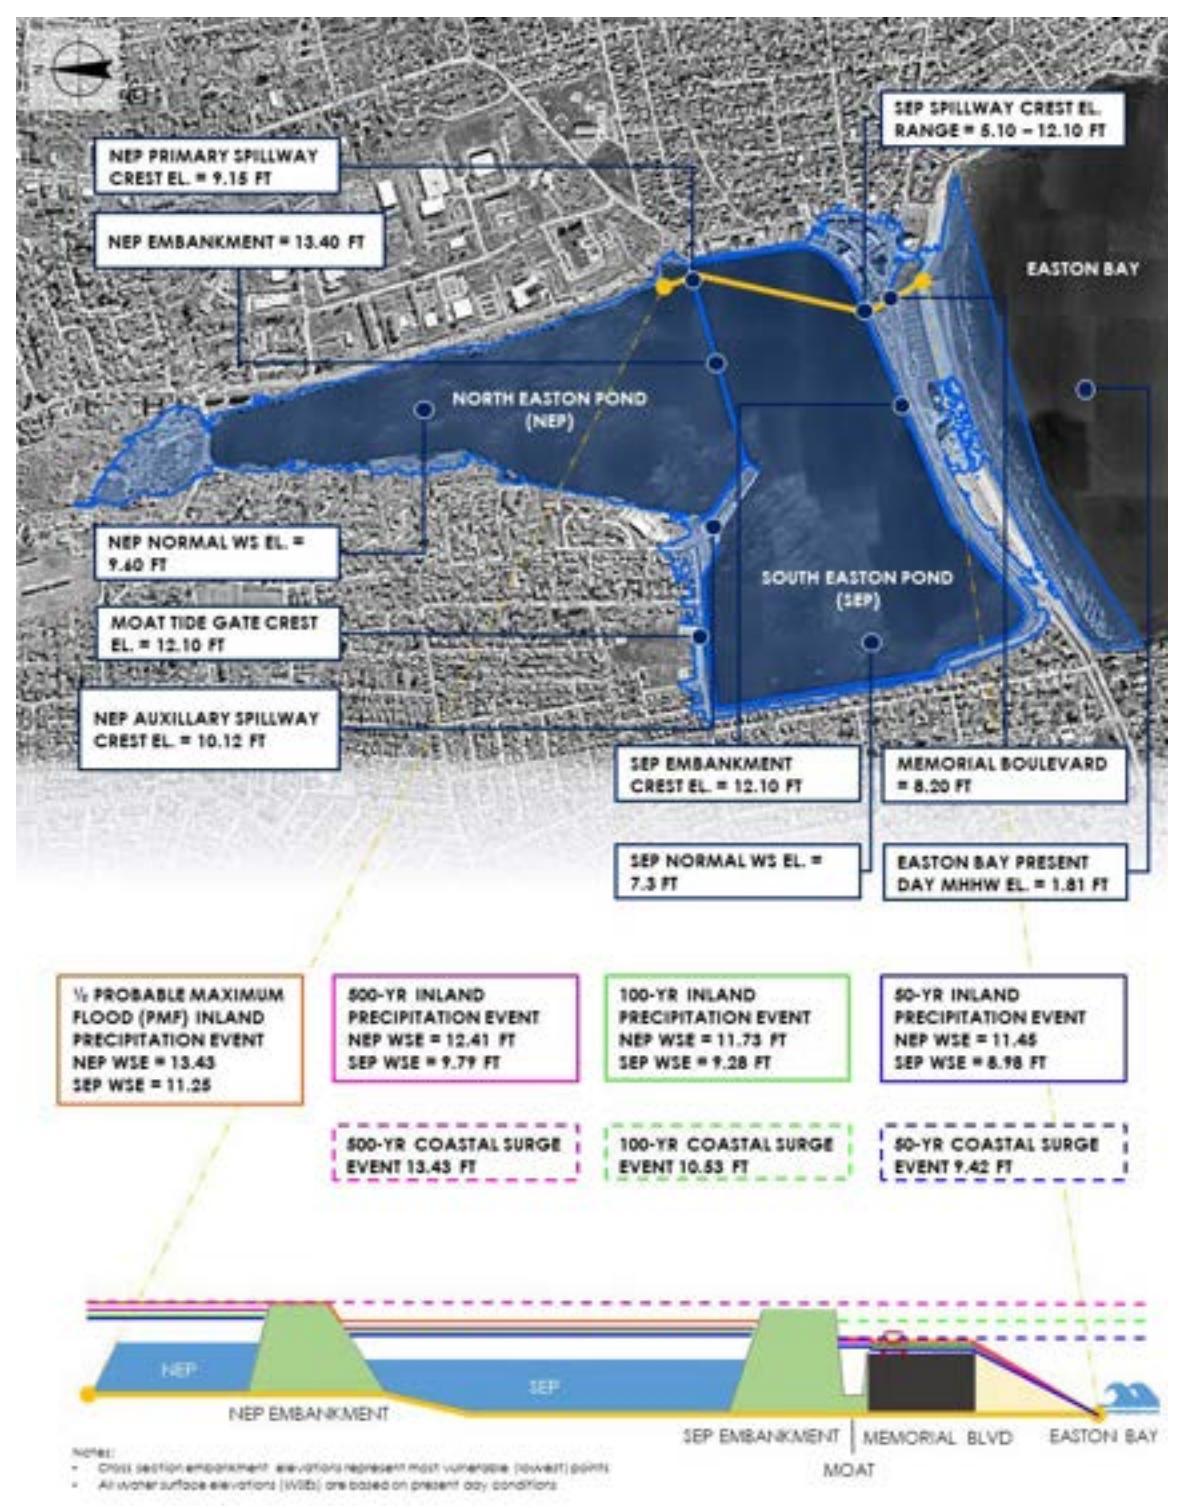
Figure 5: Peak Water Surface Elevation Plan & Profile View for Recommended Alternative (Present-Day)

Table 2 summarizes present-day and 2070 flood protection levels under existing conditions and under the recommended alternative. Figure 5 displays these results at the project site.

To account for vulnerabilities at the existing dams and to provide resilience for 2070 predicted climate conditions, Fuss & O'Neill recommends proceeding with Alternative 4 which includes several modifications that are recommended as amended by this study. A conceptual drawing of the recommended alternative can be seen in Figure 4. The recommended alternative proposes:

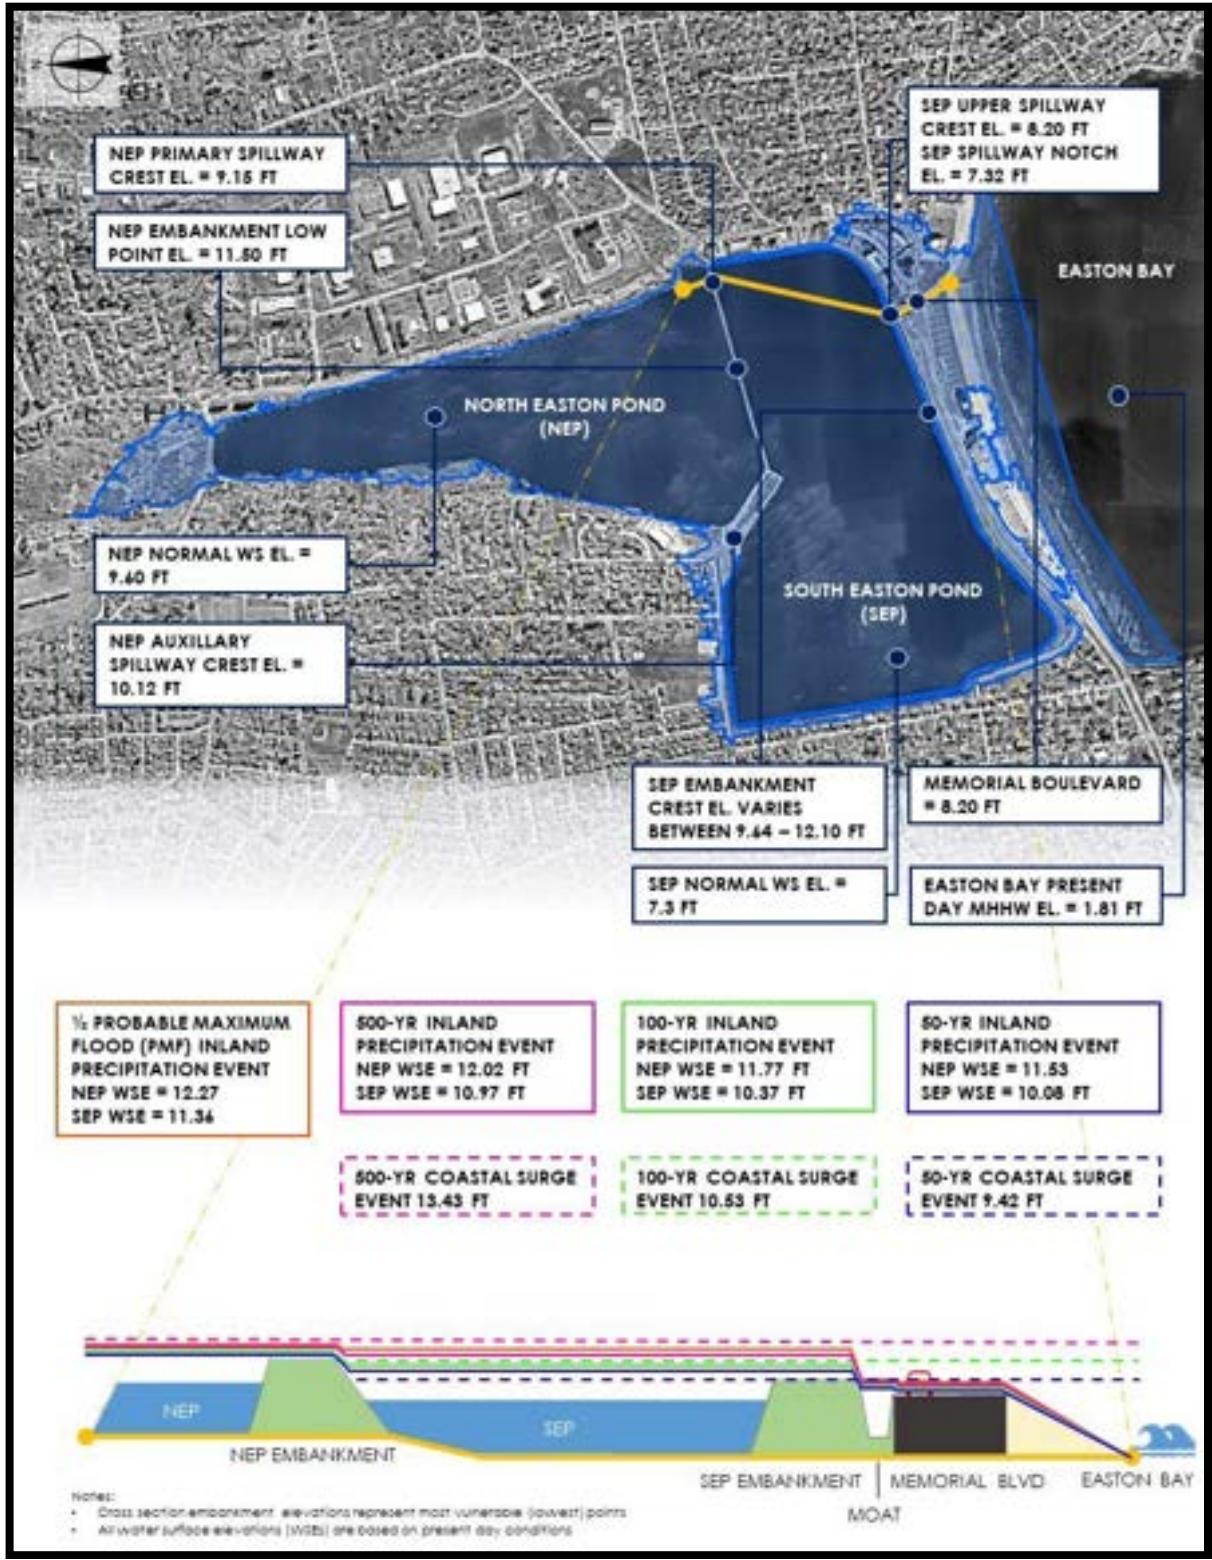
Figure 1: Peak Water Surface Elevations Plan & Profile View for Existing Conditions (Present-Day)

Table 1 summarizes present-day and 2070 flood protection levels under existing conditions and under the recommended alternative. Figure 1 and Figure 2 display selected results at the project site.

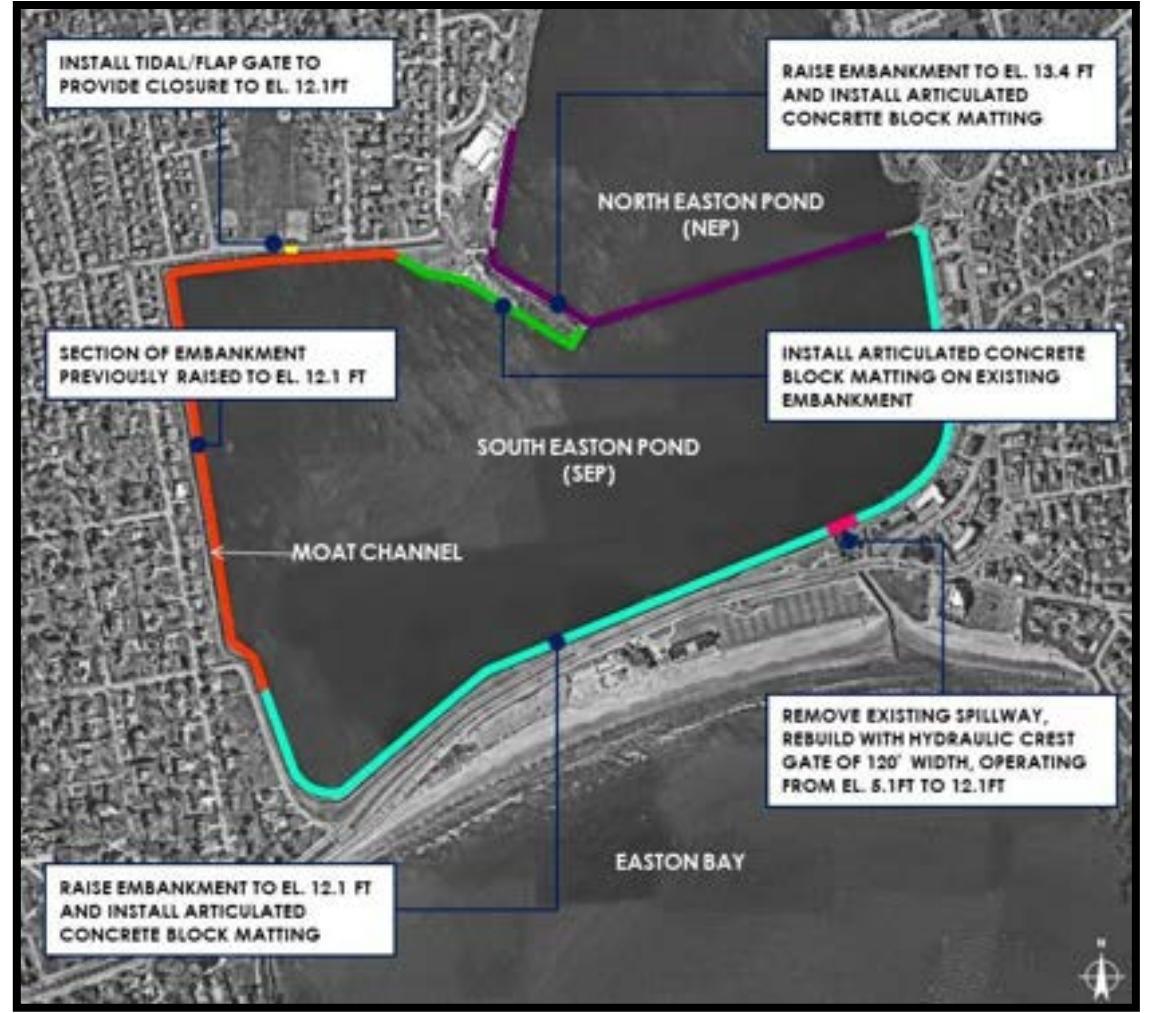
Figure 8: Summary of Improvements Proposed Under Amended Alternative 4

Because peak water surface elevations in NEP Dam still exceed that dam's proposed embankment elevations during the ½ PMF event, the embankment separating NEP and SEP Dam should be designed and constructed to overtop without forming a breach. Further, it was necessary to model Alternative 4 to determine the inflow design flood by evaluating dam breach hazards under proposed conditions. That process, in combination with modeling of more frequent large storm events without a breach to ensure downstream elevations are not increased, assisted in confirming Alternative 4 as the recommended alternative. Improvements Proposed under Alternative 4 are summarized in Figure 8.

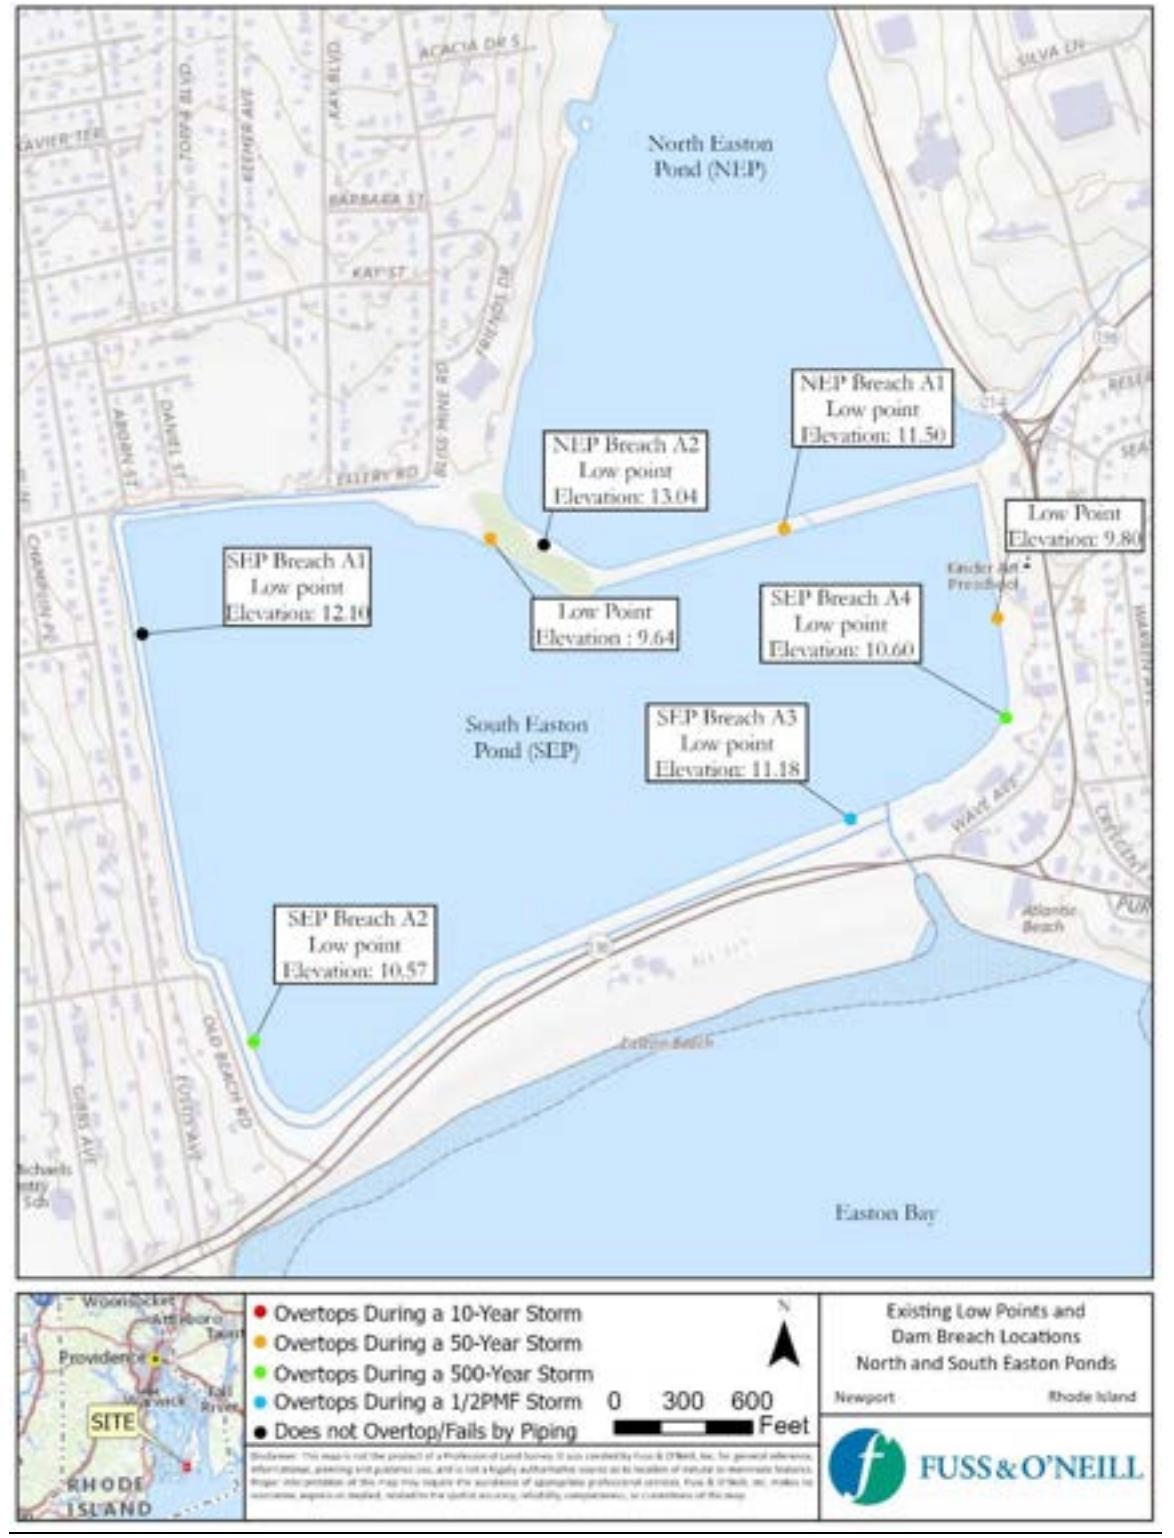
Figure 13: Modeled dam breach locations and existing embankment low points at NEP Dam and SEP Dam

- Theoretical dam breach locations were chosen to assess the localized effects of dam failure at multiple points in the NEP and SEP dam embankments. Dam breach locations and the corresponding present-day storm during which the localized existing crest elevation would be exceeded are displayed in Figure 13. These locations correspond with surveyed low points in the existing dam embankments that may be prone to overtopping and subsequent failure, and/or were chosen based on their proximity to downstream development and infrastructure.

- For storm events that did not overtop the dam embankments, dam breaches were modeled as a piping failure in the same location.
